# Appendix A

Estimated Zones of Potential  
Recharge and Discharge Areas

### Six Conservation Authorities Geological and Hydrogeological Model Project

## Assessment of Water Bodies and Distance to Project Components

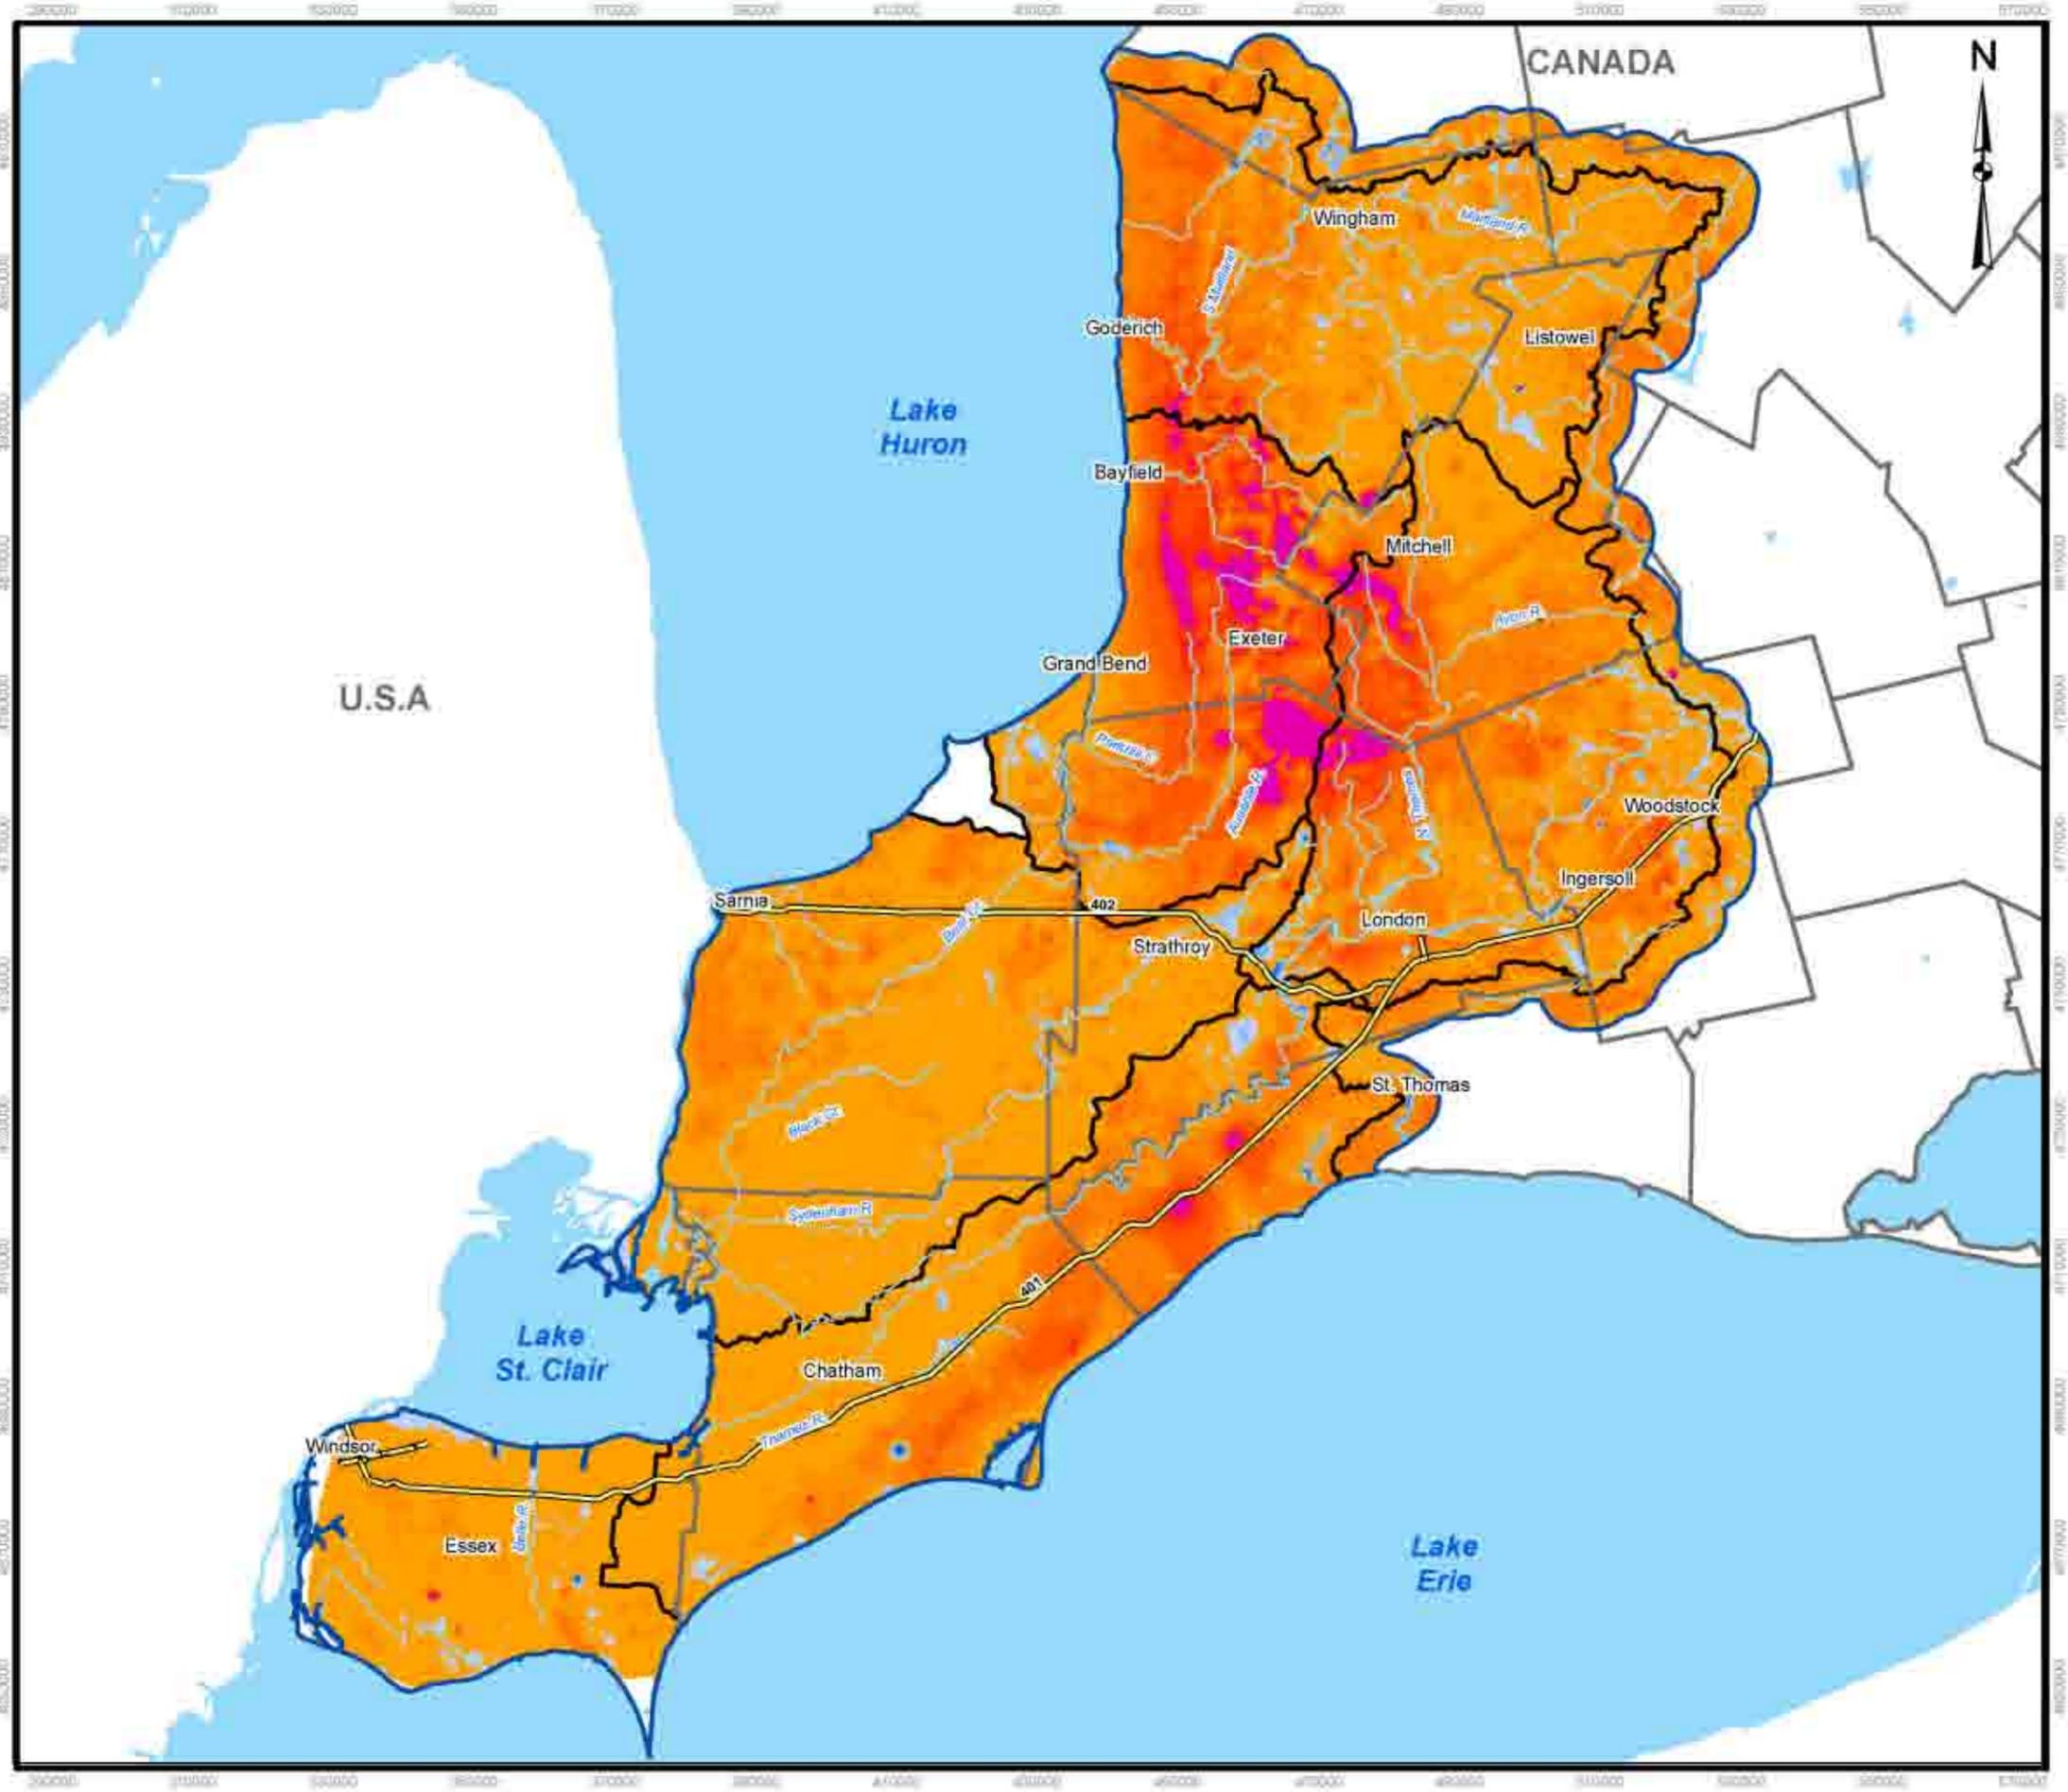
**Figure 24: Recharge/Discharge**

Disclaimer: This map is intended for illustrative purposes only. Figure is to be read in conjunction with the Six Conservation Authorities FEFLCW model report.  
 Digital Mapping Sources: Base mapping features - Ministry of the Environment; Water well information - Ministry of the Environment.

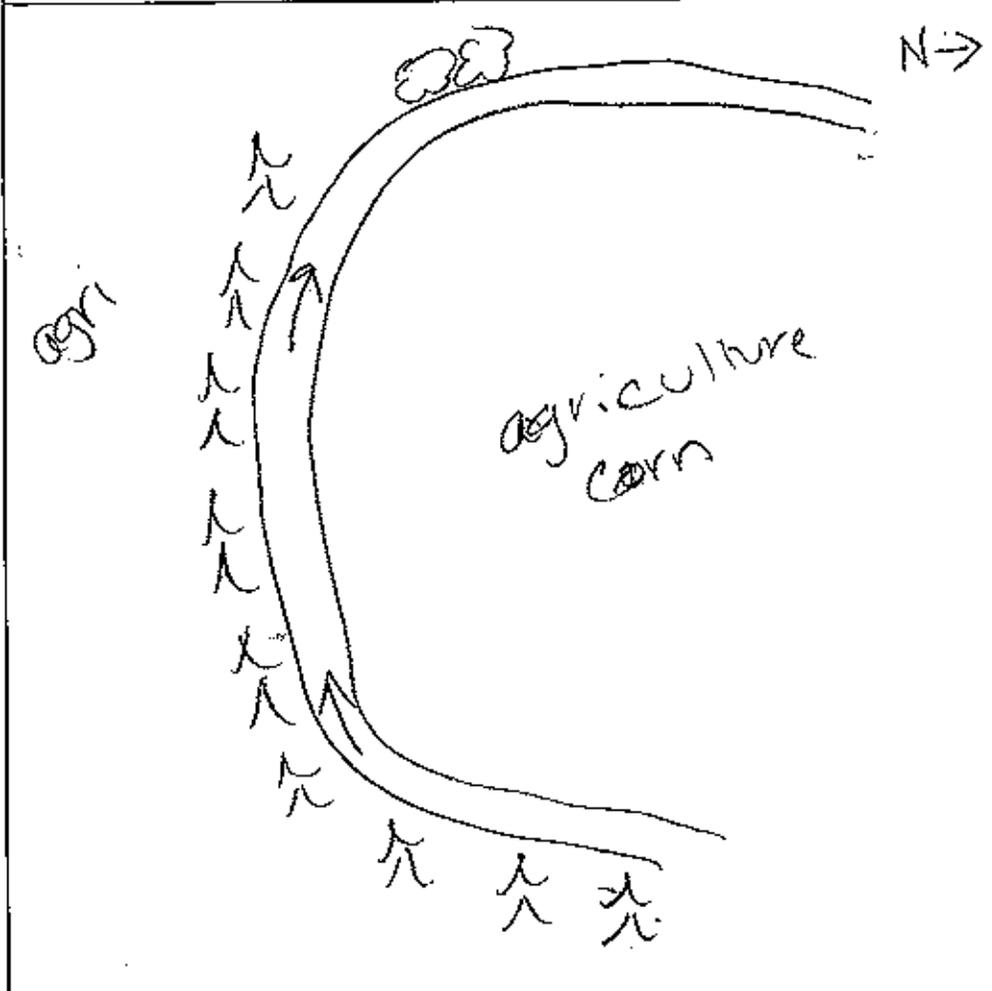
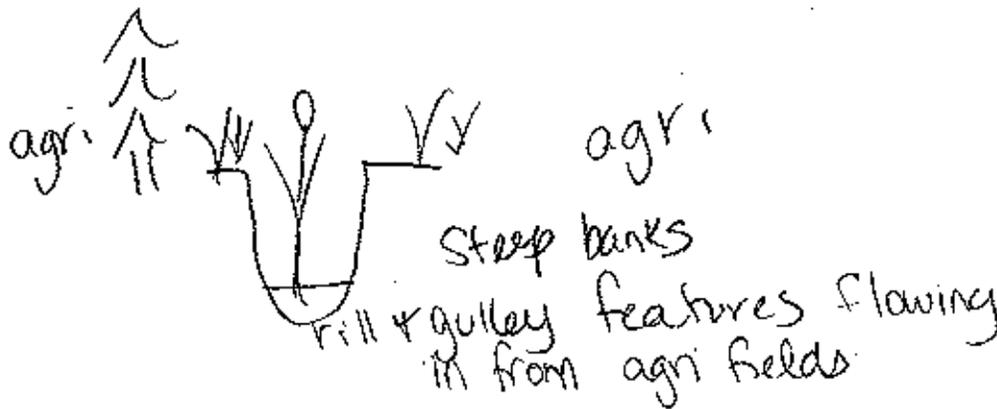
Study Area: Jericho Goshen Bluewater Land Parcel# 1031 Turbina# SMW10

Watercourse Sketch

Horizontal View of Channel

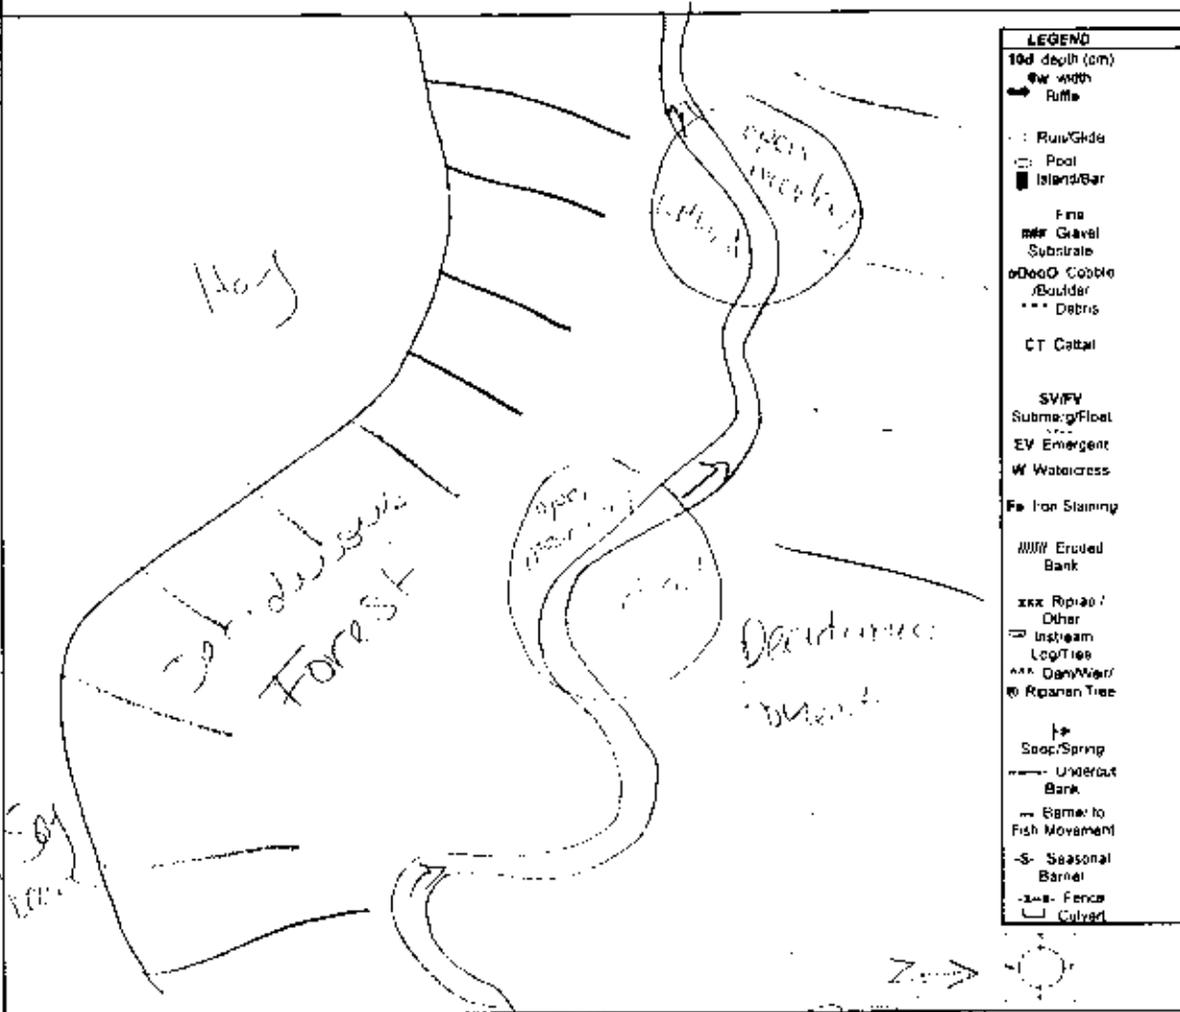
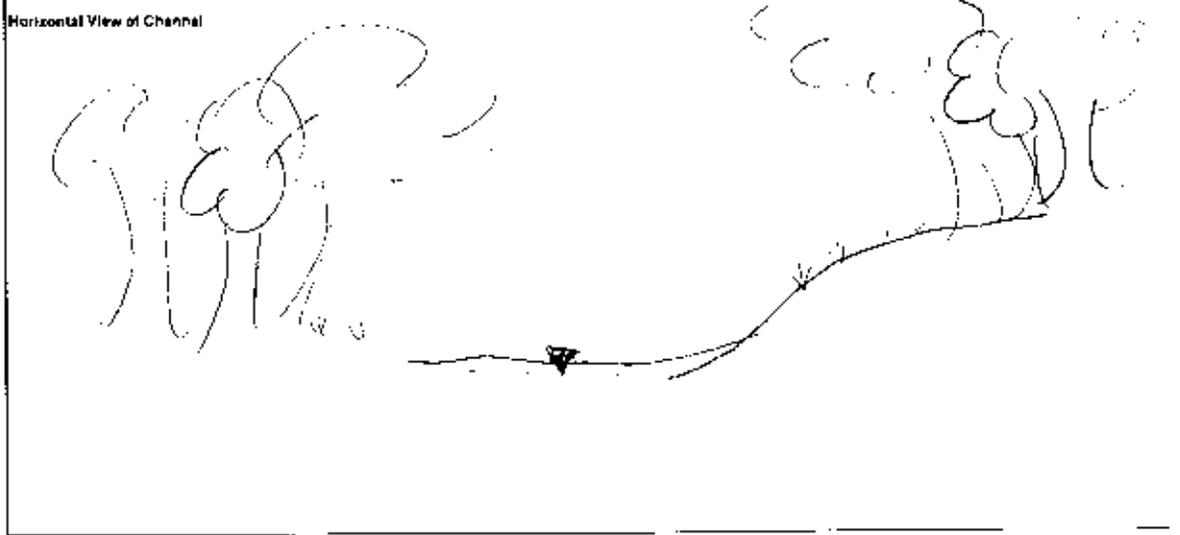
Study Area: Jericho Goshen Bluewater Land Parcel# 1665 Turbine # SMNS - 6016

Watercourse Sketch

Several small tributaries observed flowing into stream, several dry ephemeral pools + dry creek beds observed					
<b>In-Situ Water Quality</b>		<b>Ground Water Indicators</b>			
WT (°C)	17.5	AT (°C)			
pH	8.32	Cond (µS/cm)	0.65		
Water Clarity:	Clear <input checked="" type="checkbox"/>	Turbid <input type="checkbox"/>			
		Watercress	<input checked="" type="checkbox"/>		
		Bubbling	<input type="checkbox"/>		
		Iron Staining	<input type="checkbox"/>		
		Bank Seepage	<input checked="" type="checkbox"/>		
		None	<input type="checkbox"/>		
		Other	<input type="checkbox"/>		
Notes: lots of bank seepage observed mostly along RB - slightly turbid watercourse					
<b>Stream Morphology</b>					
Site Length (m):	Bank Stability:				
Channel Dimensions	Stable	Slightly unstable	Moderately unstable		
Mean Wetted Width (m): 1.5	Left Bank	<input checked="" type="checkbox"/>	<input type="checkbox"/>		
Mean Bankfull Width (m): 3.0	Right Bank	<input checked="" type="checkbox"/>	<input type="checkbox"/>

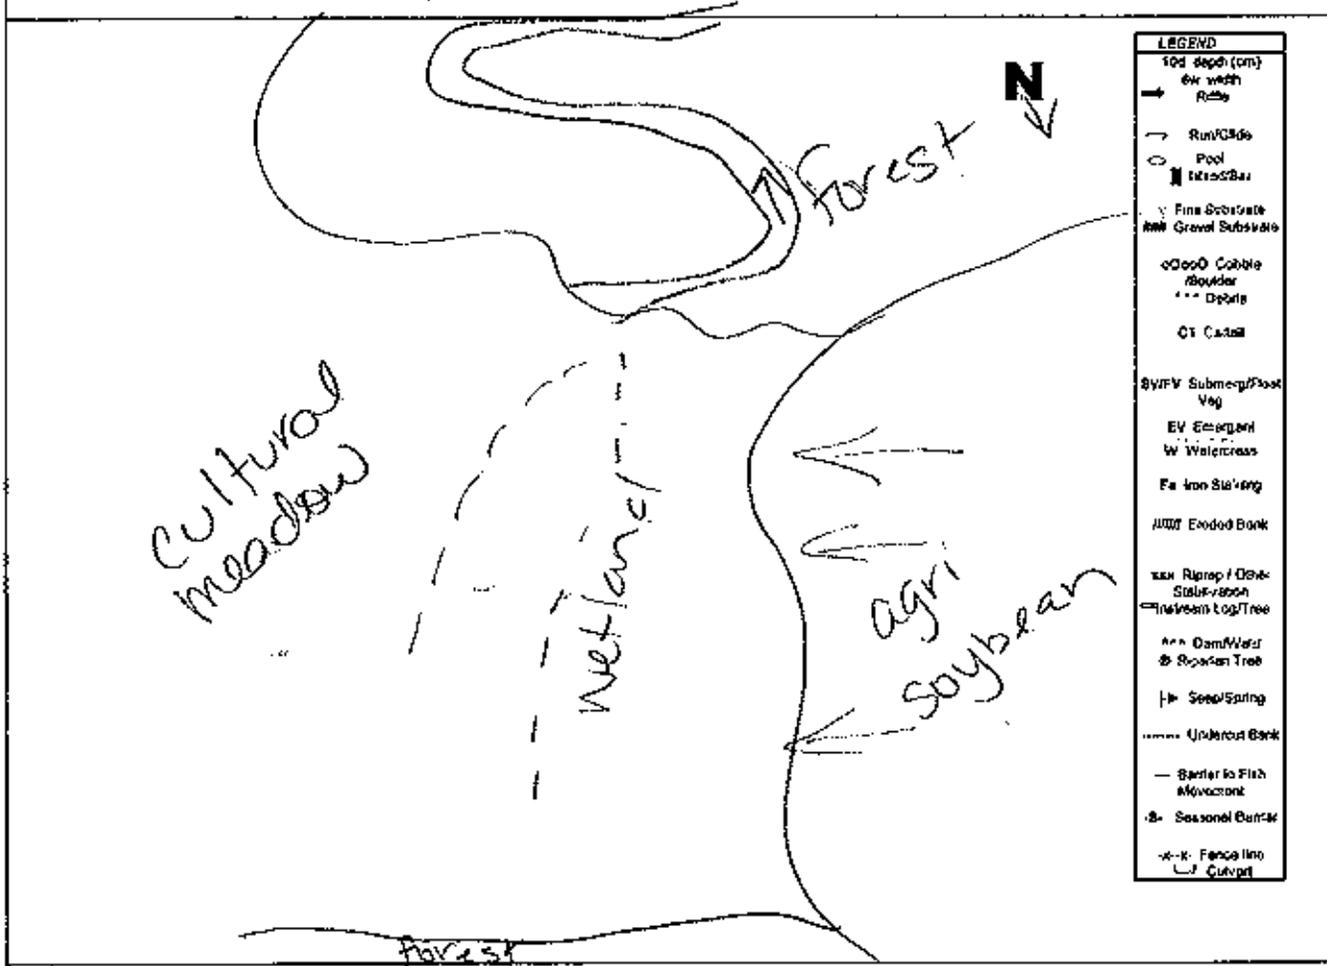
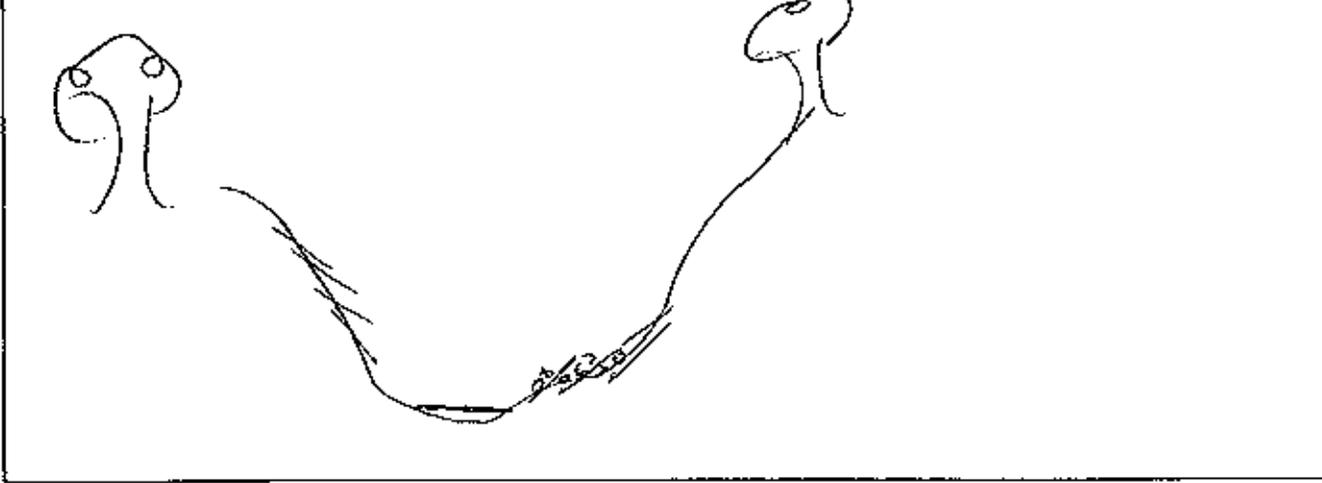
Study Area: Jericho Goshen Bluewater Land Parcel# 1047 Turbine # GTE168

Watercourse Sketch

Horizontal View of Channel

- trail running through wet area dividing channel
- assessment done in forest
- highly meandering channel, with obvious flashflooding due to unstable eroded banks and deposition
- no fish observed
- observed water striders, racoon prints

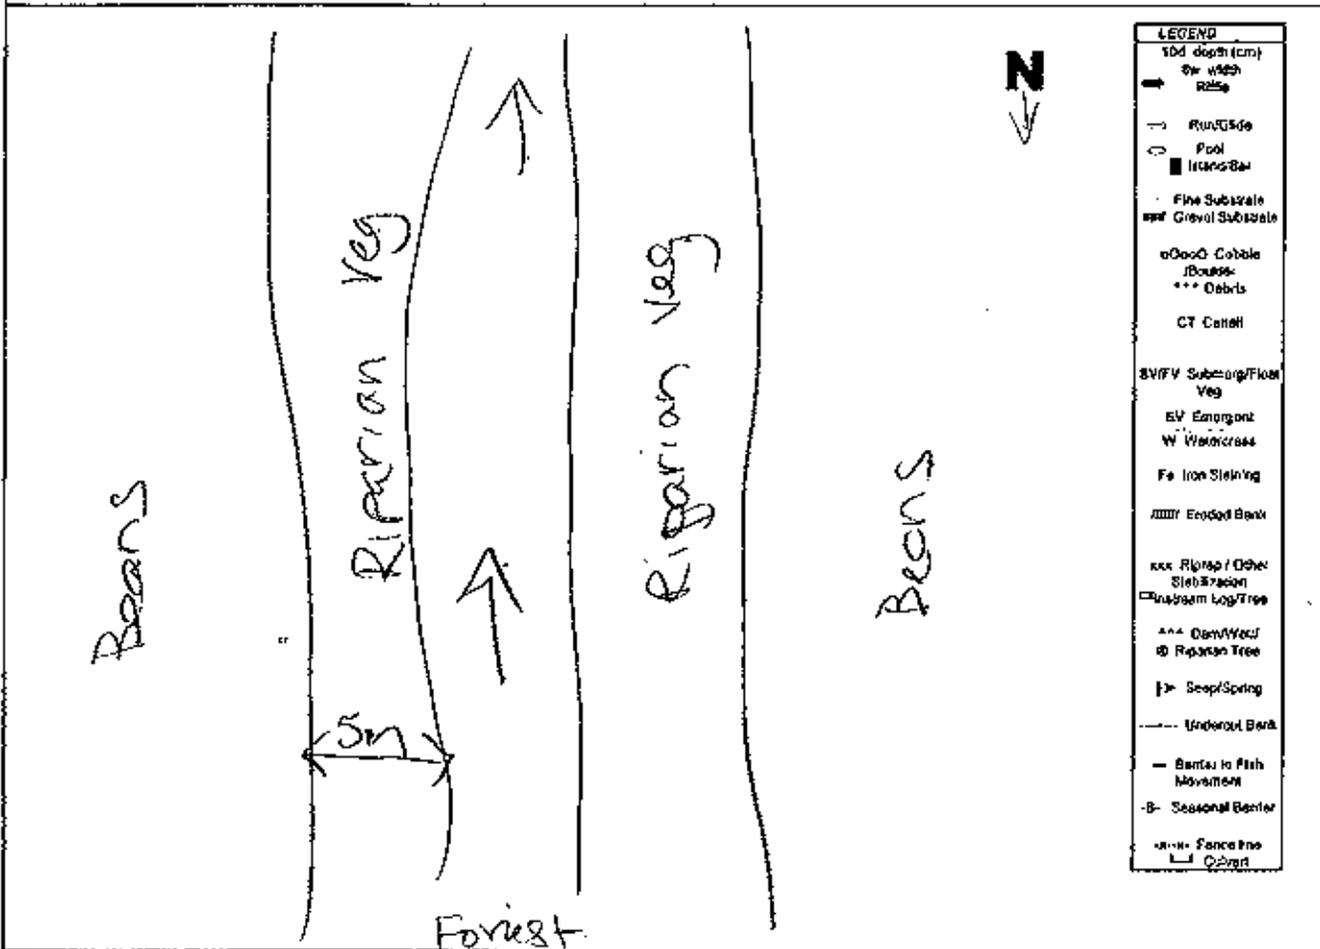
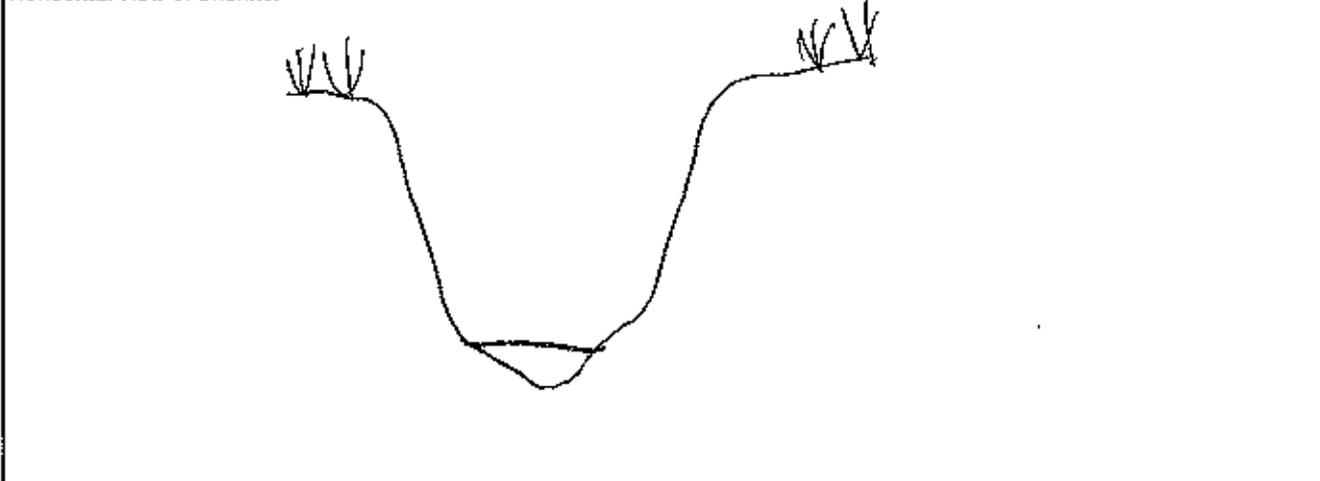
Study Area: Jericho Goshan Bluewater Land Parcel# 136A Turbine # GE16A112

Watercourse Sketch

Horizontal View of Channel

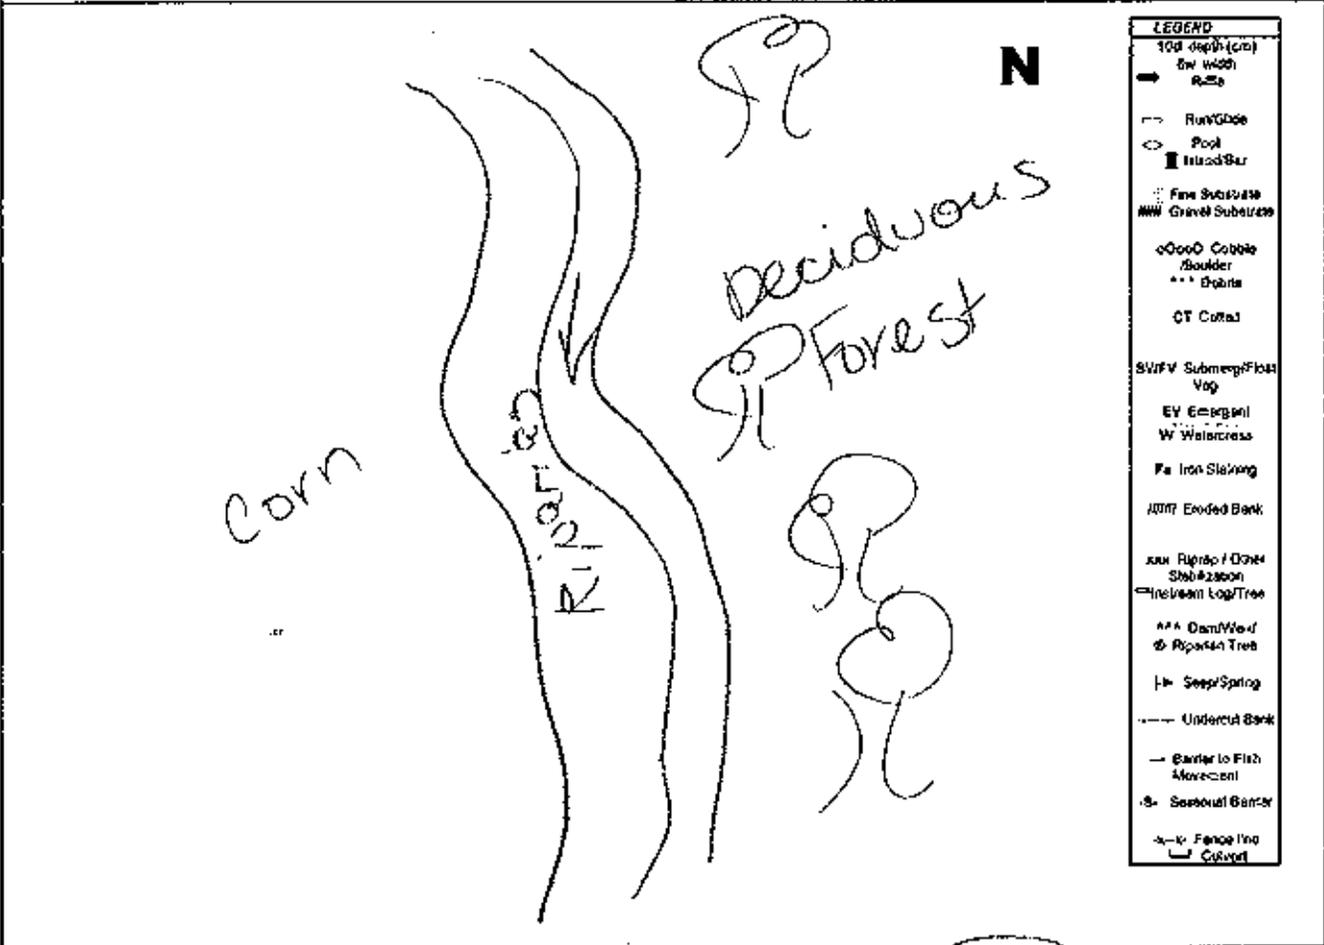
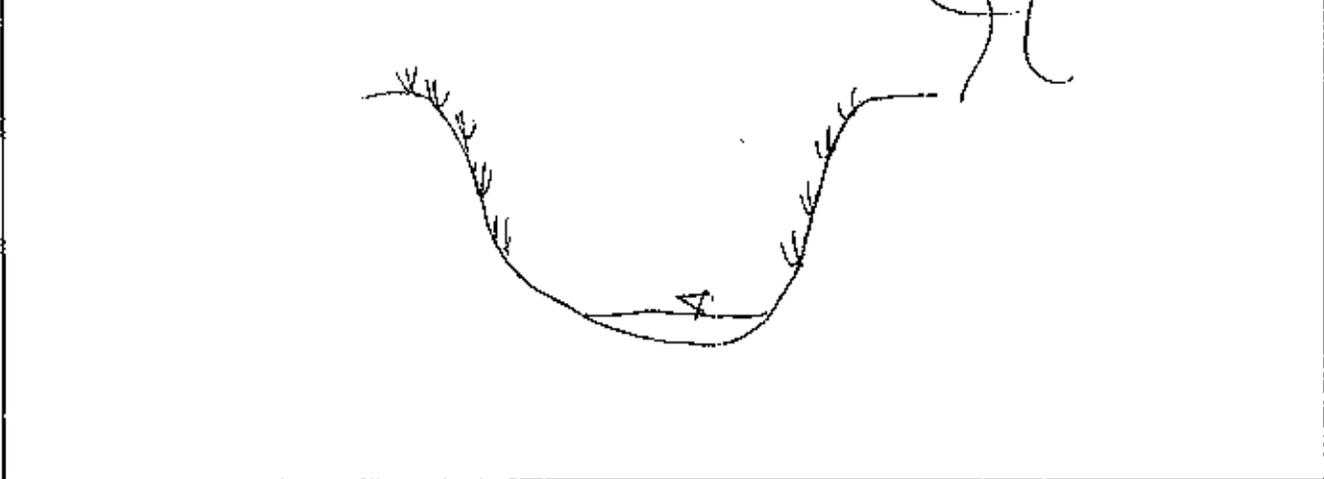
Study Area: Jericho Goshen Bluewater Land Parcel# 1036 Turbine #

Watercourse Sketch

Horizontal View of Channel

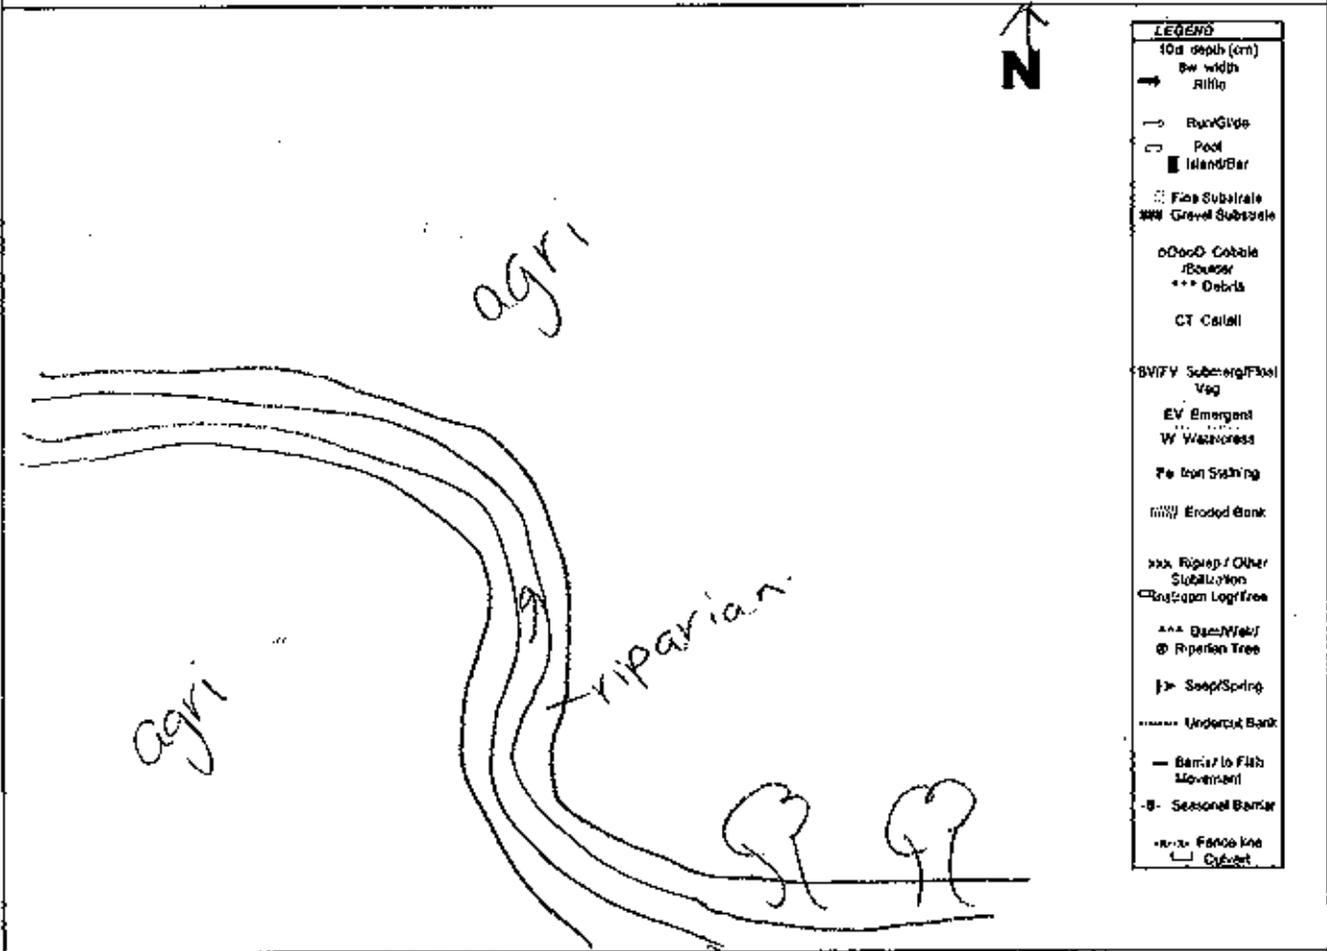
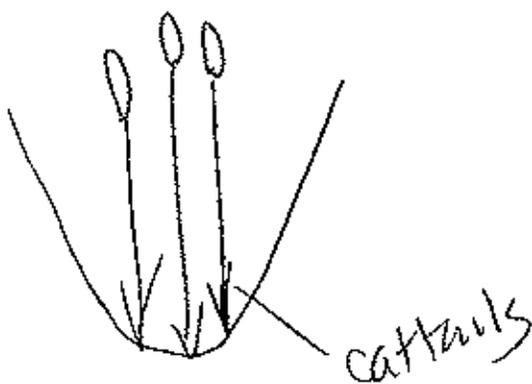
Study Area: Jericho Goshen Bluewater Land Parcel# 1824 Turbine # 61E 16-3

Watercourse Sketch

Horizontal View of Channel

Other:			
Notes: (include any inputs into the system i.e. tile drainage, seepages, overland flow)			
receives tile drainage from adjacent fields			
In-Situ Water Quality		Ground Water Indicators	
WT (°C):	AT (°C):	Watercross <input type="checkbox"/>	Bank Seepage <input type="checkbox"/>
pH:	Cond (µ/cm):	Iron Staining <input type="checkbox"/>	None <input checked="" type="checkbox"/>
Water Clarity: Clear <input type="checkbox"/>	Turbid <input type="checkbox"/>	Bubbling <input type="checkbox"/>	Other <input type="checkbox"/>
Notes:			
Stream Morphology			
Site Length (m):		Bank Stability:	
Channel Dimensions		Stable	Slightly unstable
Mean Wetted Width (m):	Mean Bankfull Width (m):	Moderately unstable	Unstable
Mean Wetted Depth (m):	Mean Bankfull Depth (m):	Left Bank <input checked="" type="checkbox"/>	<input type="checkbox"/>
		Right Bank <input checked="" type="checkbox"/>	<input type="checkbox"/>
Flow Description:

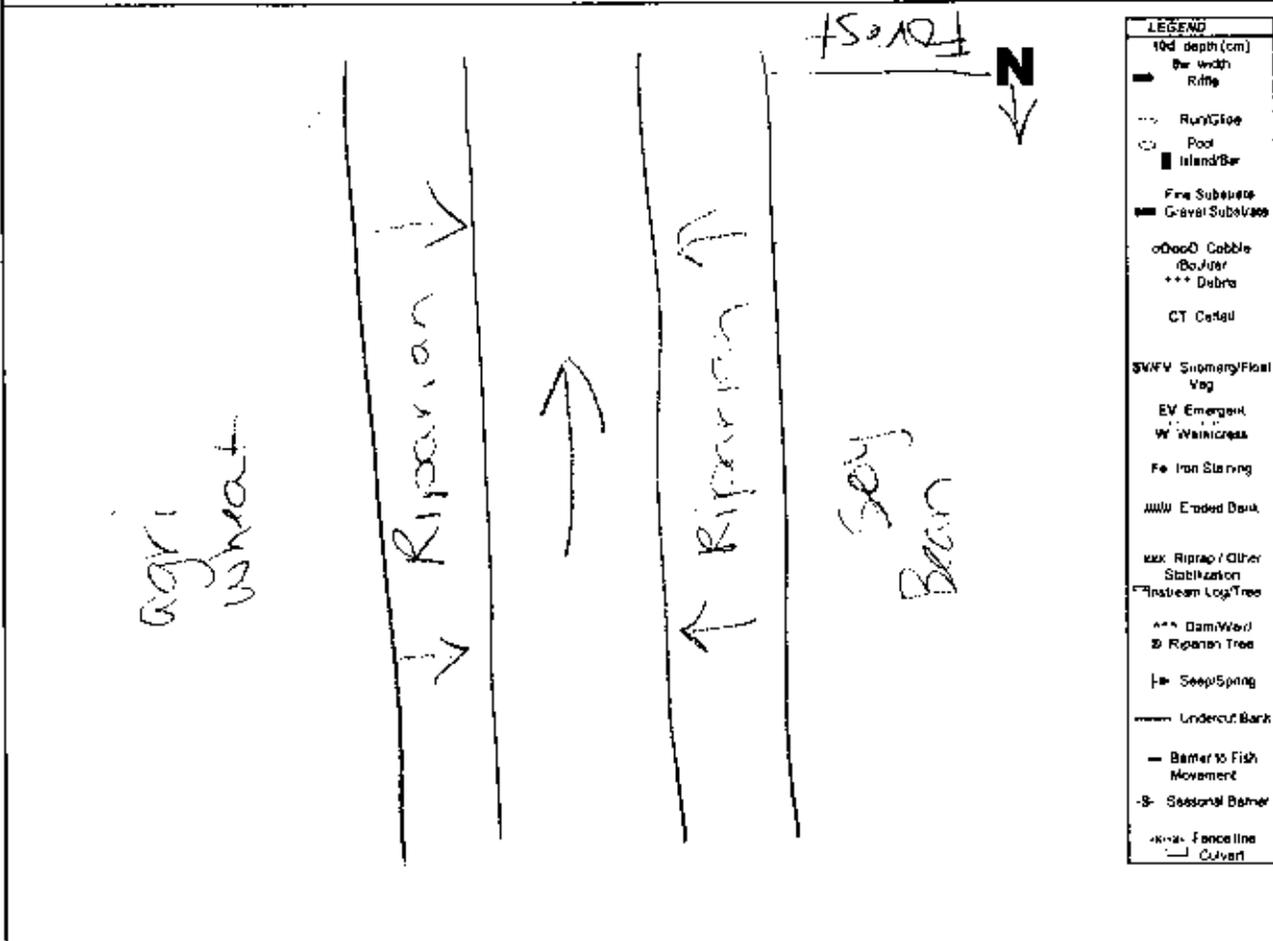
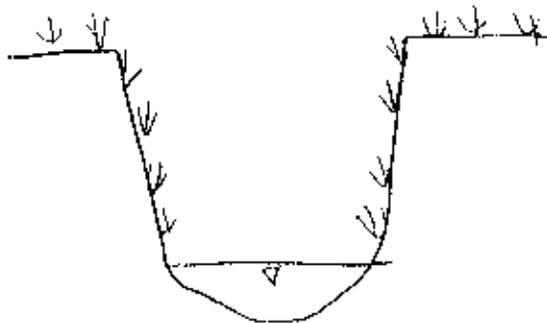
Study Area: Jericho Goshen Bluewater Land Parcel# 1853 Turbine # GE16-27

Watercourse Sketch

Horizontal View of Channel

- observed toadpole & heard green frog
- riparian 5.4m wide - all herbaceous + grasses
- fairly straight and uniform

Picture #	Description	Picture #	Description
1	overview from west side of stream		
2	facing ups		
3	facing ups		
4	pic of aquatic veg		
5	pool in middle of field - no rain - <sup>depression</sup>		observed lots of water on bank bottom 1.4 feet to 2.2 wet area 30m x 15m
6	view of wheat field where turbine will be

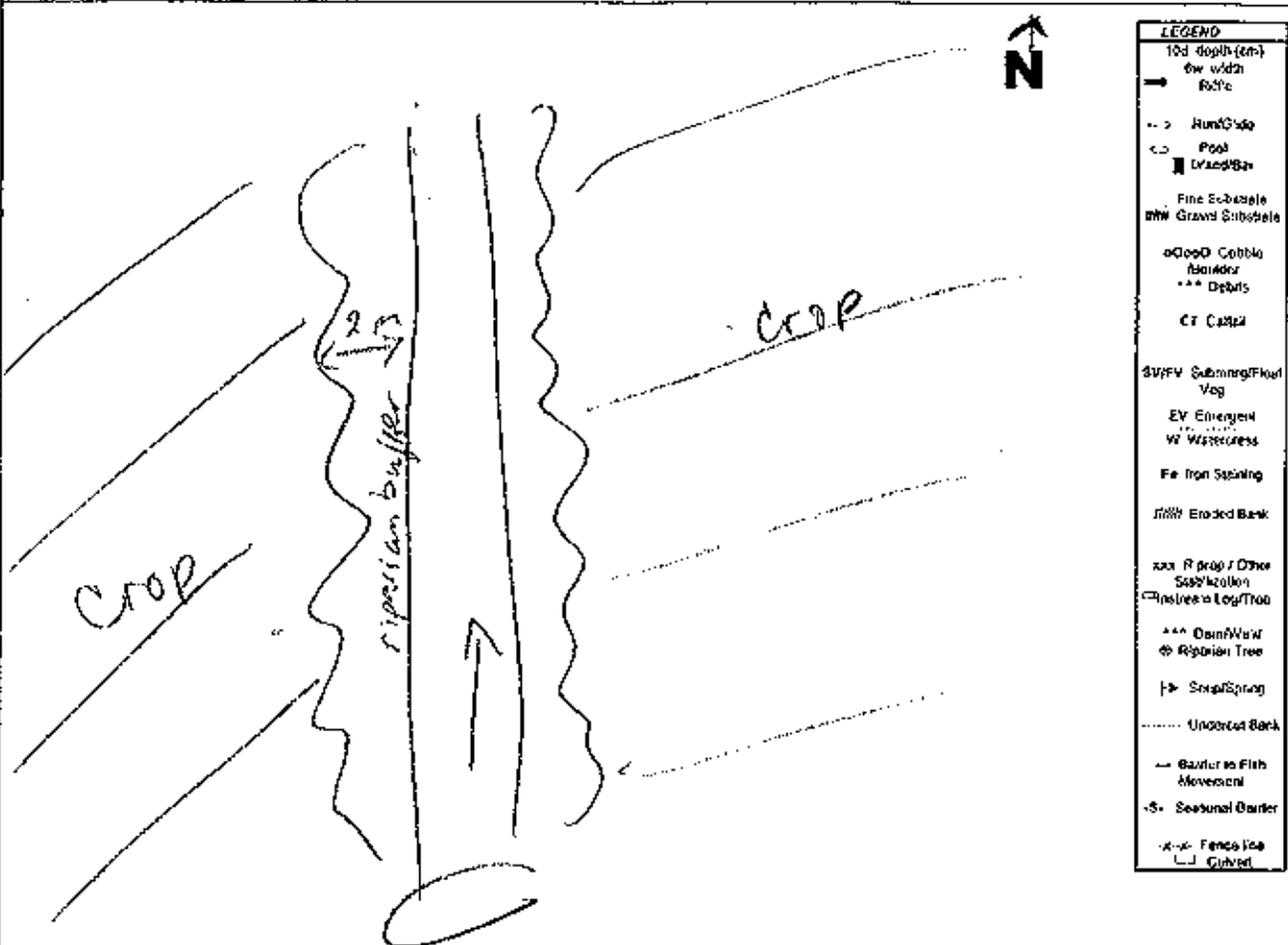
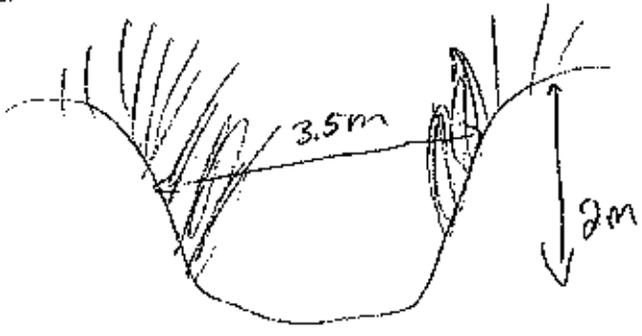
Study Area: Jericho Goshan Bluewater Land Parcel# \_\_\_\_\_ Turbine # BLW T1-North

Watercourse Sketch

Horizontal View of Channel

Forest <input type="checkbox"/>	Livestock <input type="checkbox"/>	Ephemeral <input type="checkbox"/>			
Other:					
Notes: (include any inputs into the system i.e. tile drainage, seepages, overland flow)					
<u>- flowing at bank full</u>					
In-Situ Water Quality		Ground Water Indicators			
WT (°C):	AT (°C):	Watercross <input type="checkbox"/>	Bank Seepage <input type="checkbox"/>		
pH:	Cond (µs/cm):	Iron Staining <input type="checkbox"/>	None <input checked="" type="checkbox"/>		
Water Clarity: Clear <input type="checkbox"/>	Turbid <input type="checkbox"/>	Bubbling <input type="checkbox"/>	Other <input type="checkbox"/>		
Notes: <u>w/g done on South side.</u>					
Stream Morphology					
Site Length (m): <u>100m</u>	Bank Stability:				
Channel Dimensions		Stable	Slightly unstable	Moderately unstable	Unstable
Mean Wetted Width (m): <u>2</u>	Mean Bankfull Width (m): <u>2</u>	Left Bank <input checked="" type="checkbox"/>	<input type="checkbox"/>	<input type="checkbox"/>	<input type="checkbox"/>

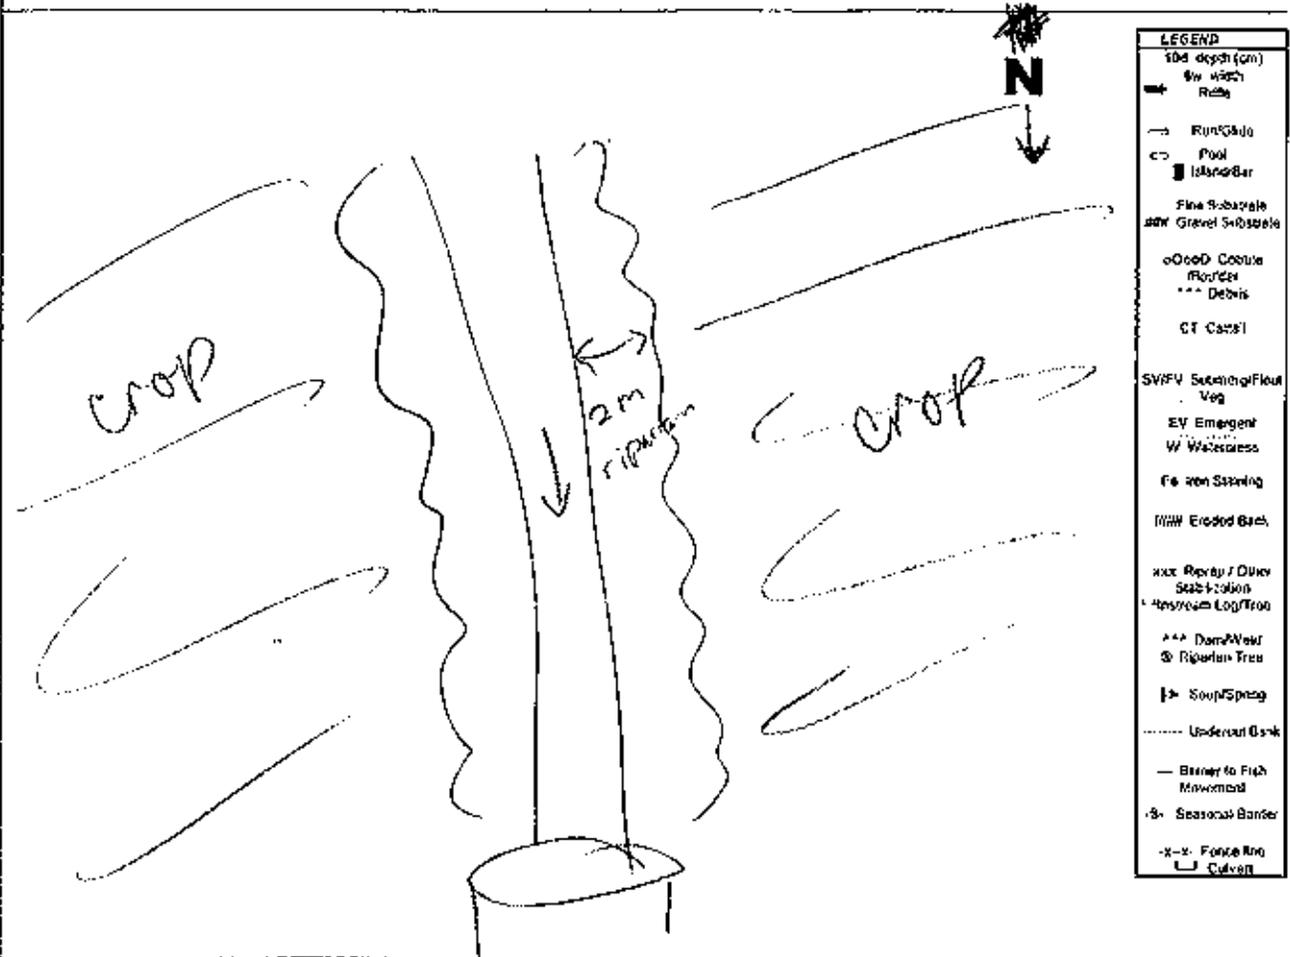
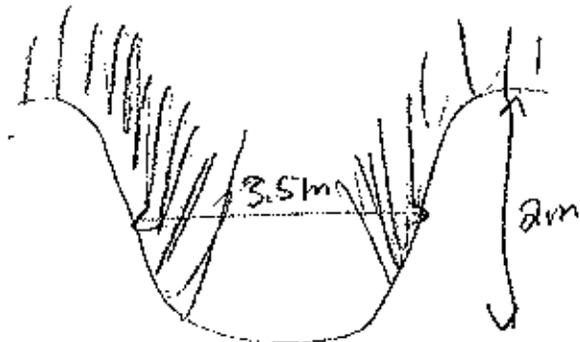
Study Area: Jericho Goshen Bluewater Land Parcel# \_\_\_\_\_ Turbine# BLW-TJ-South

Watercourse Sketch

Horizontal View of Channel

- 2m culvert → water flowing through - not a fish barrier
- frog noted

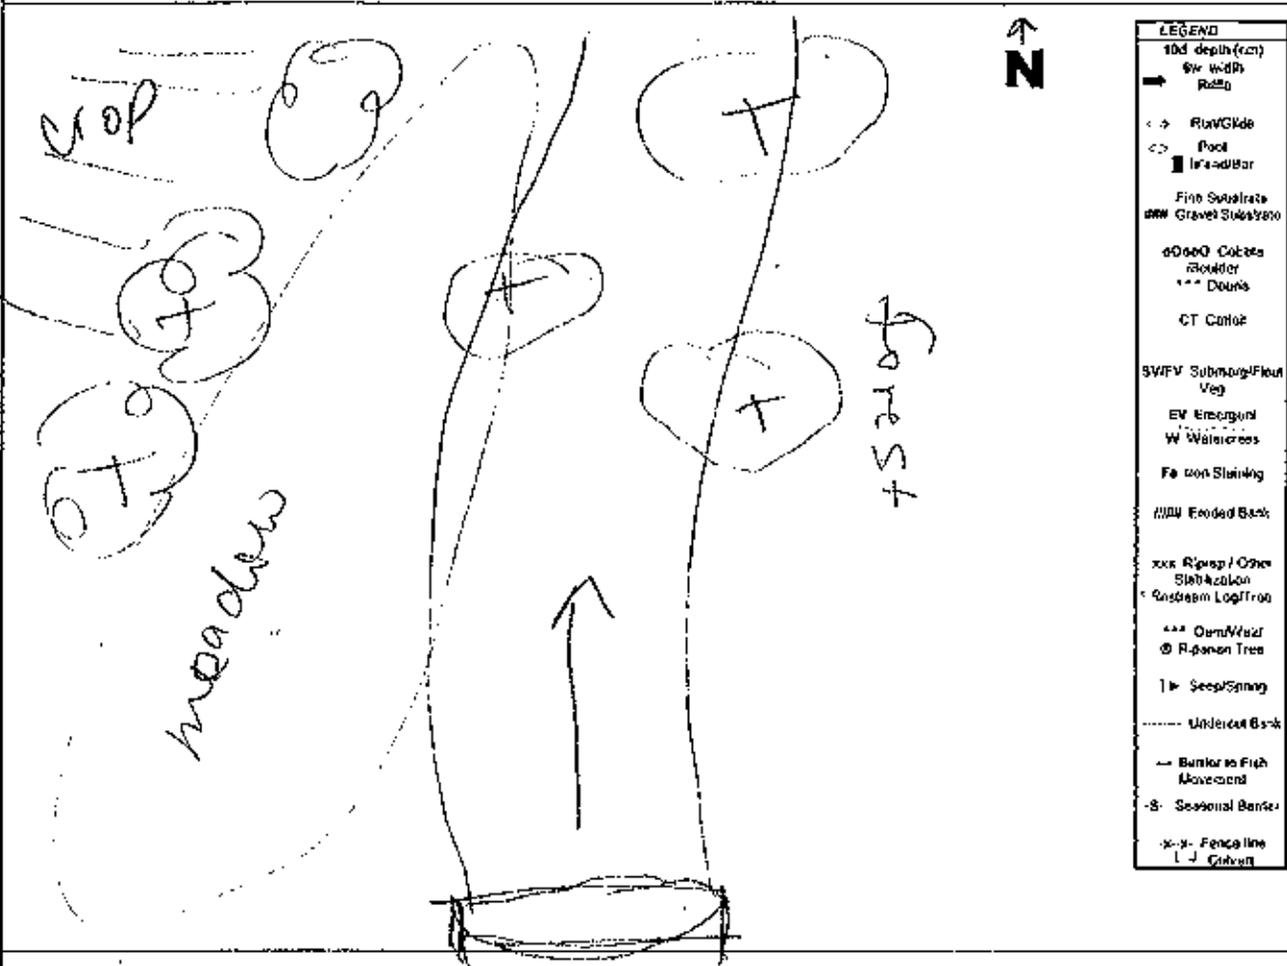
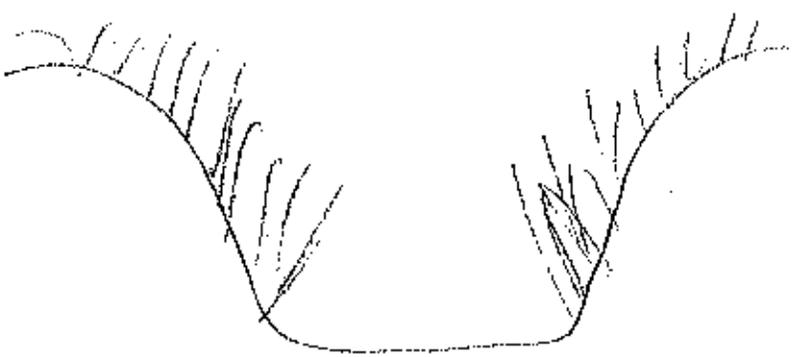
Study Area: Jericho Goshen Bluewater Band Parcel# Turbine # BW-72 North

Watercourse Sketch

Horizontal View of Channel

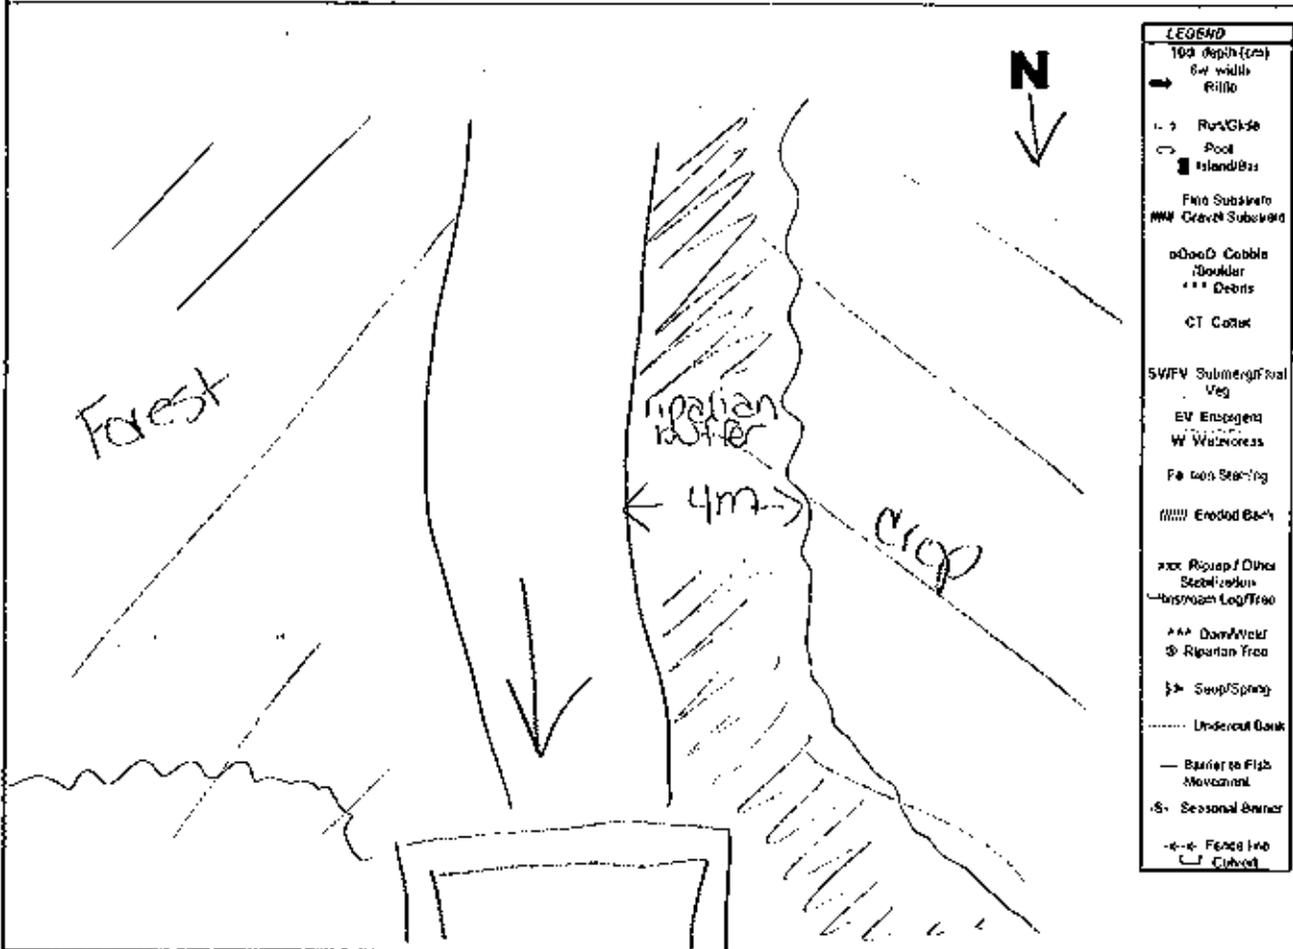
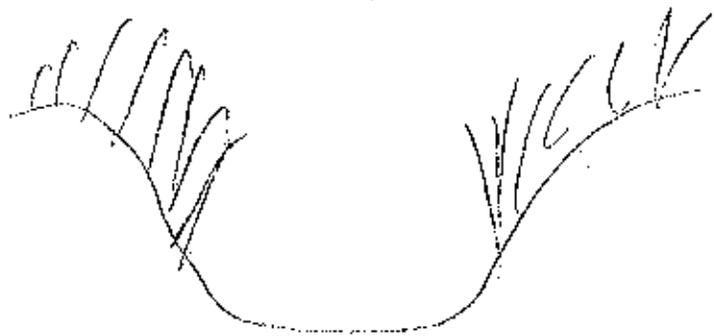
Turbine # BW12-South

Study Area: Jericho Goshen Bluewater Land Parcel#

Horizontal View of Channel

Forest <input checked="" type="checkbox"/>	Livestock <input type="checkbox"/>	Ephemeral <input type="checkbox"/>	
Other:			
Notes: (include any inputs into the system i.e. tile drainage, seepages, overland flow) <u>None observed.</u>			
In-Situ Water Quality		Ground Water Indicators	
WT (°C): <u>20.3</u>	AT (°C): <u>18</u>	Watercress <input type="checkbox"/>	Bank Seepage <input type="checkbox"/>
pH: <u>7.05</u>	Cond (µs/cm): <u>0.52</u>	Iron Staining <input type="checkbox"/>	None <input checked="" type="checkbox"/>
Water Clarity: Clear <input type="checkbox"/>	Turbid <input checked="" type="checkbox"/>	Bubbling <input type="checkbox"/>	Other <input type="checkbox"/>
Notes: <u>Due to rain, water high &amp; turbid</u>			
Stream Morphology			
Site Length (m): <u>~80m visible from road</u>		Bank Stability:	
Channel Dimensions		Stable	Slightly unstable
Mean Wetted Width (m): <u>4.0</u>	Mean Bankfull Width (m): <u>4.0</u>	Moderately unstable	Unstable
