# Appendix A

Estimated Zones of Potential  
Recharge and Discharge Areas

### Six Conservation Authorities Geological and Hydrogeological Model Project

## Assessment of Water Bodies and Distance to Project Components

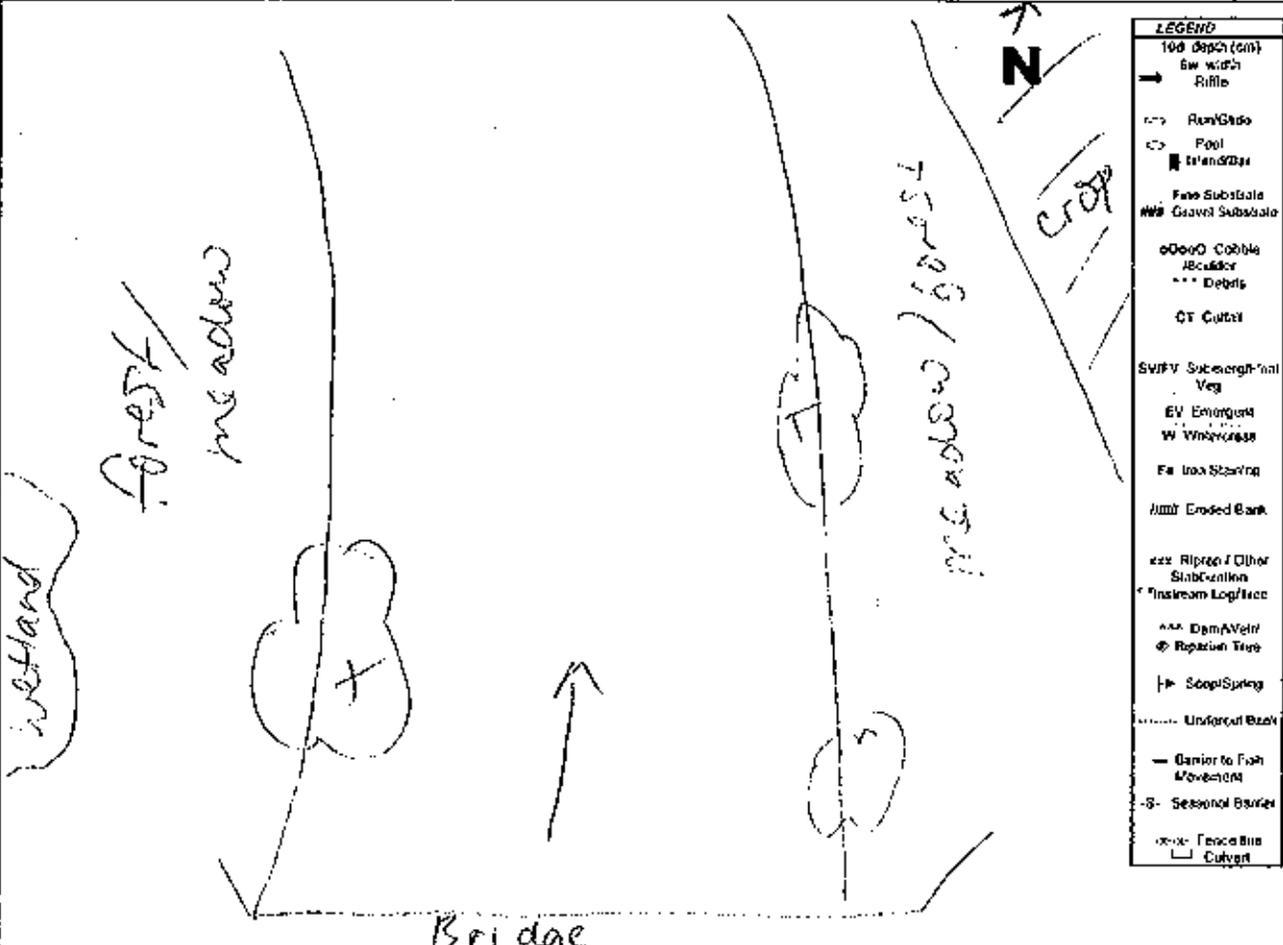
Turbine # BLW T3 North

Study Area: Jericho Goshen Bluewater Land Parcel#

Horizontal View of Channel

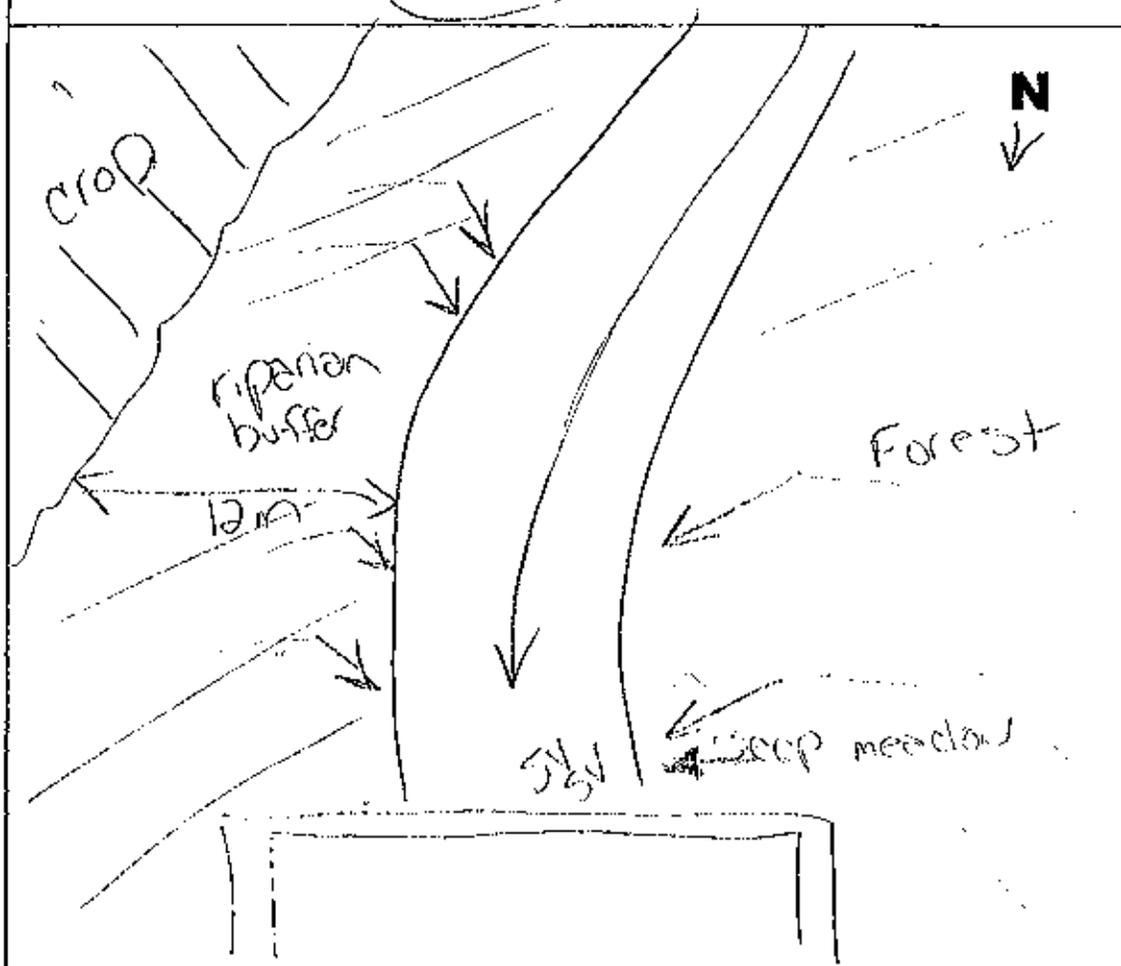
Turbine # BLW-10 SOUTH

Study Area: Jericho Goshen Bluewater Land Parcel#

Horizontal View of Channel

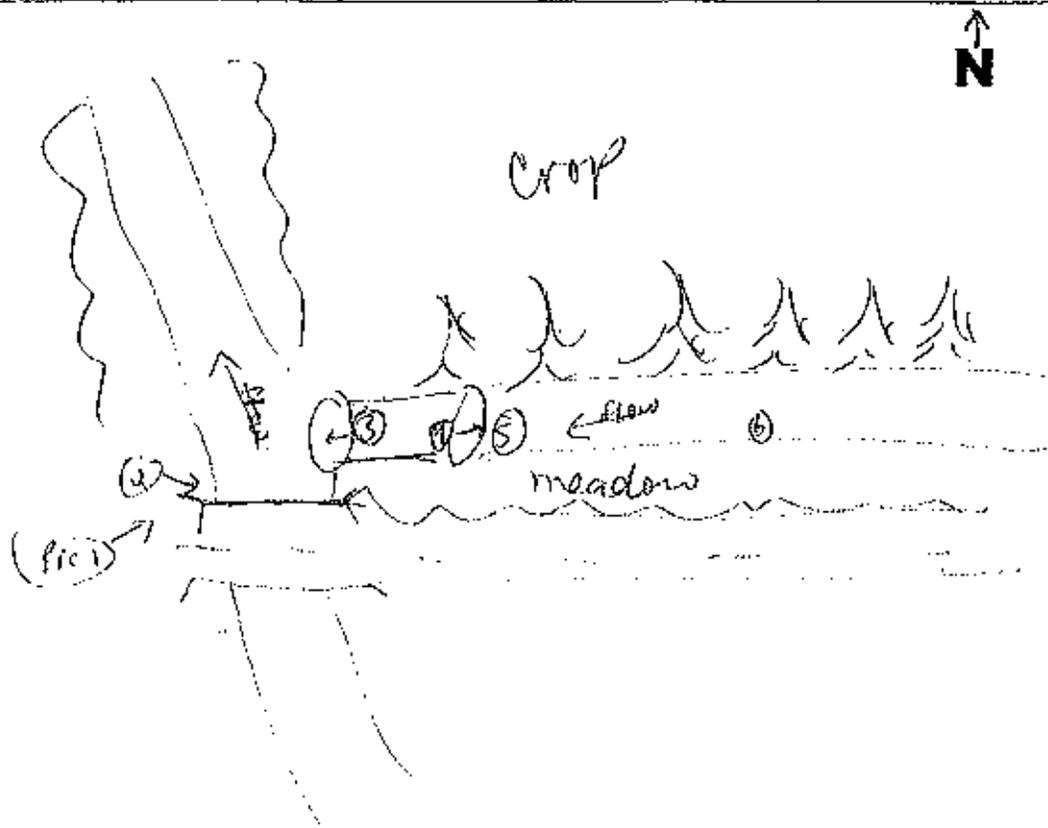
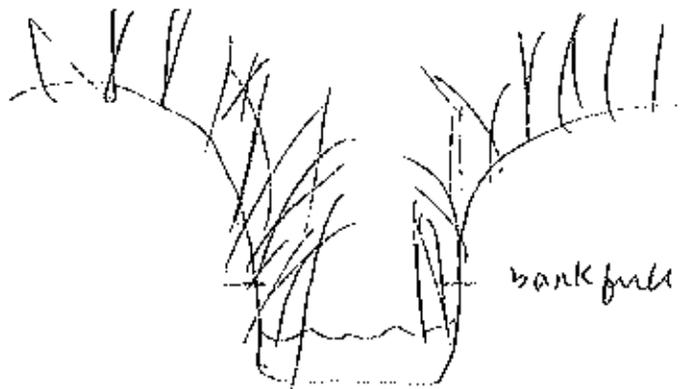
Turbine # BLW-T4 North

Horizontal View of Channel

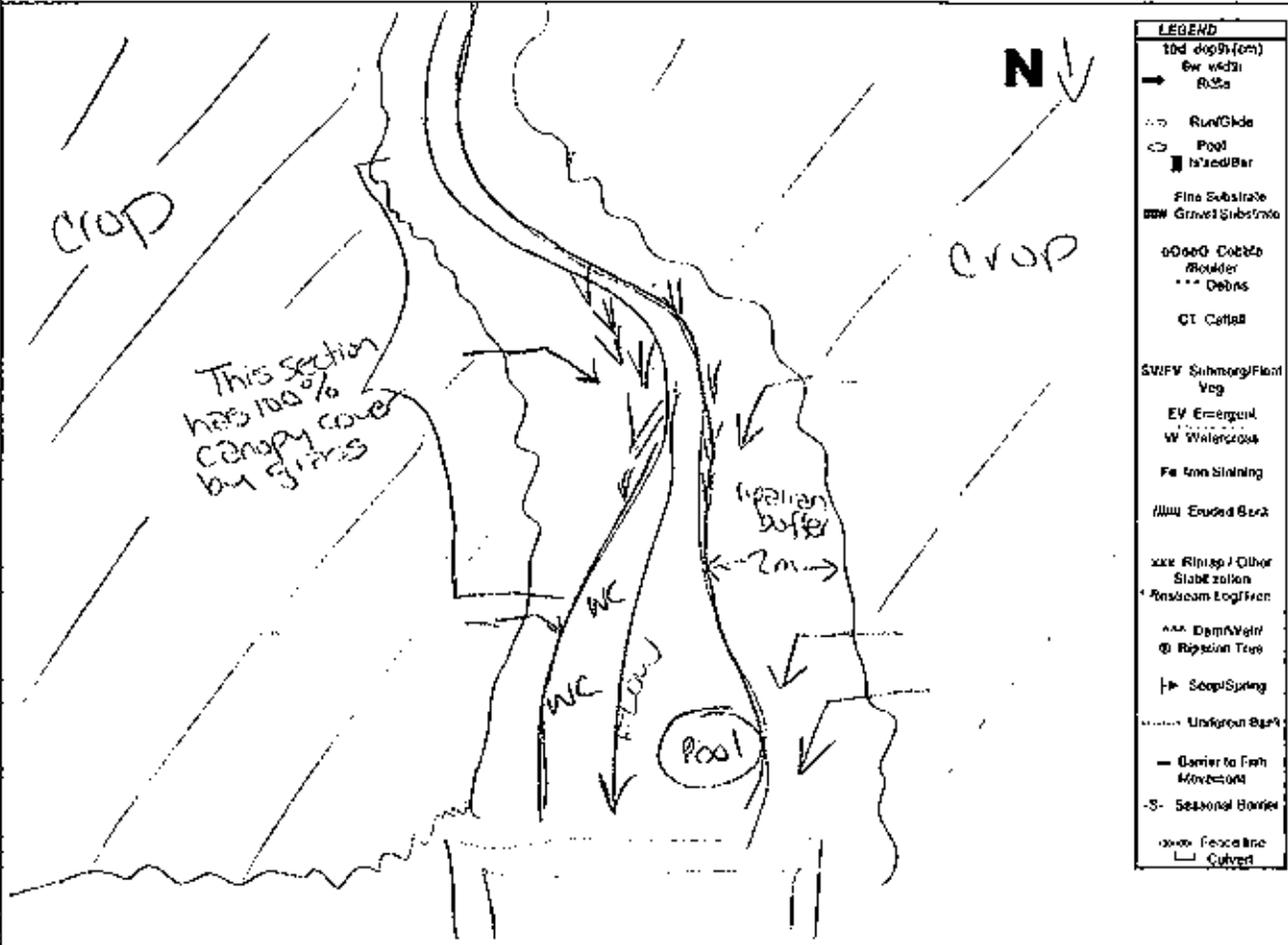
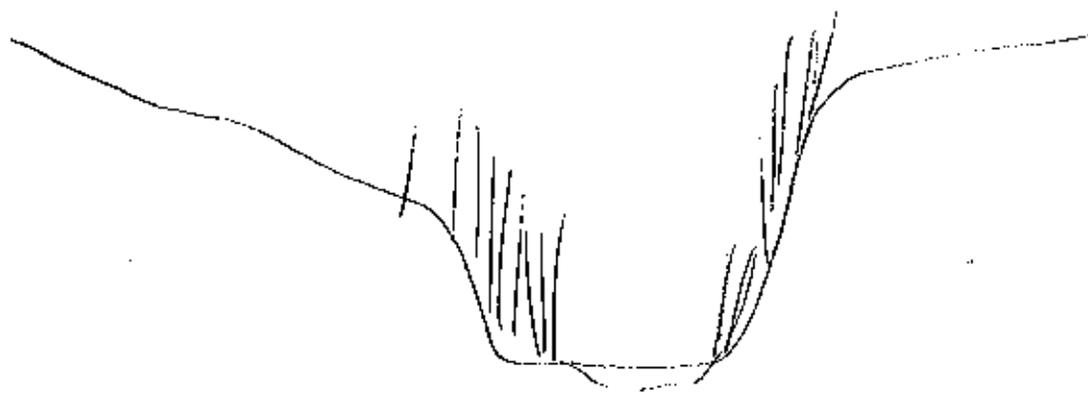
Turbine # BLW 74 - South

Horizontal View of Channel

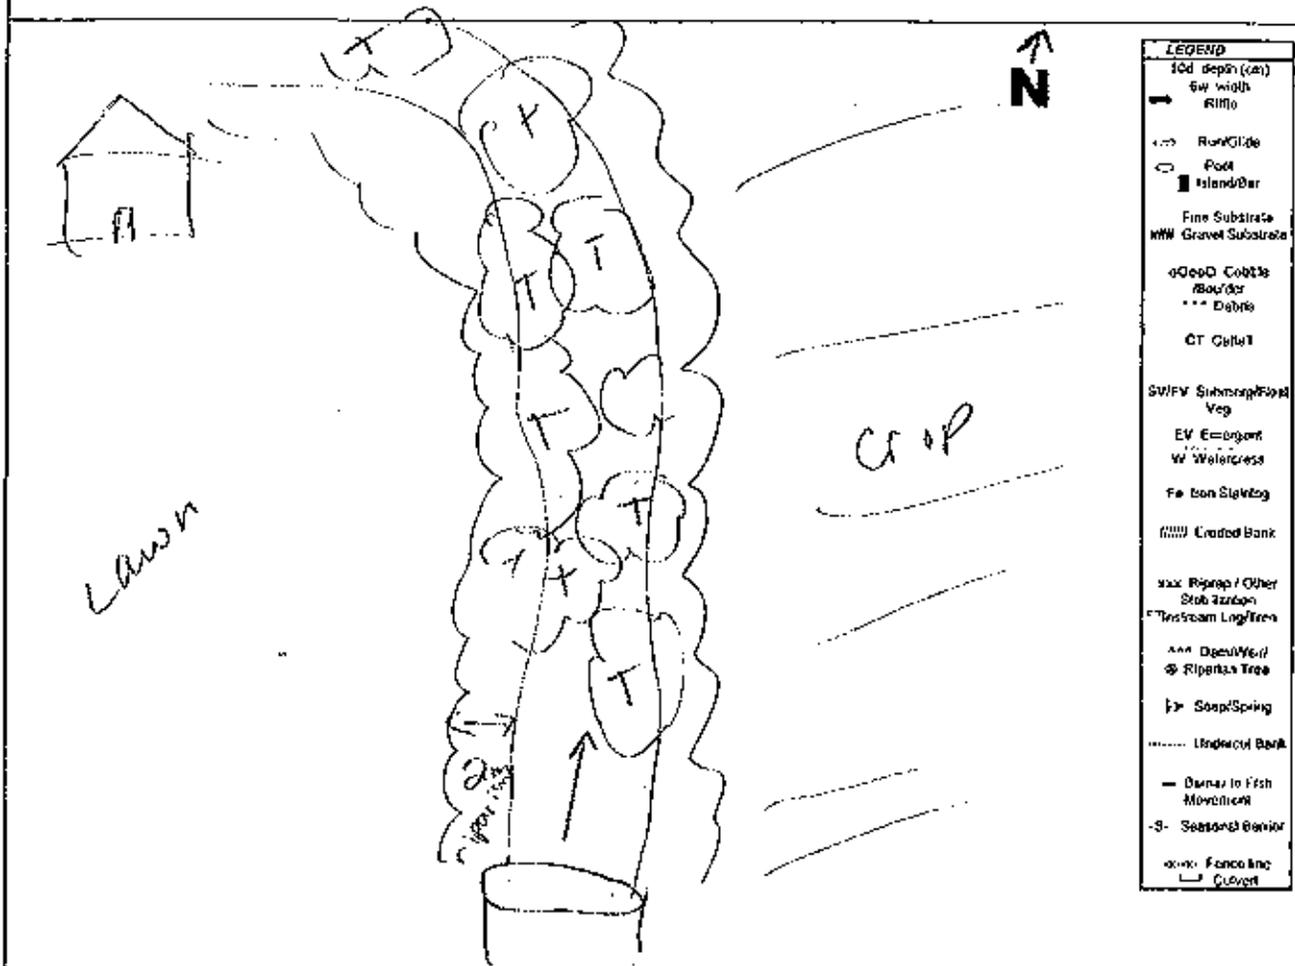
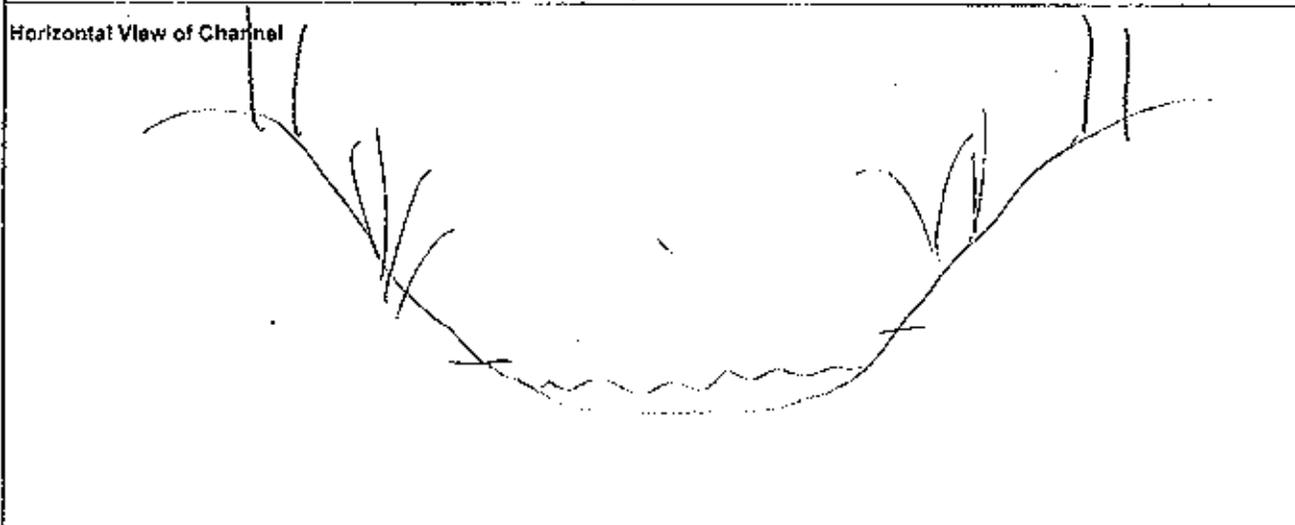
Study Area: Jericho Goshen Bluewater Land Parcel# Turbine # BLW T5 North

Watercourse Sketch

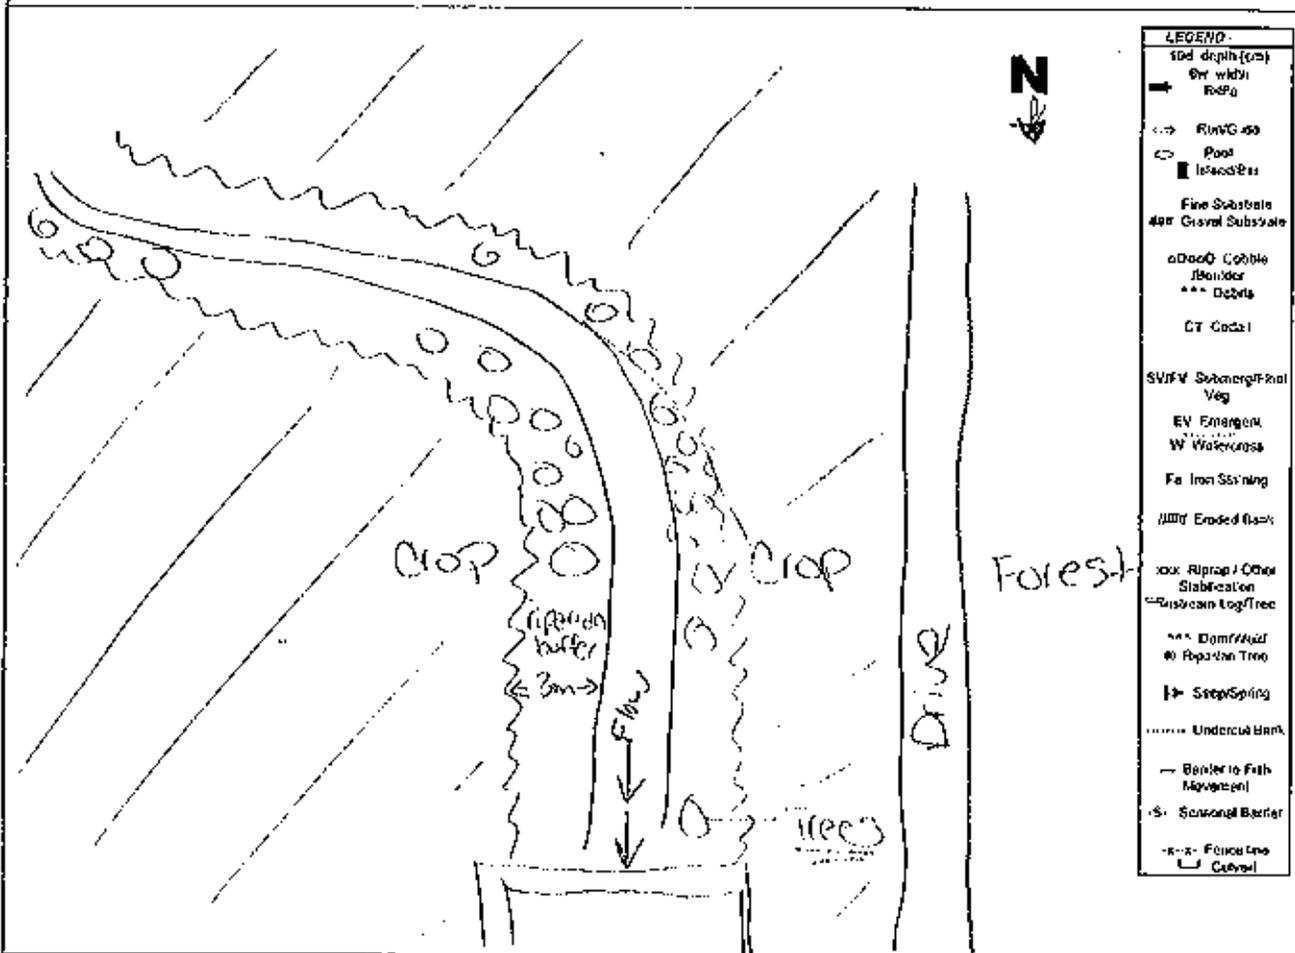
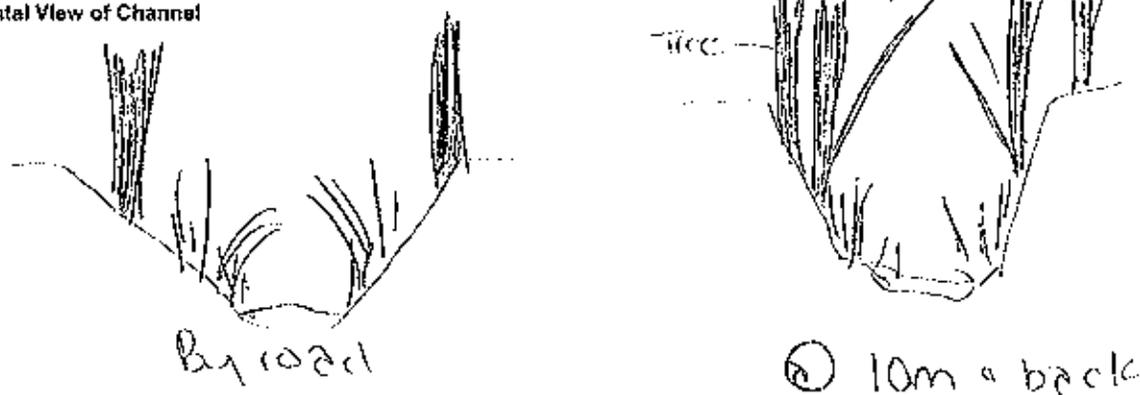
Turbine # BLW-T5-South

Horizontal View of Channel

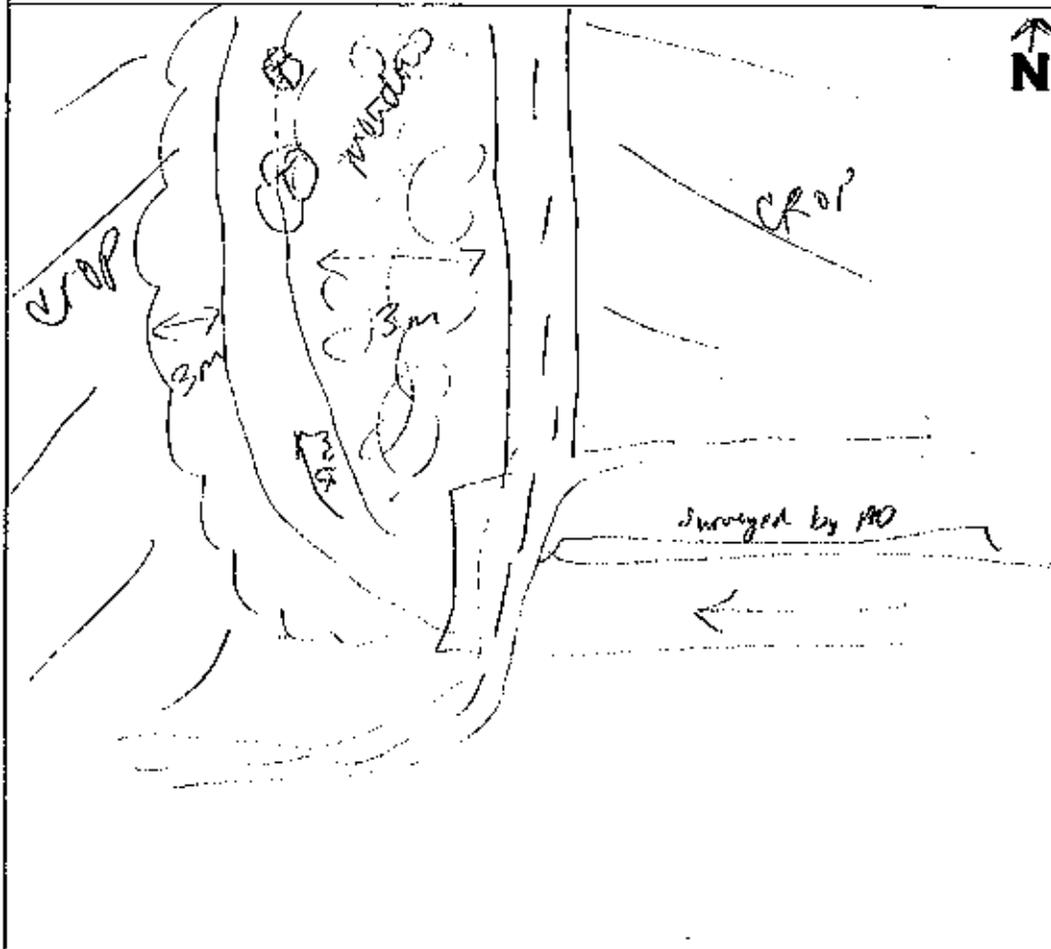
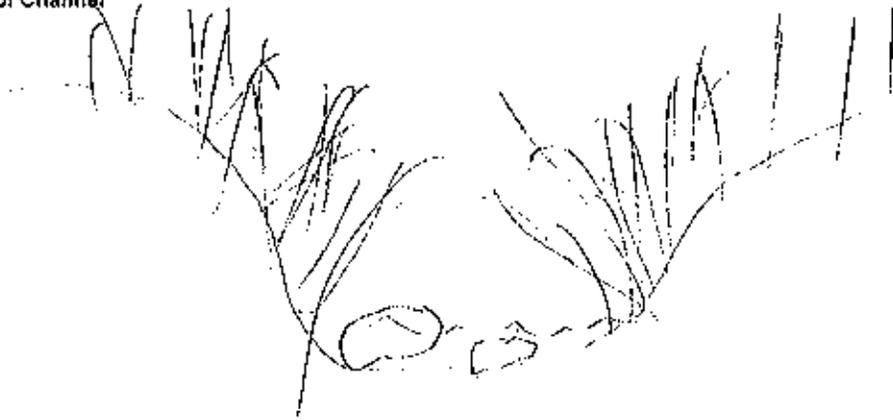
Turbine # BLW 7.6 - North

Horizontal View of Channel

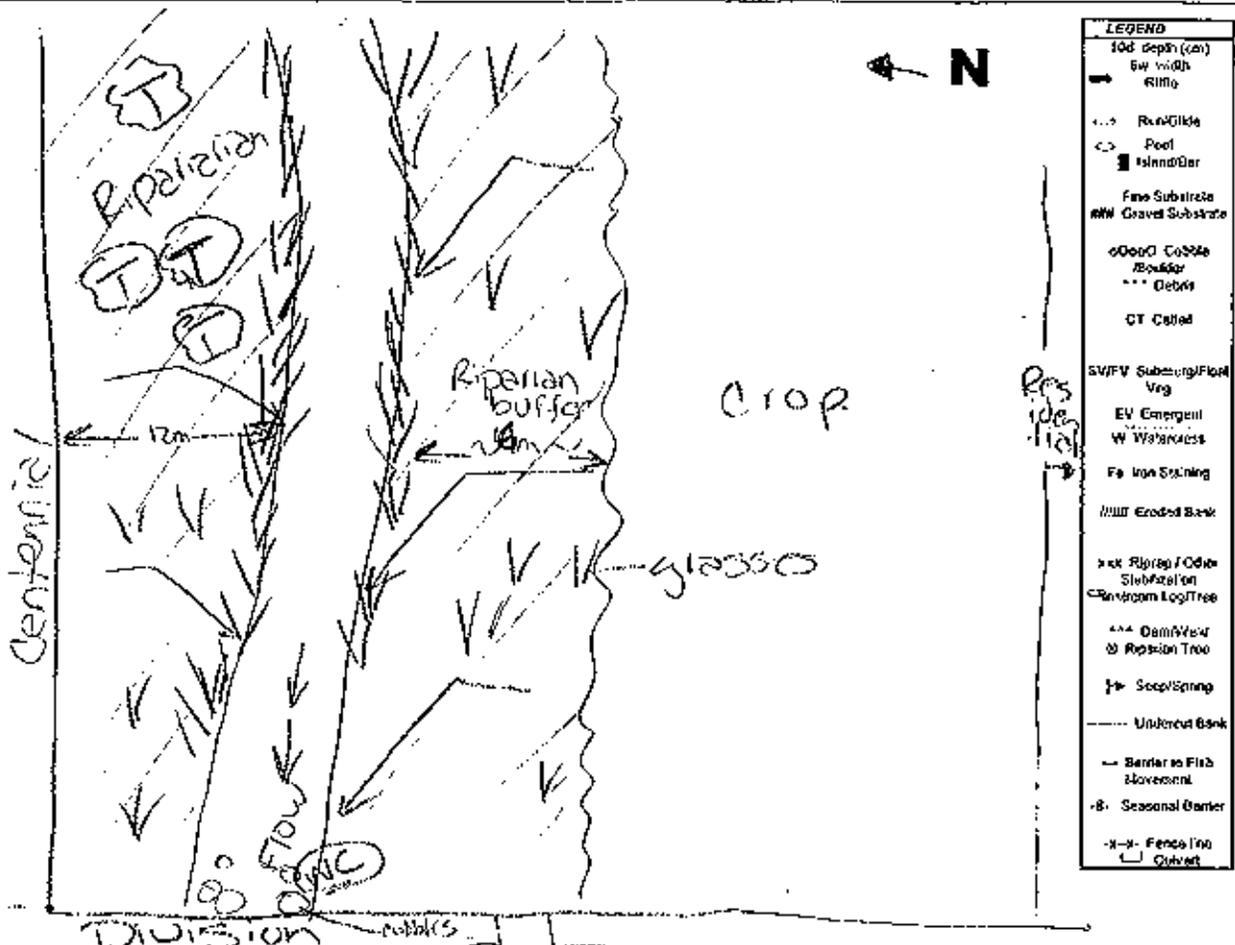
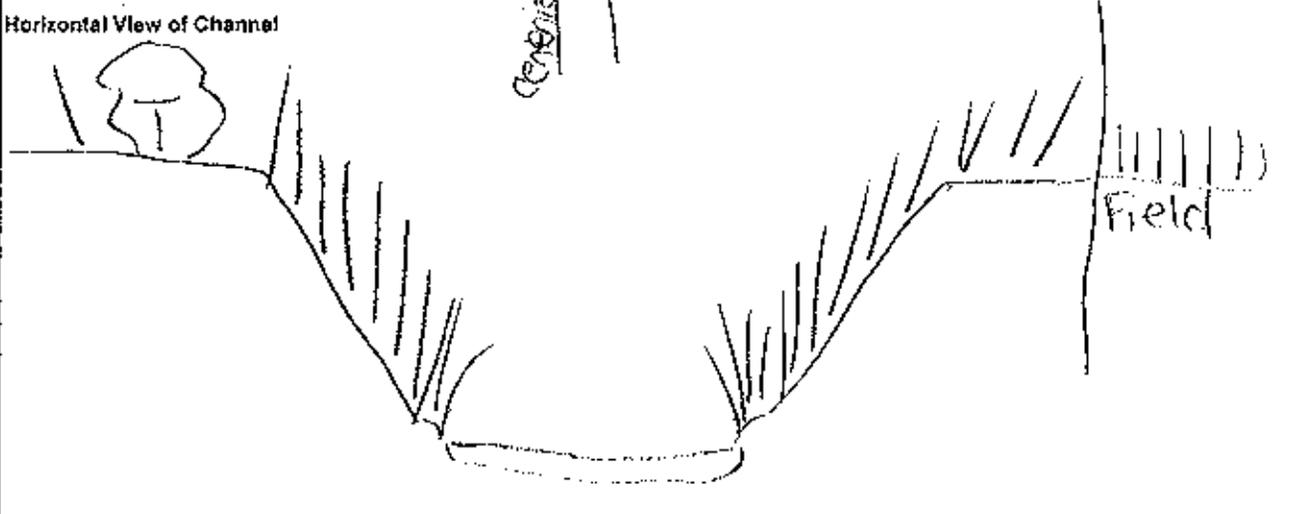
Study Area: Jericho Goshen Bluewater Land Parcel# Turbine # BLW-T6-30

Watercourse Sketch

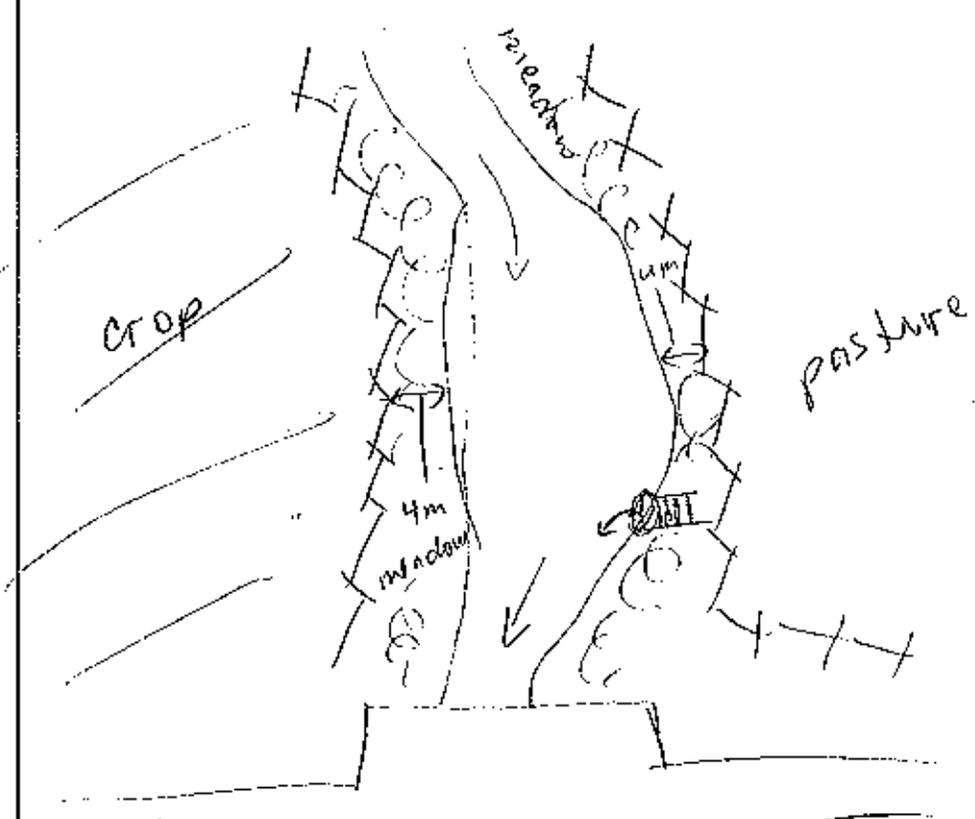
Horizontal View of Channel

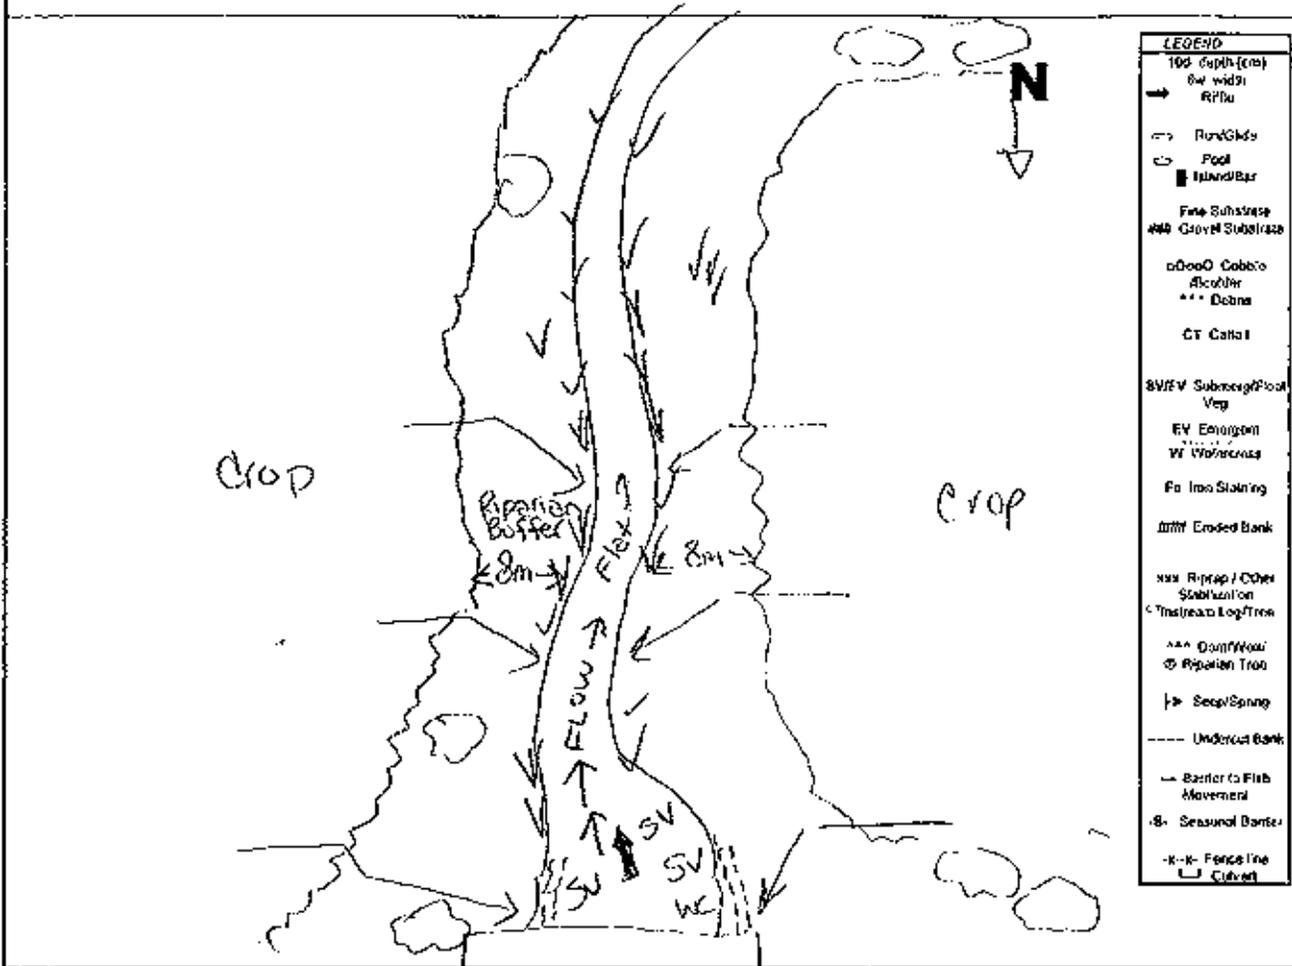
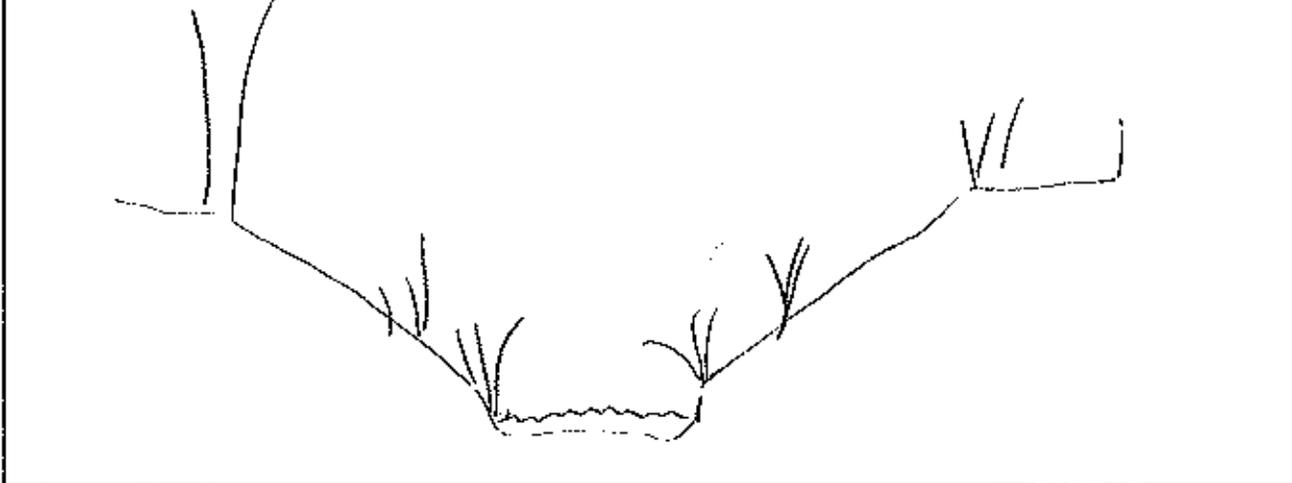
Study Area: Jaricho Goshen Bluewater Land Parcel# Turbine # BLWT7-South

Watercourse Sketch

Horizontal View of Channel

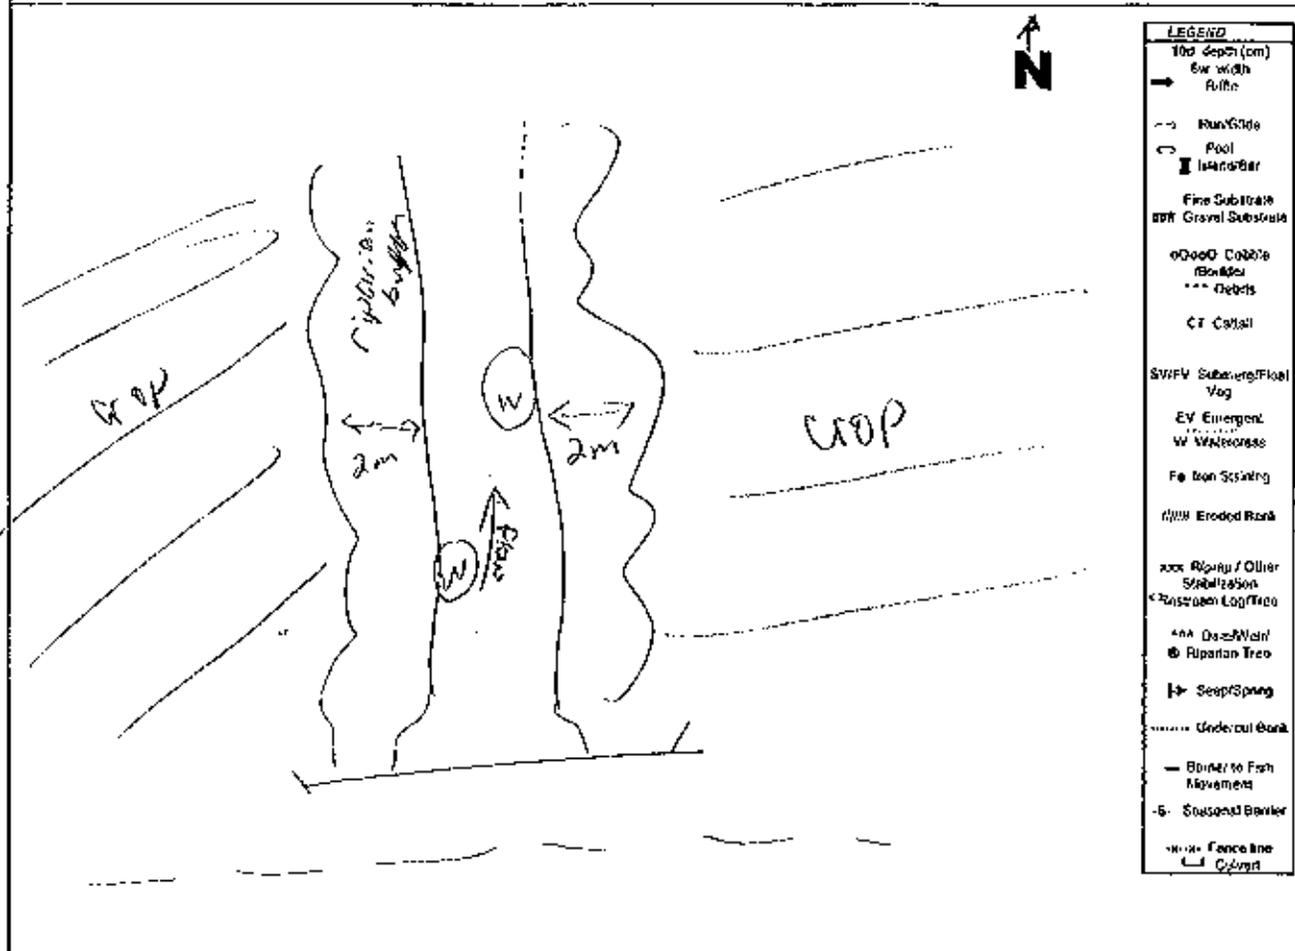
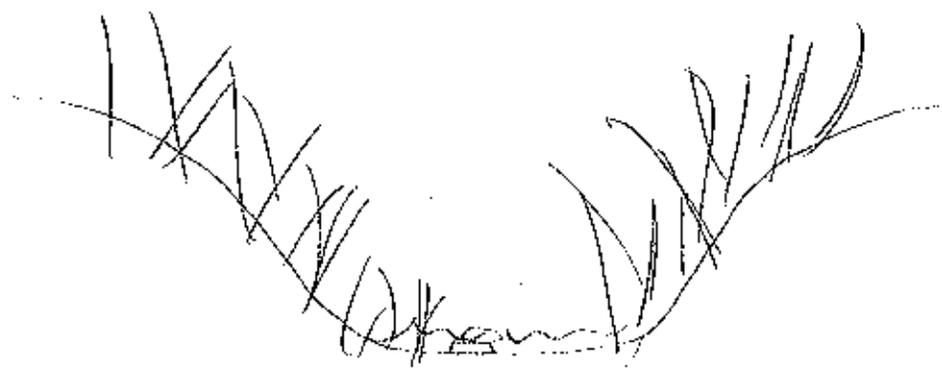
Turbine # BLW T8-North

Horizontal View of Channel

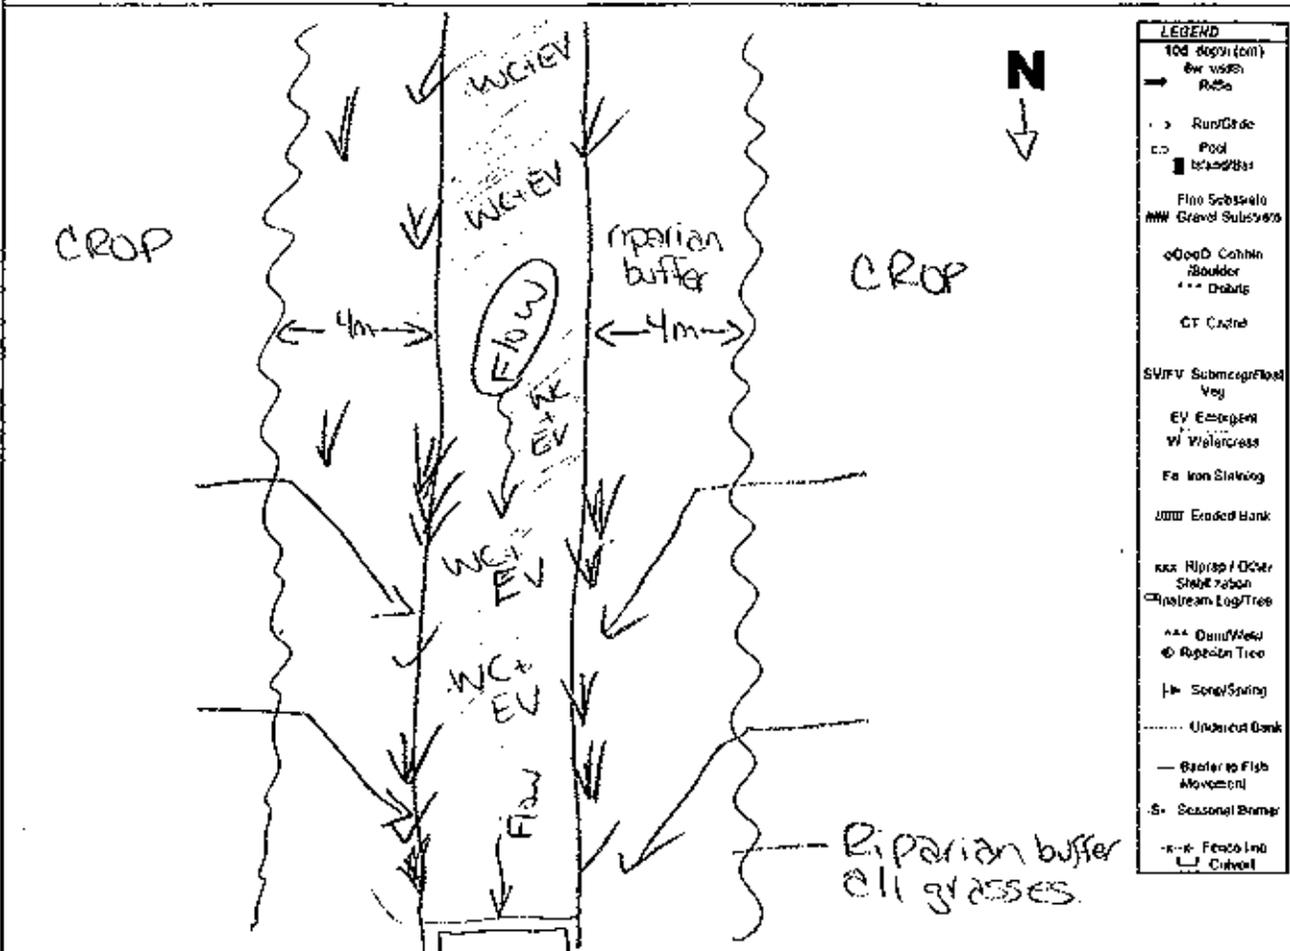
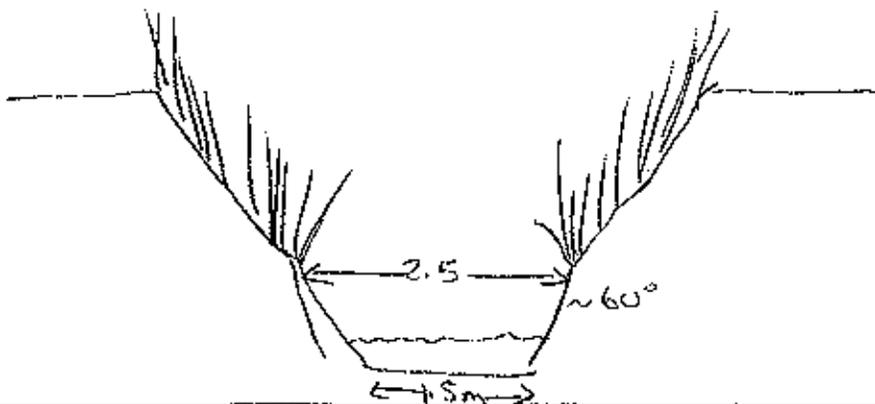
Study Area: Jericho Goshen Bigwater Land Parcel# Turbine # BLW T8-South

Watercourse Sketch

Horizontal View of Channel

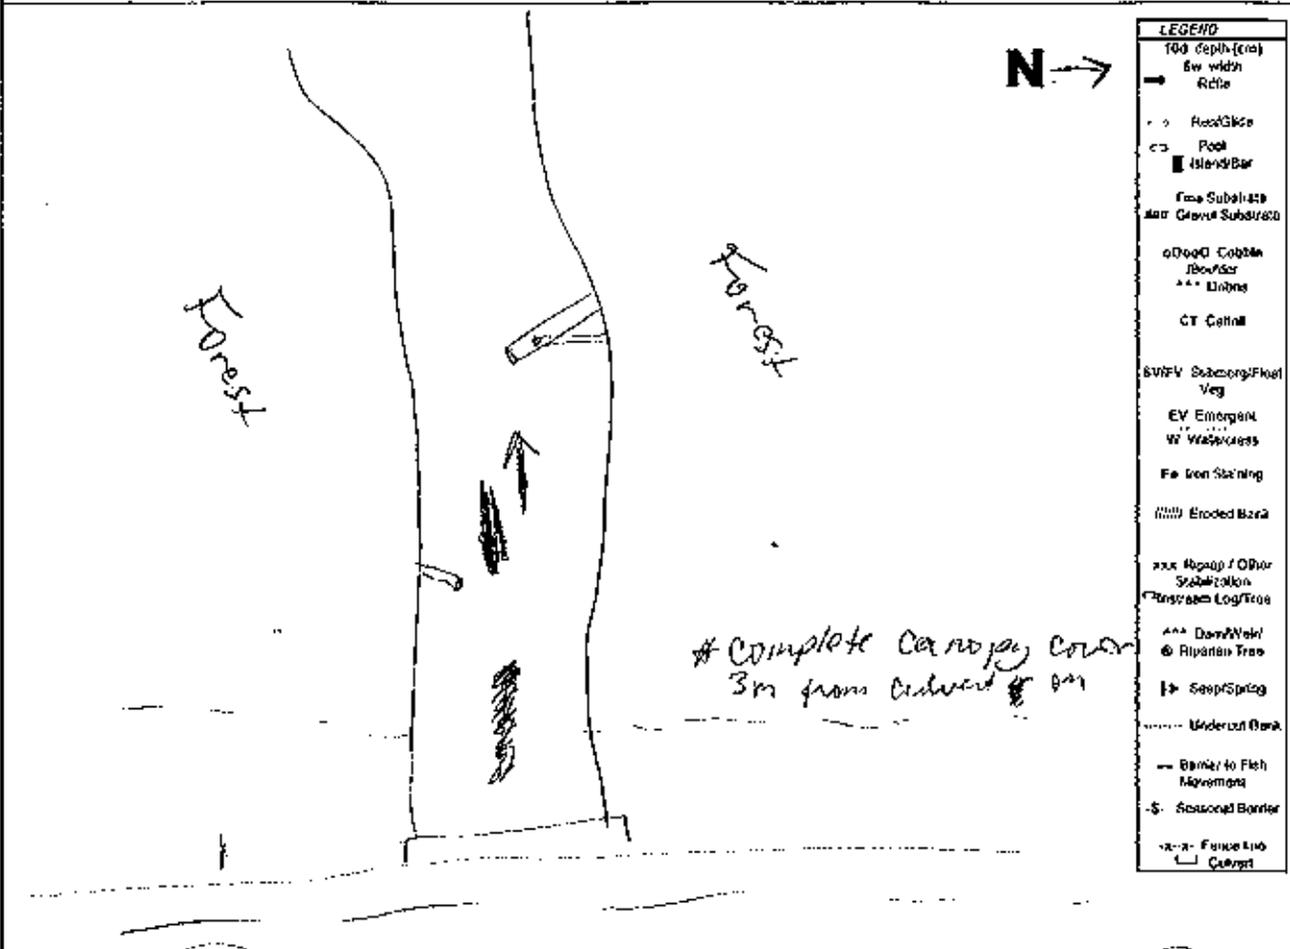
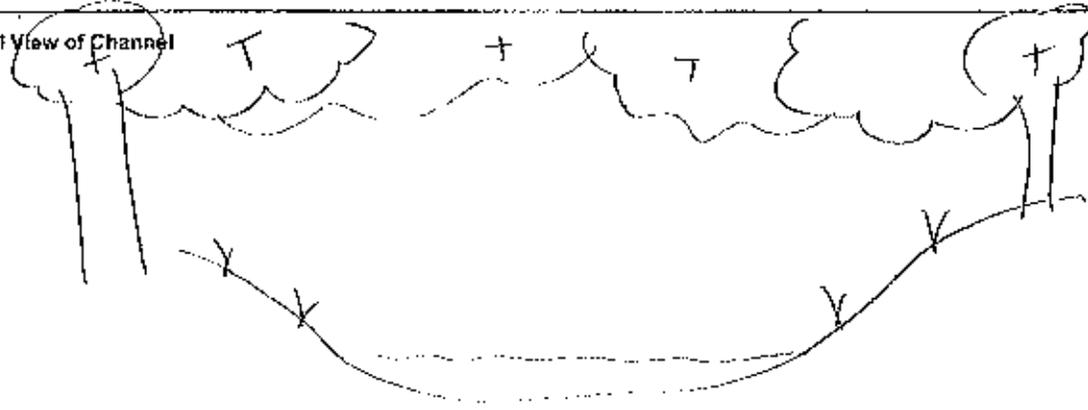
Study Area: Jericho Goshen Bluewater Land Parcel# Turbine # BLW-T9-West

Watercourse Sketch

Horizontal View of Channel

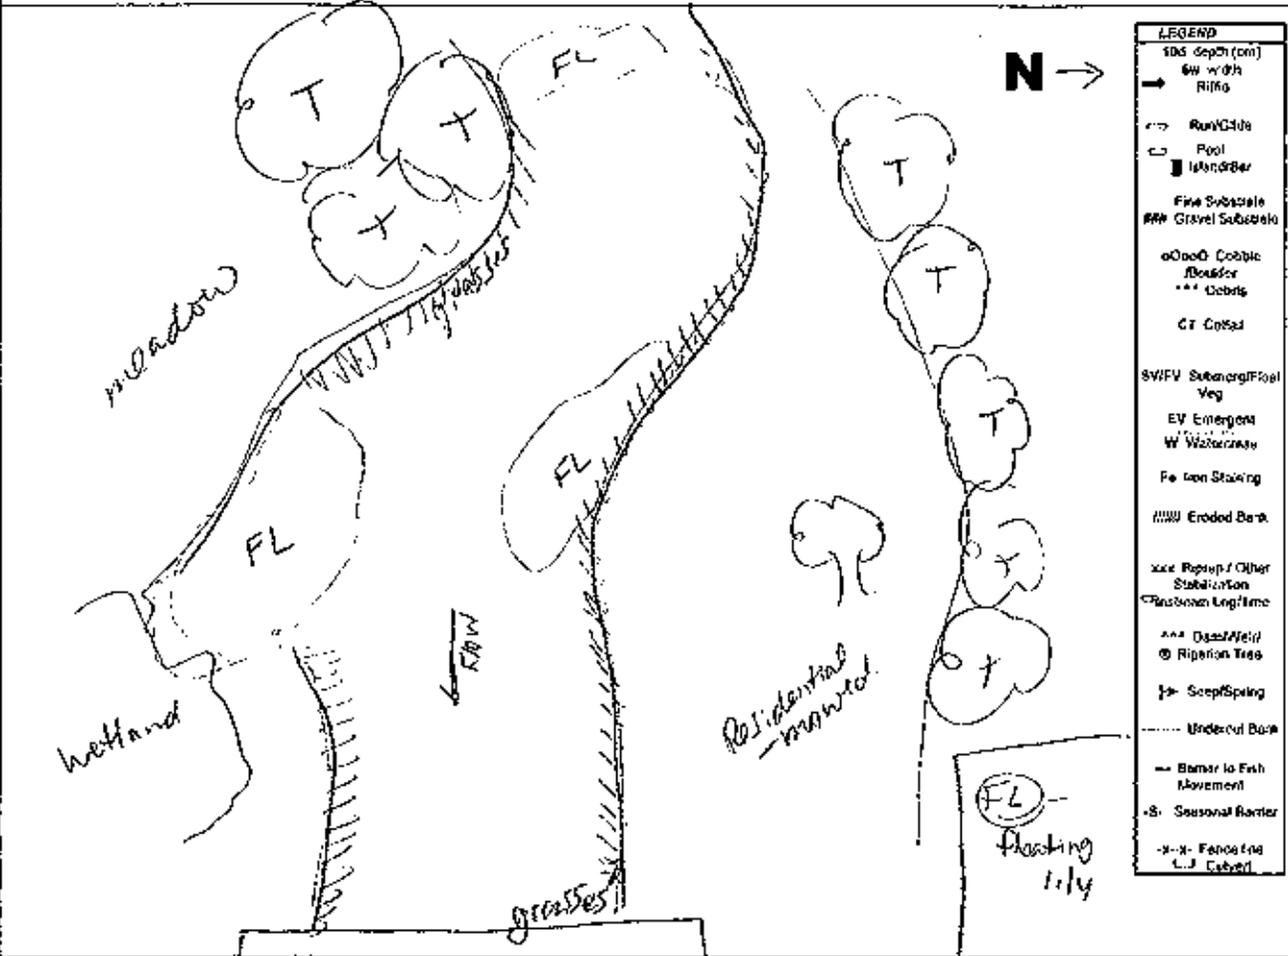
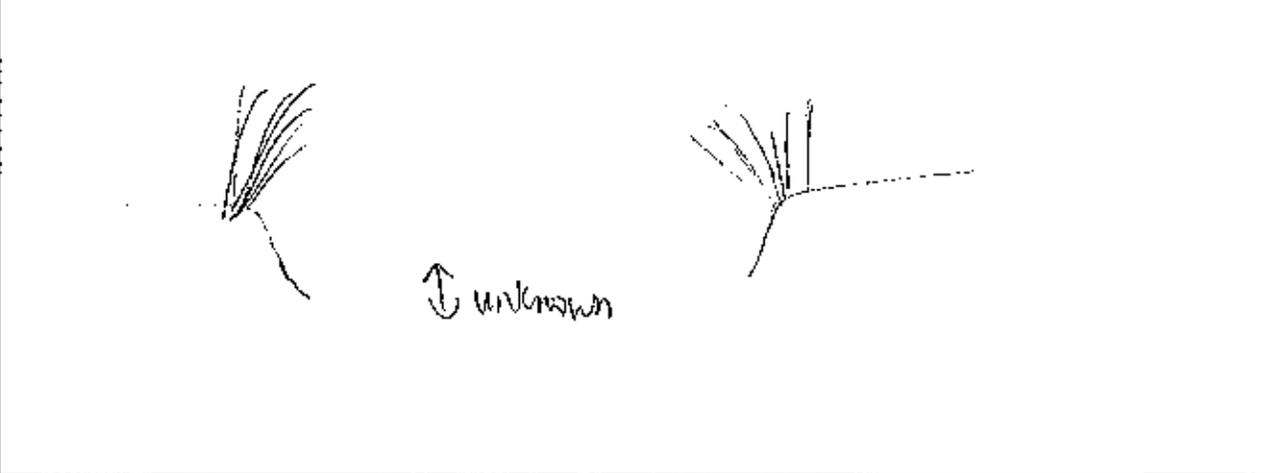
Study Area: Jericho Goshen Bluewater Land Parcel# Turbine # BW-T10-West

Watercourse Sketch

Horizontal View of Channel

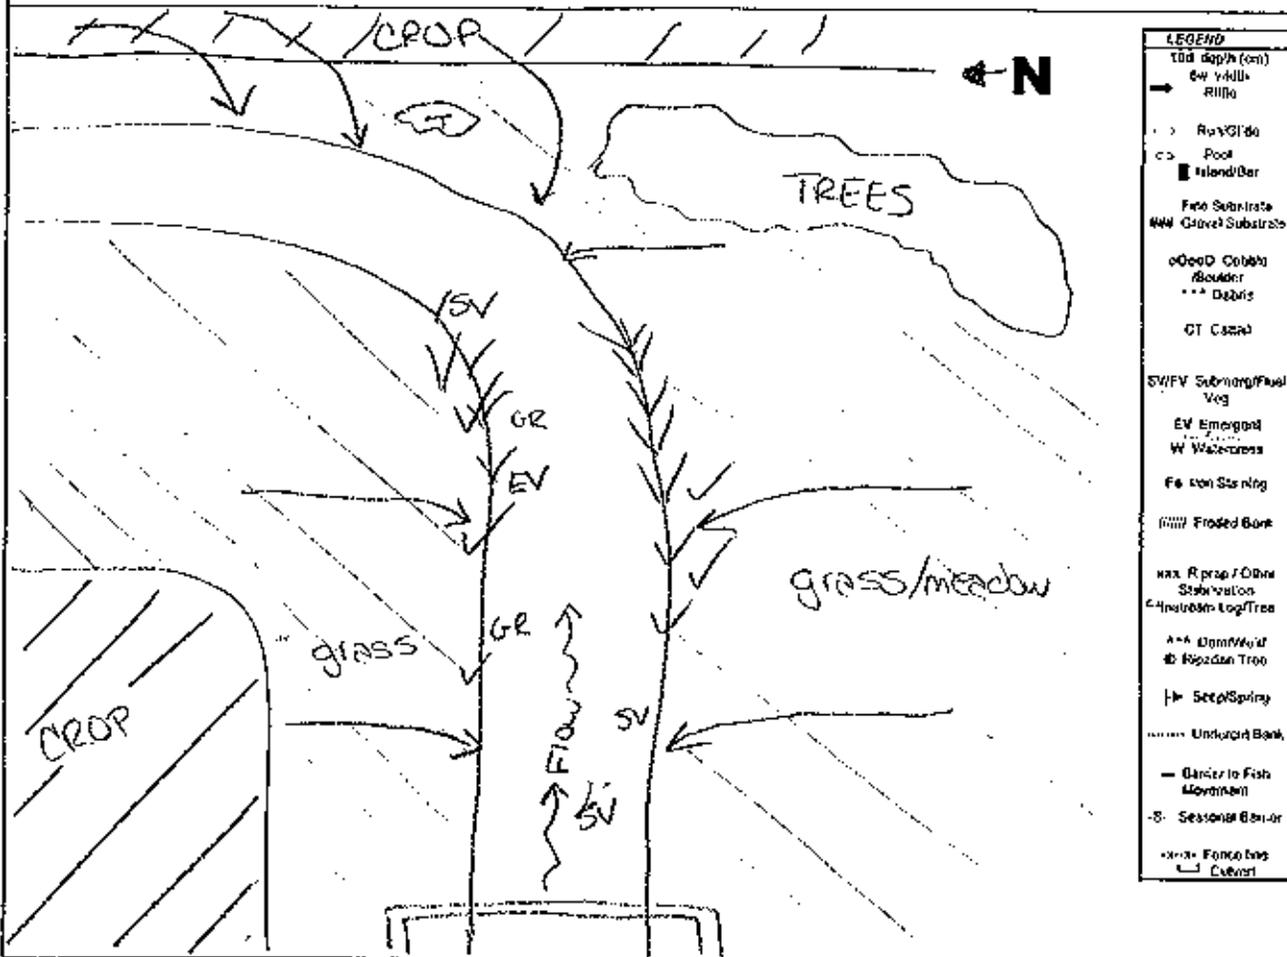
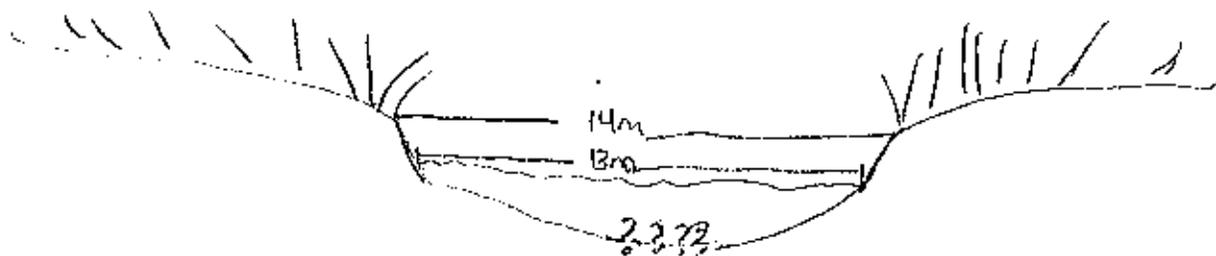
Turbine # BLW-TD-E

Horizontal View of Channel
