# Appendix A

Estimated Zones of Potential  
Recharge and Discharge Areas

### Six Conservation Authorities Geological and Hydrogeological Model Project

## Assessment of Water Bodies and Distance to Project Components

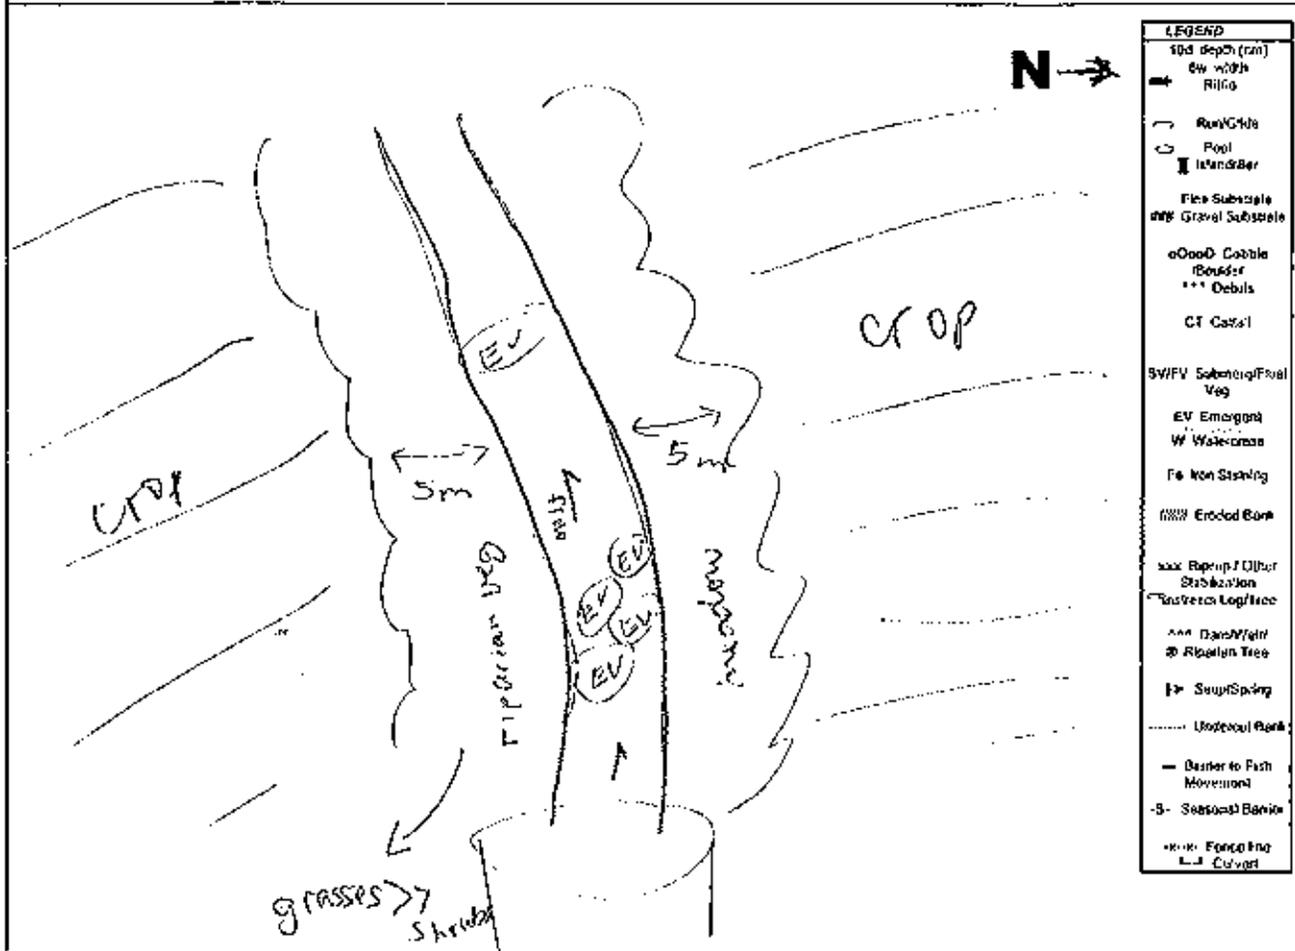
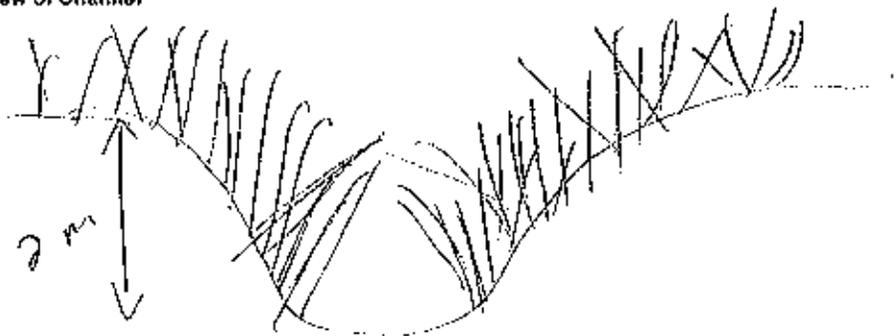
Study Area: Jericho Goshen Bluewater Land Parcel# Turbine # BLW-T17-West

Watercourse Sketch

Horizontal View of Channel

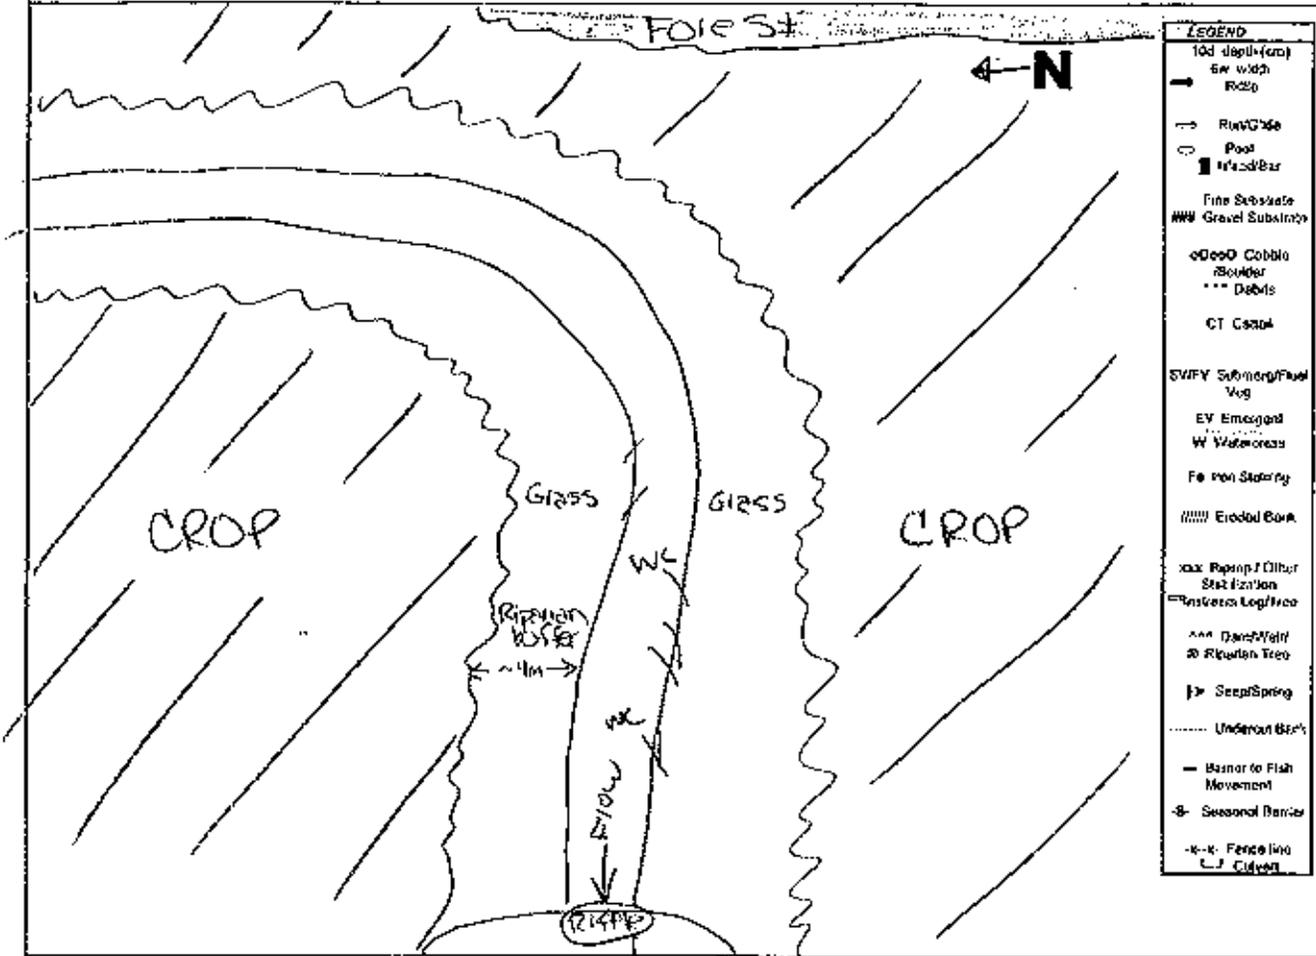
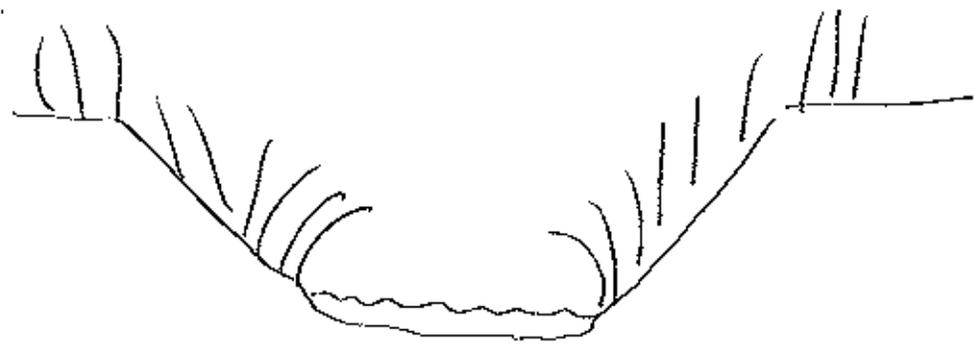
Study Area: Jericho Goshen Bluewater Land Parcel# \_\_\_\_\_ Turbine # BLW J17-EAST

Watercourse Sketch

Horizontal View of Channel

over corrugated culvert

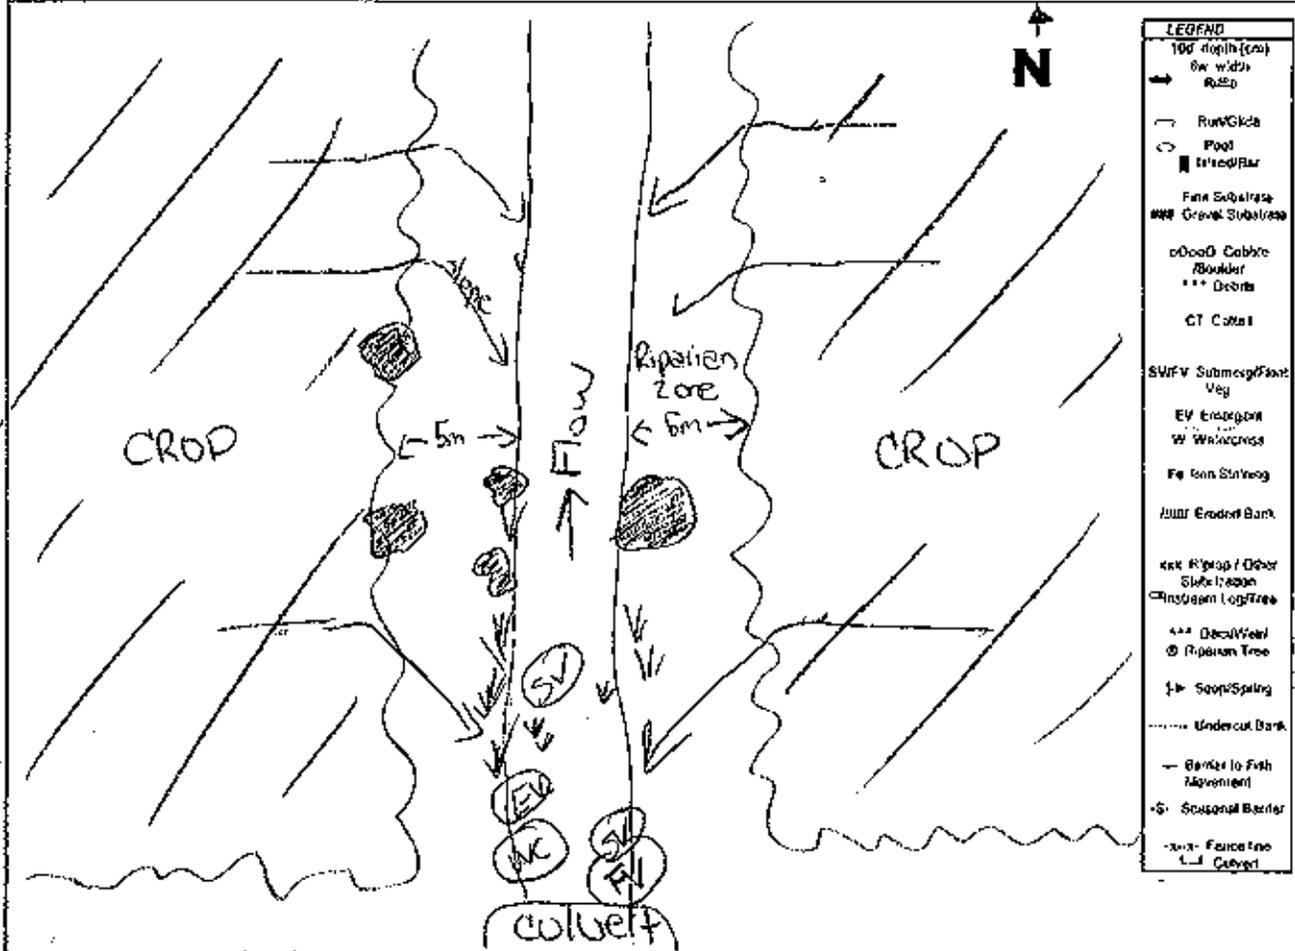
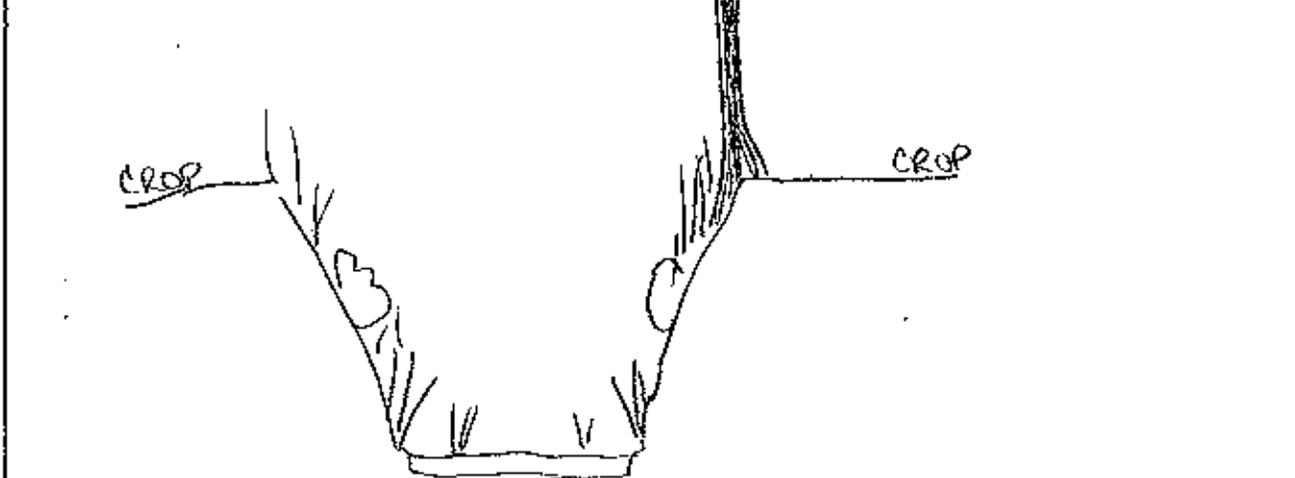
Turbine # BLW TII-N

Horizontal View of Channel

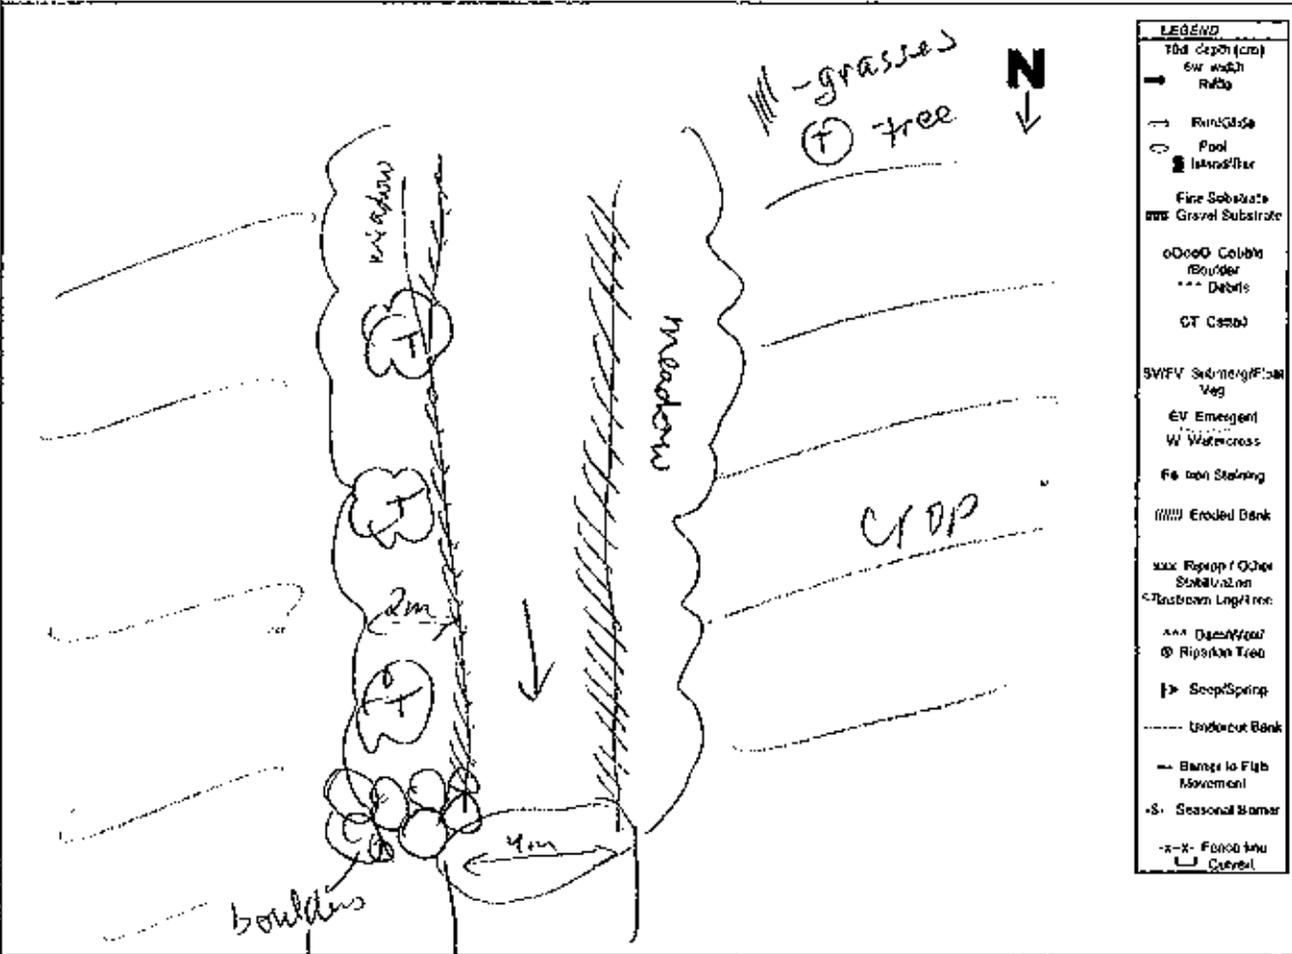
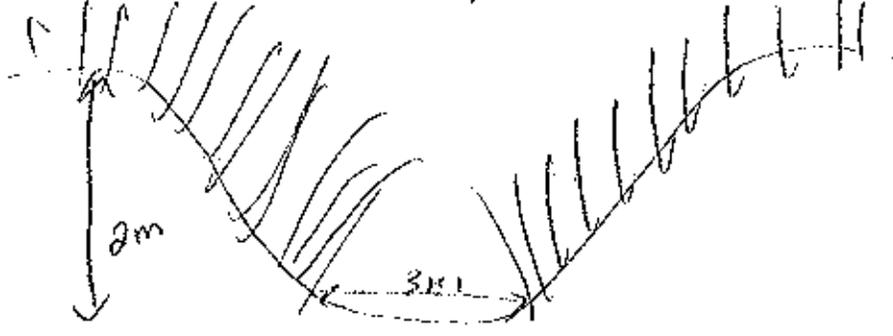
Study Area: Jericho Goshen Bluewater Land Parcel# Turbine # BLW-T11-South

Watercourse Sketch

Horizontal View of Channel possible drainage from road

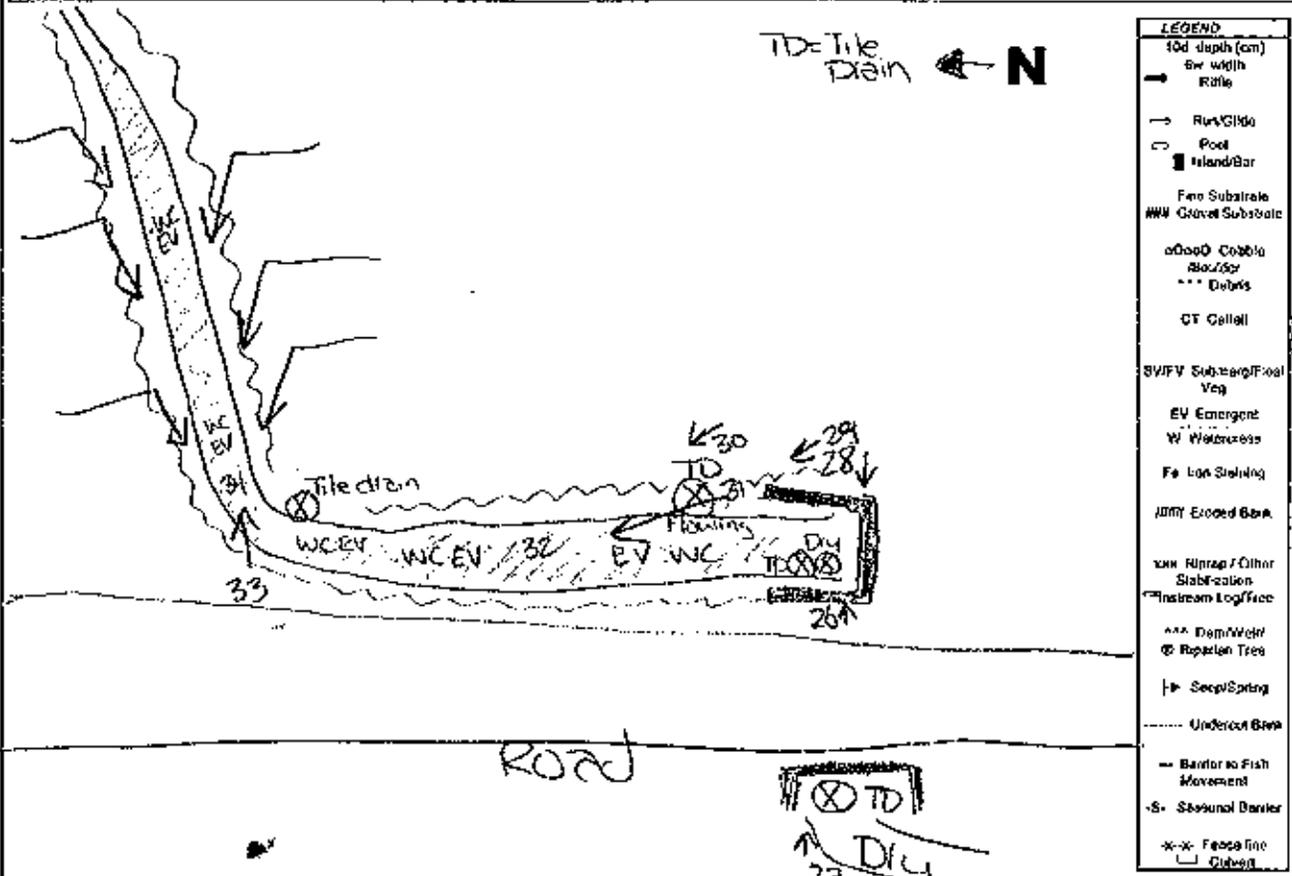
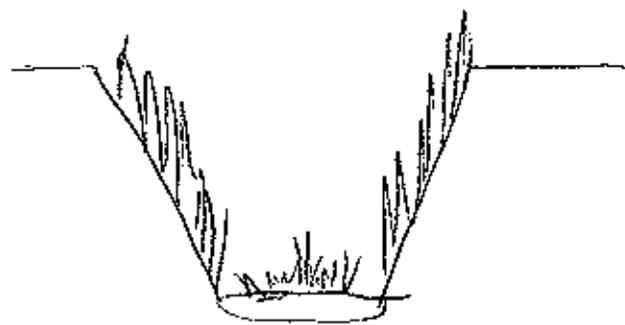
Study Area: Jericho Goshen Bluewater Land Parcel# Turbine # BLW T12 East

Watercourse Sketch

Horizontal View of Channel

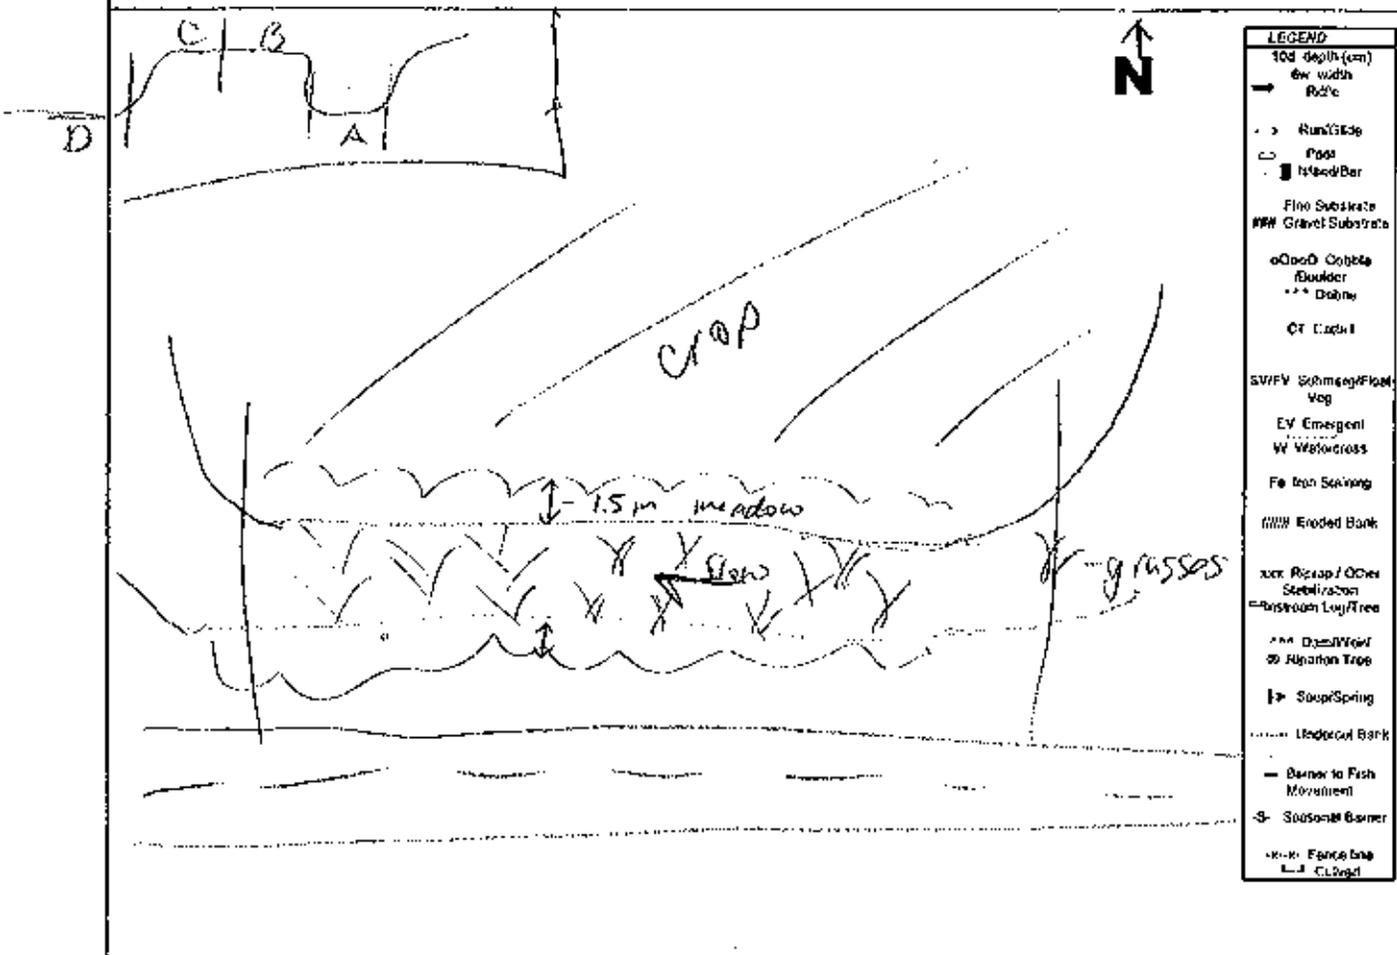
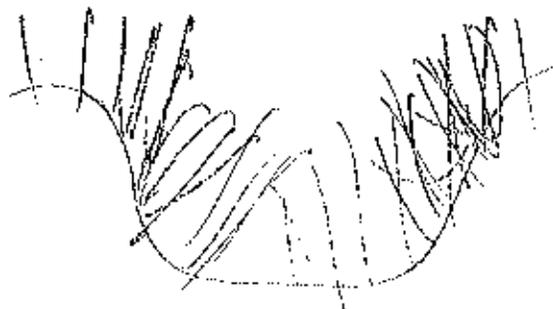
Turbine # BLW-T13-A

Horizontal View of Channel

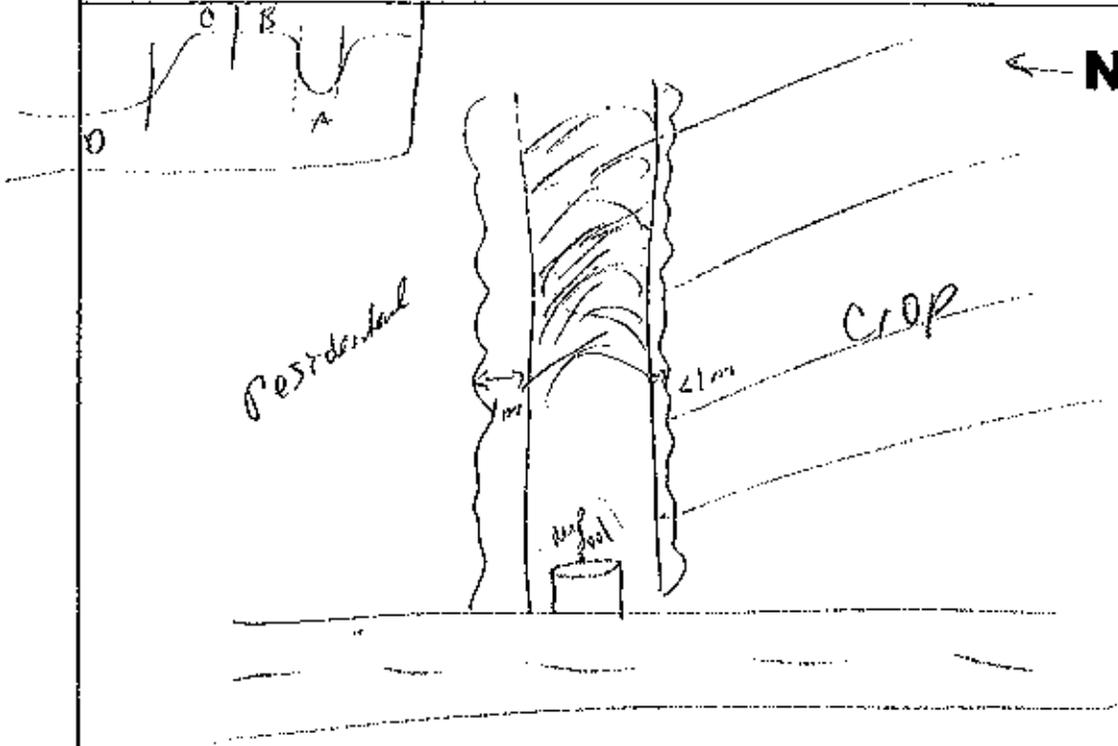
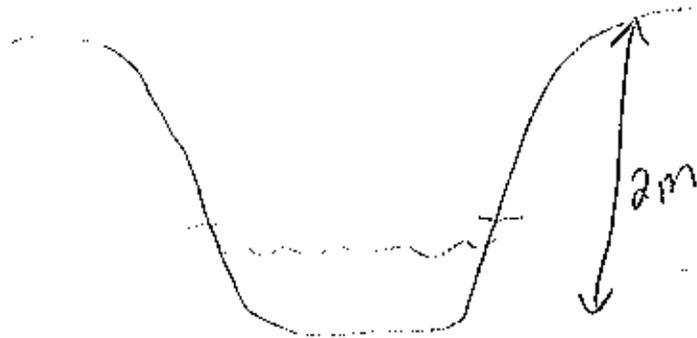
Study Area: Jericho Goshen Bluewater Land Parcel# \_\_\_\_\_ Turbine # BLW-T.13.B

Watercourse Sketch

Horizontal View of Channel

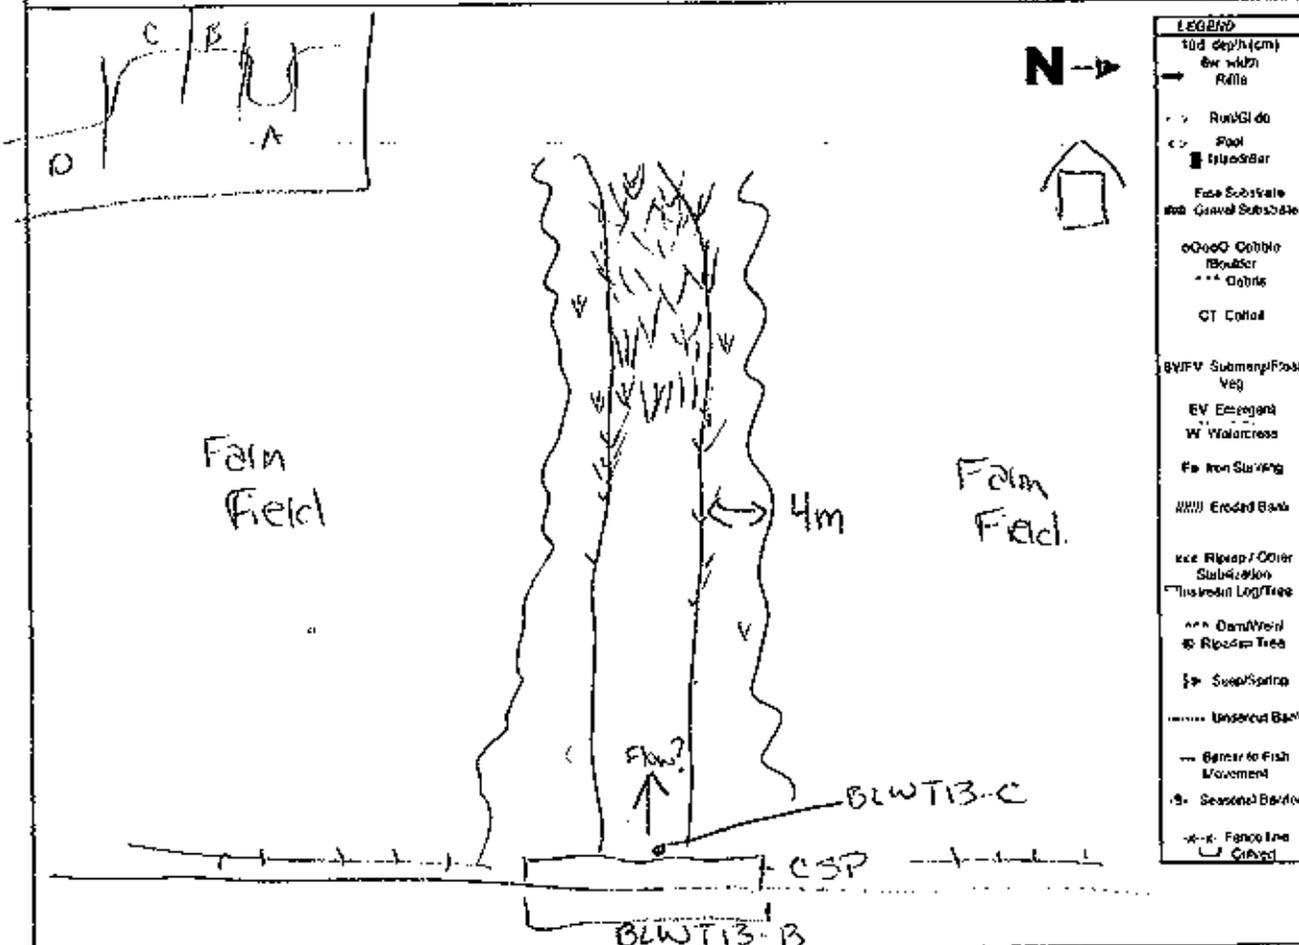
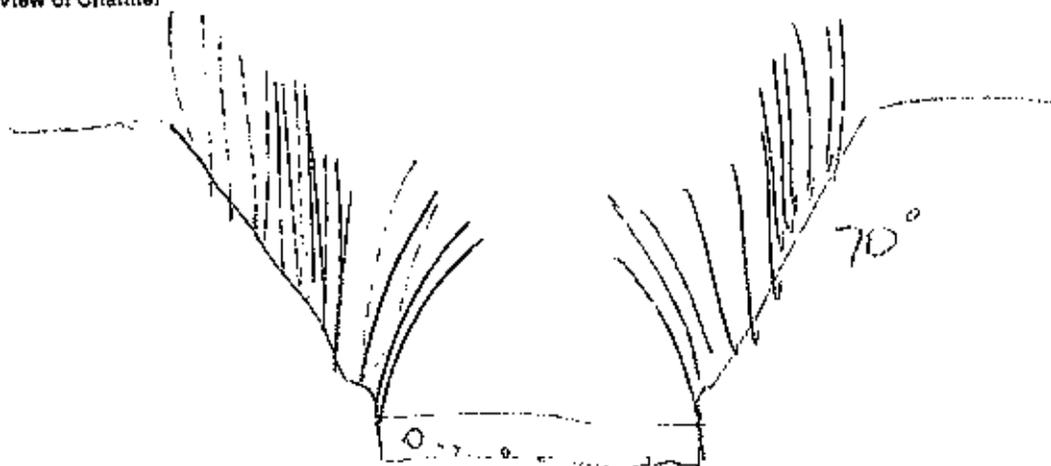
BLWT13-C

Horizontal View of Channel

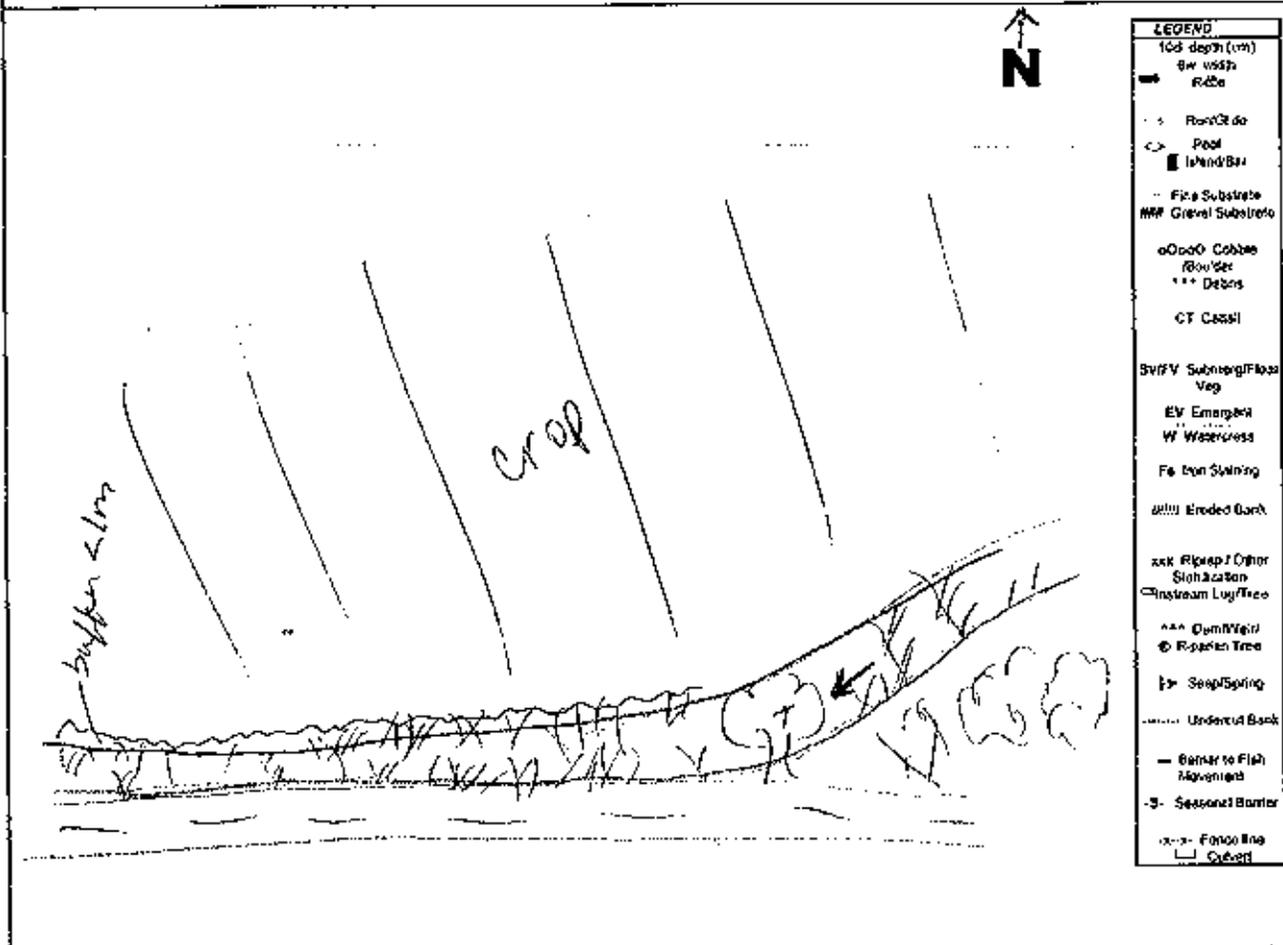
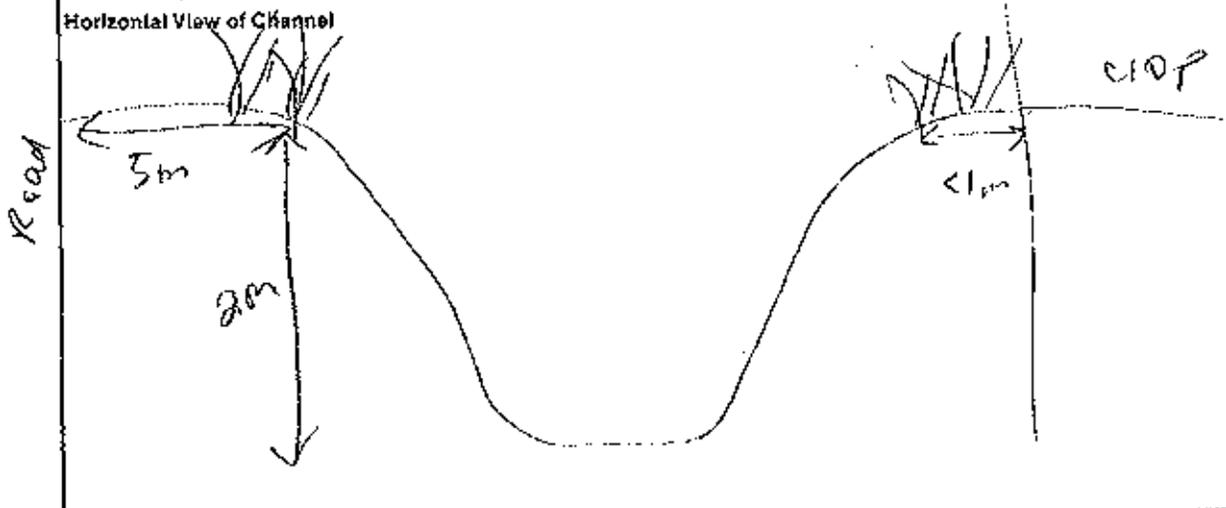
Turbine # BLW-T13-P

Horizontal View of Channel

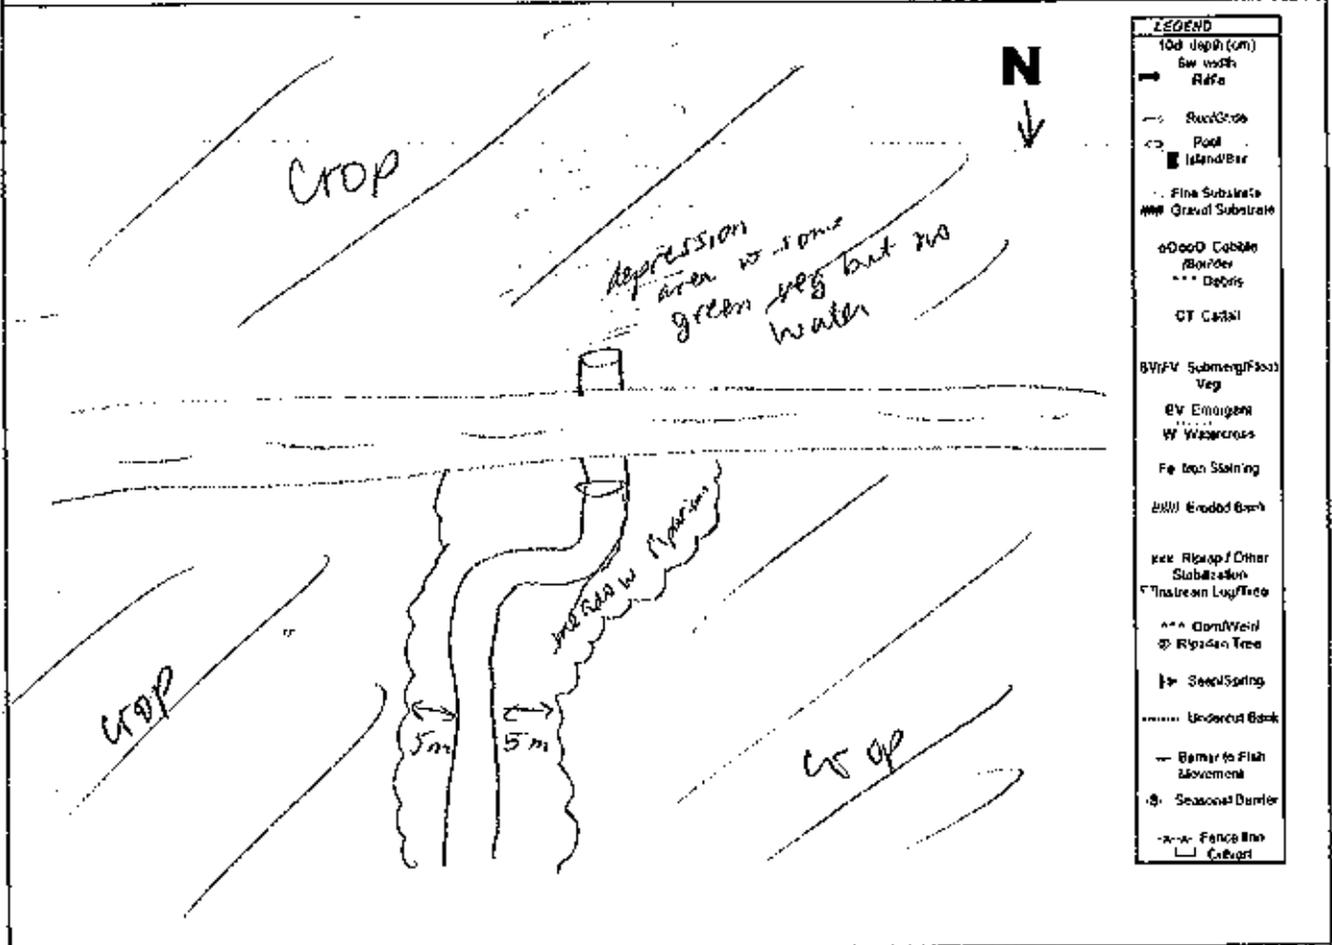
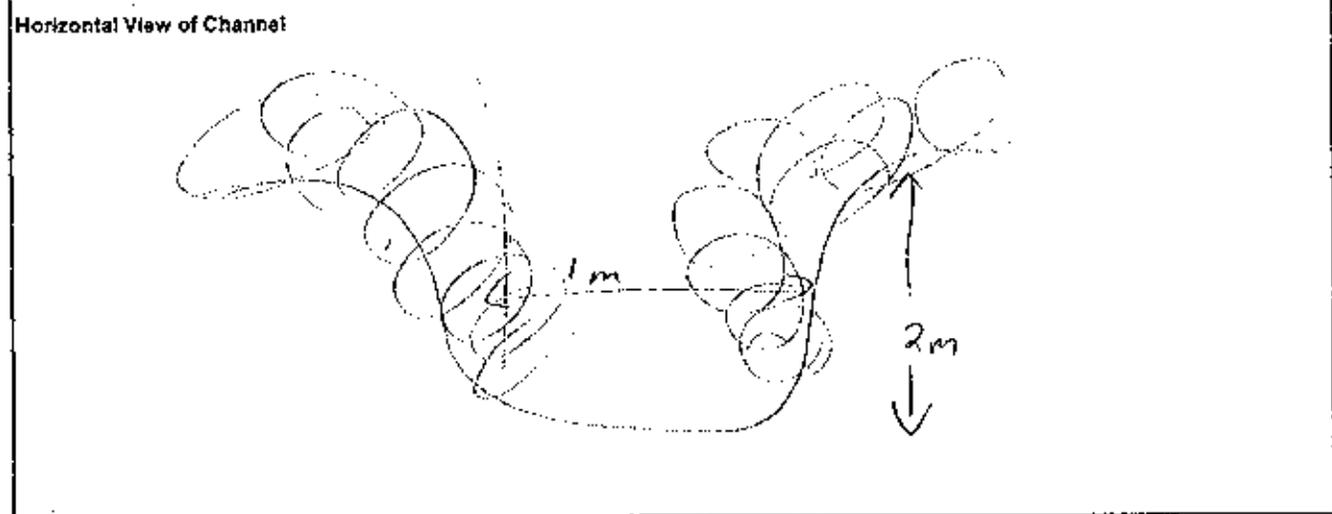
Study Area: Jericho Goshen Bluewater Land Parcel# 1055 Turbine # BLW-C7

Watercourse Sketch

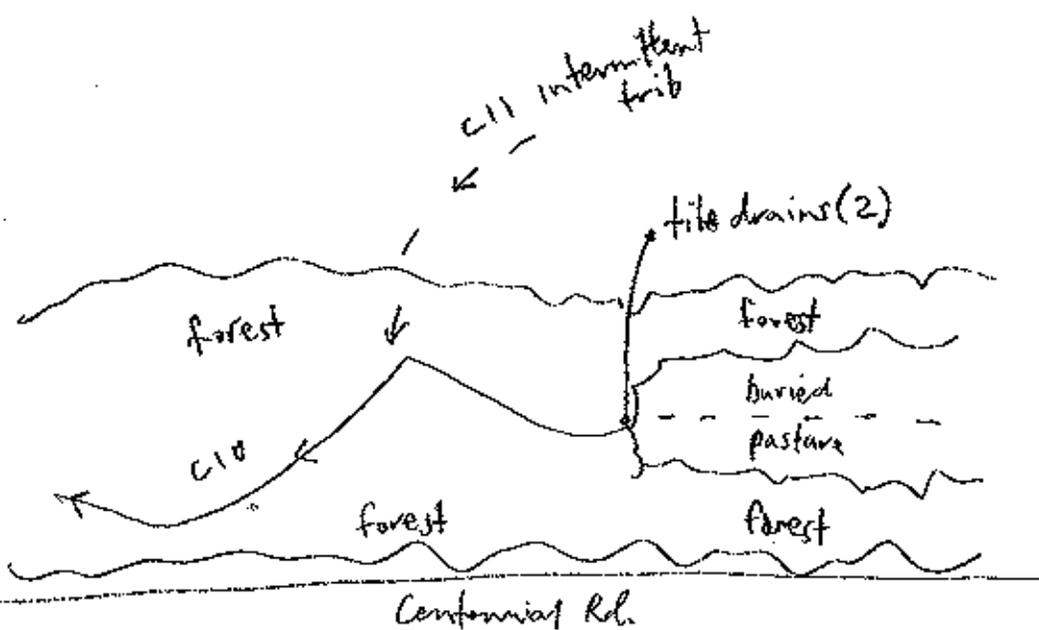
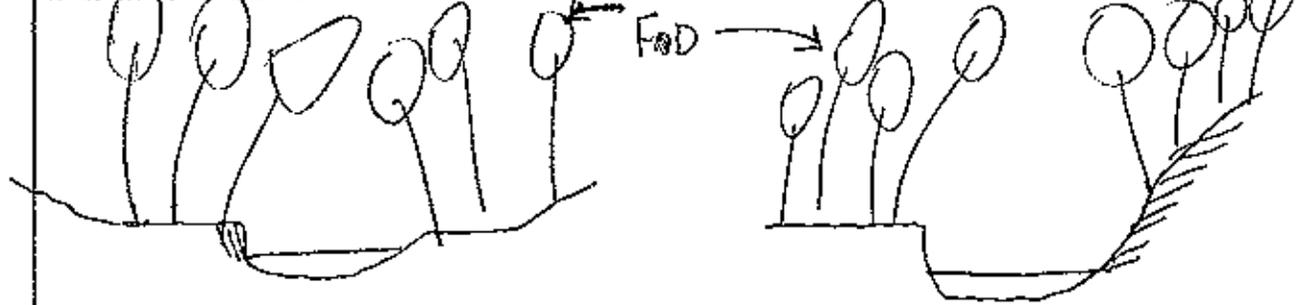
Horizontal View of Channel

Rep. A  
lateral erosion low tops

Rep. B  
lateral erosion high tops

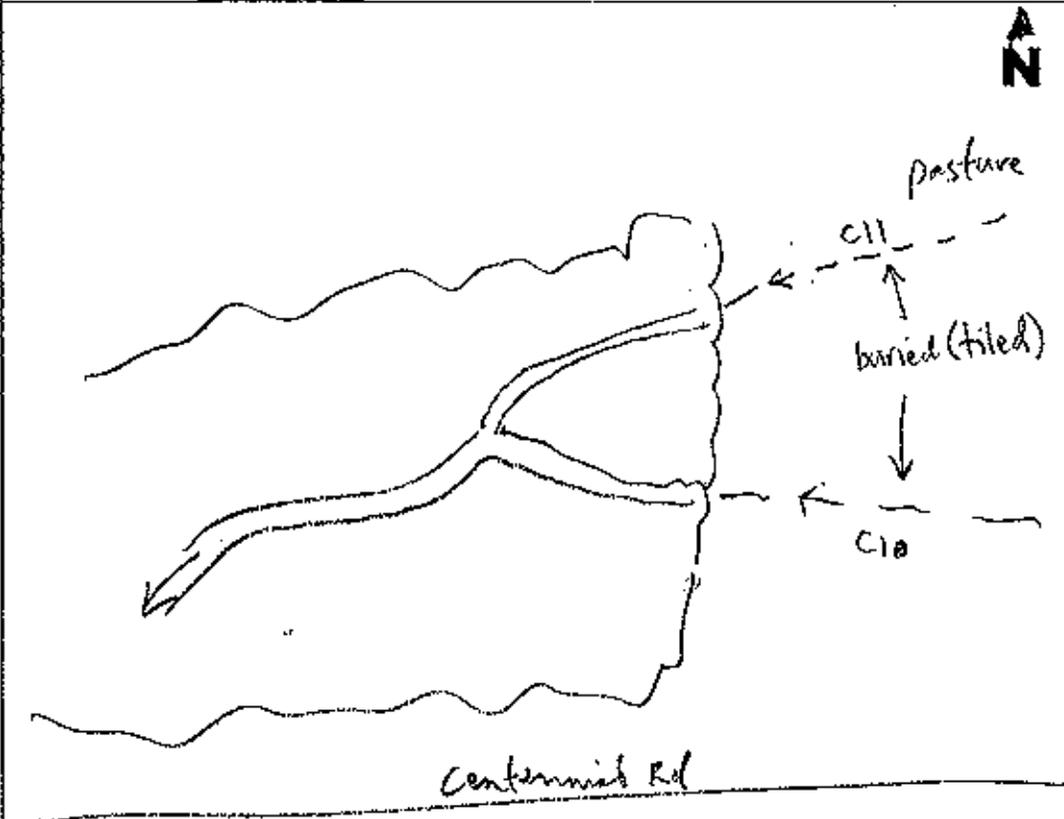
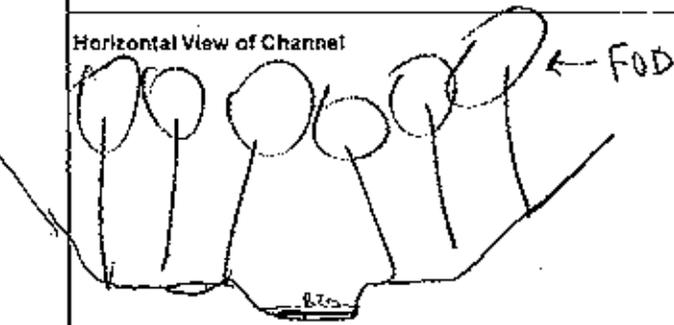
C11

Horizontal View of Channel

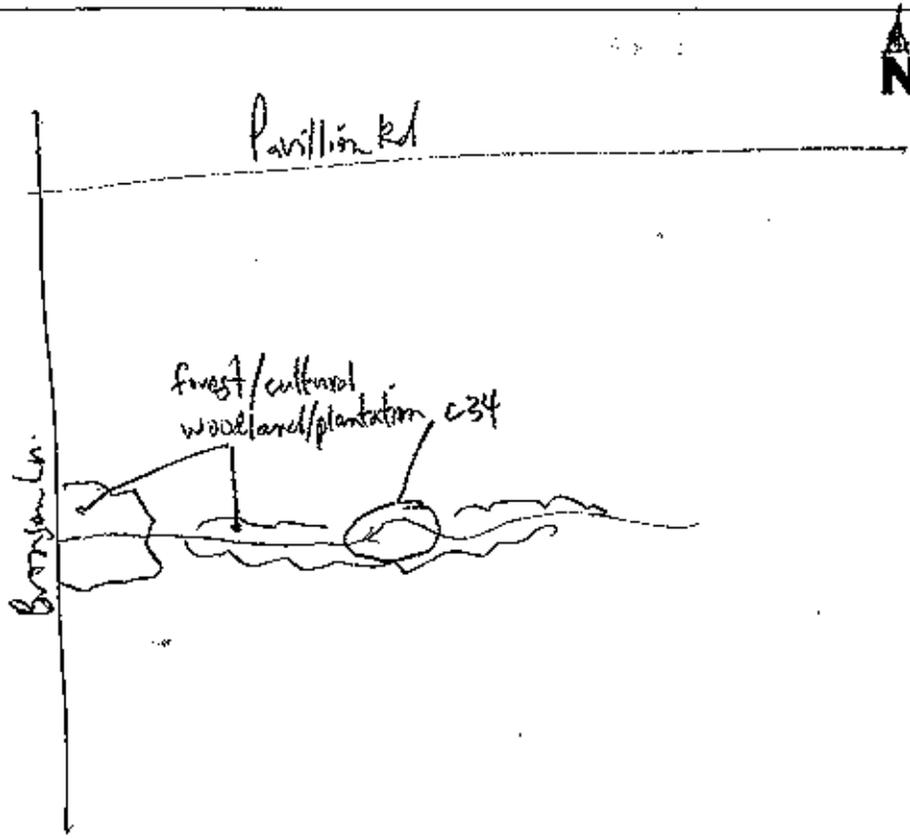
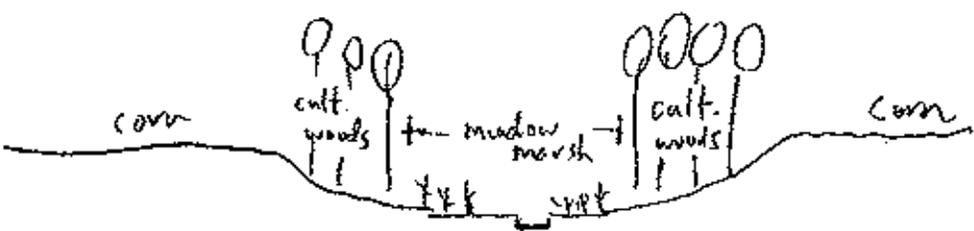
Site C34

Horizontal View of Channel

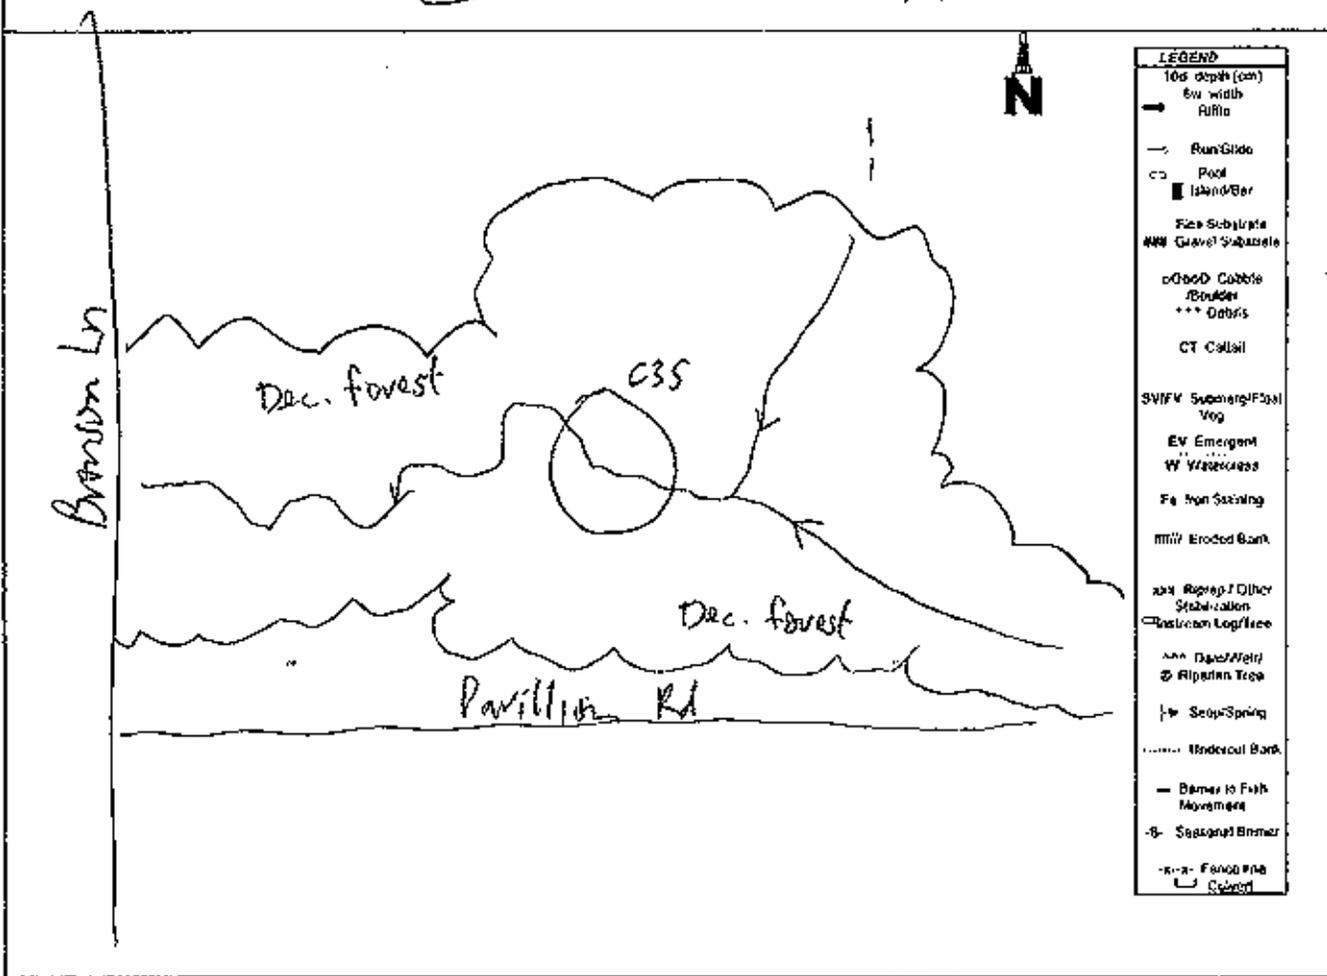
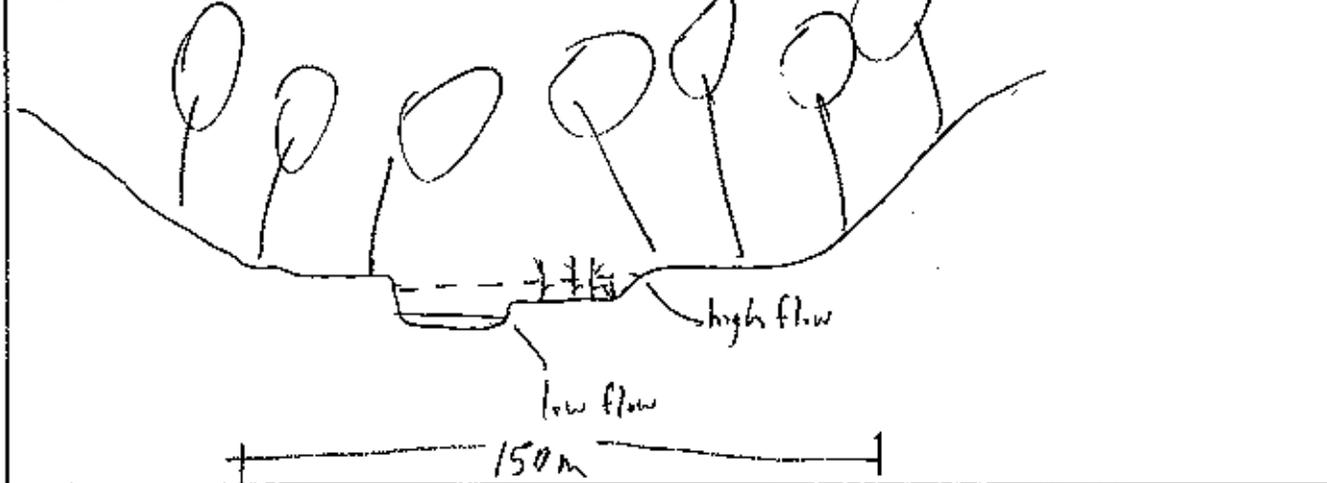
Study Area: Jericho Goshen Bluewater Land Parcel# BLW 1050 Turbine # C35

Watercourse Sketch

Horizontal View of Channel

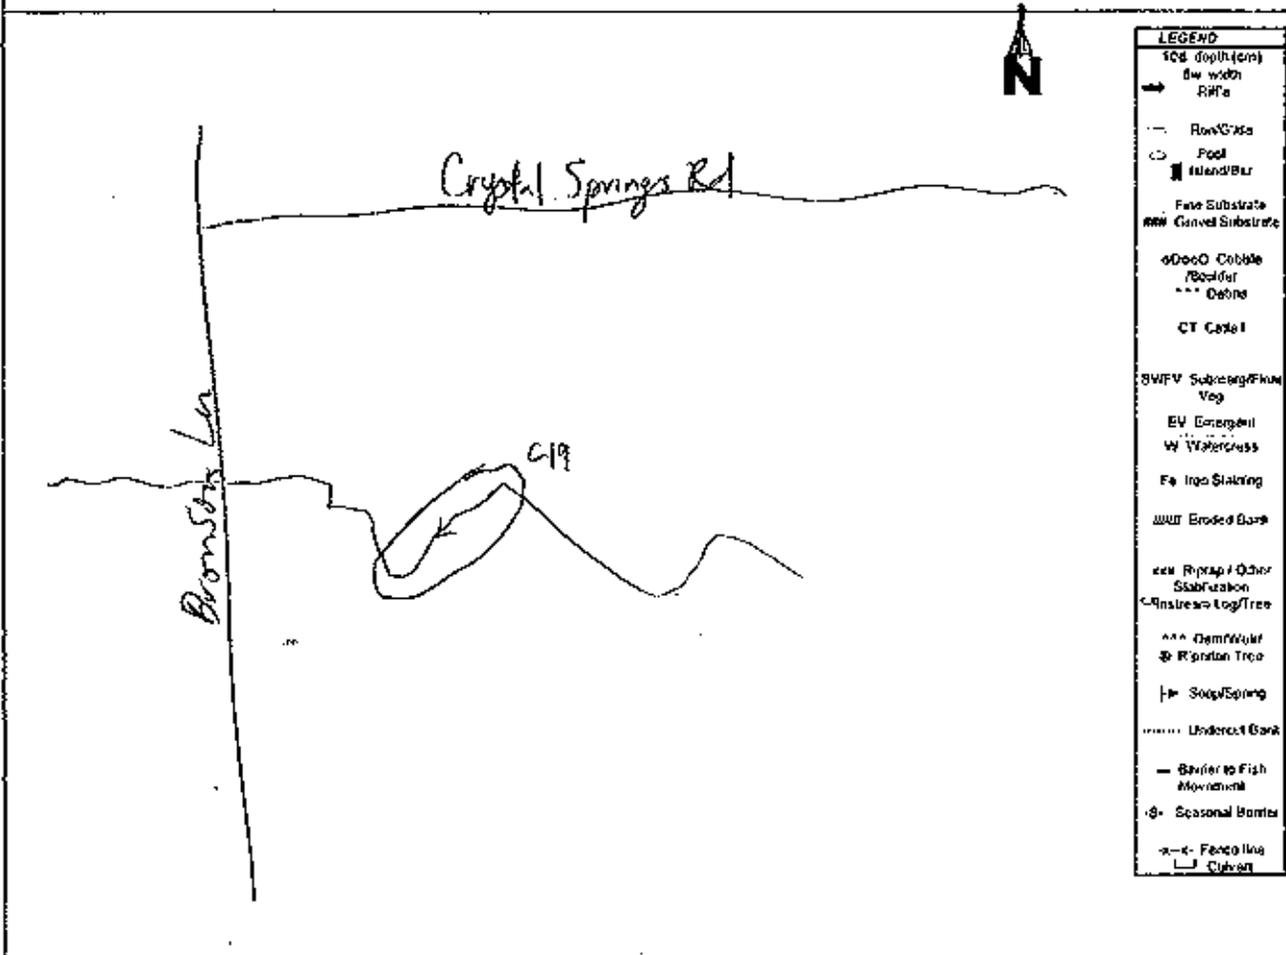
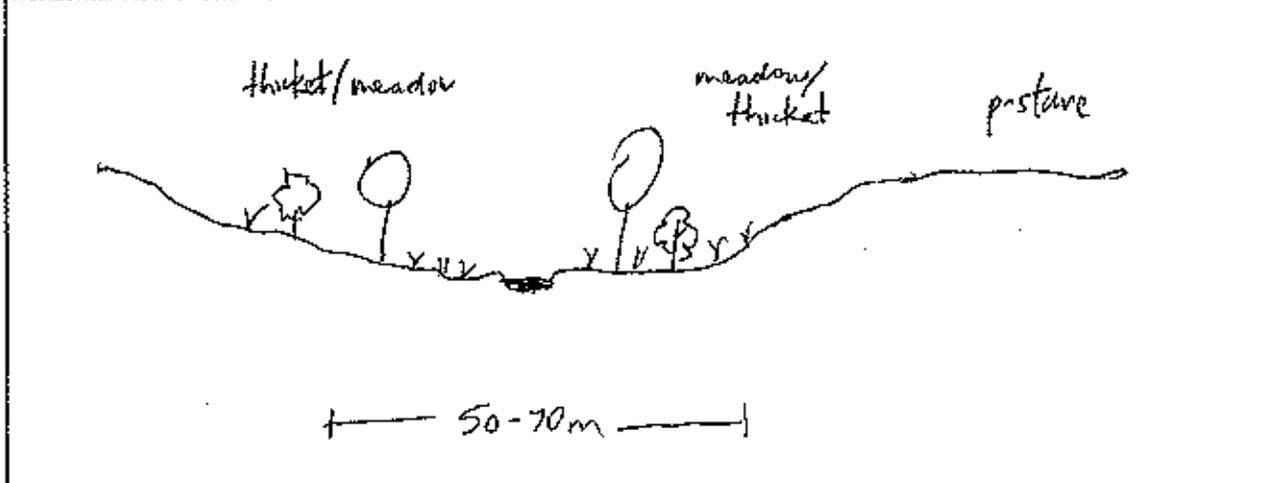
Site C19

Horizontal View of Channel
