# Appendix A

Estimated Zones of Potential  
Recharge and Discharge Areas

### Six Conservation Authorities Geological and Hydrogeological Model Project

## Assessment of Water Bodies and Distance to Project Components

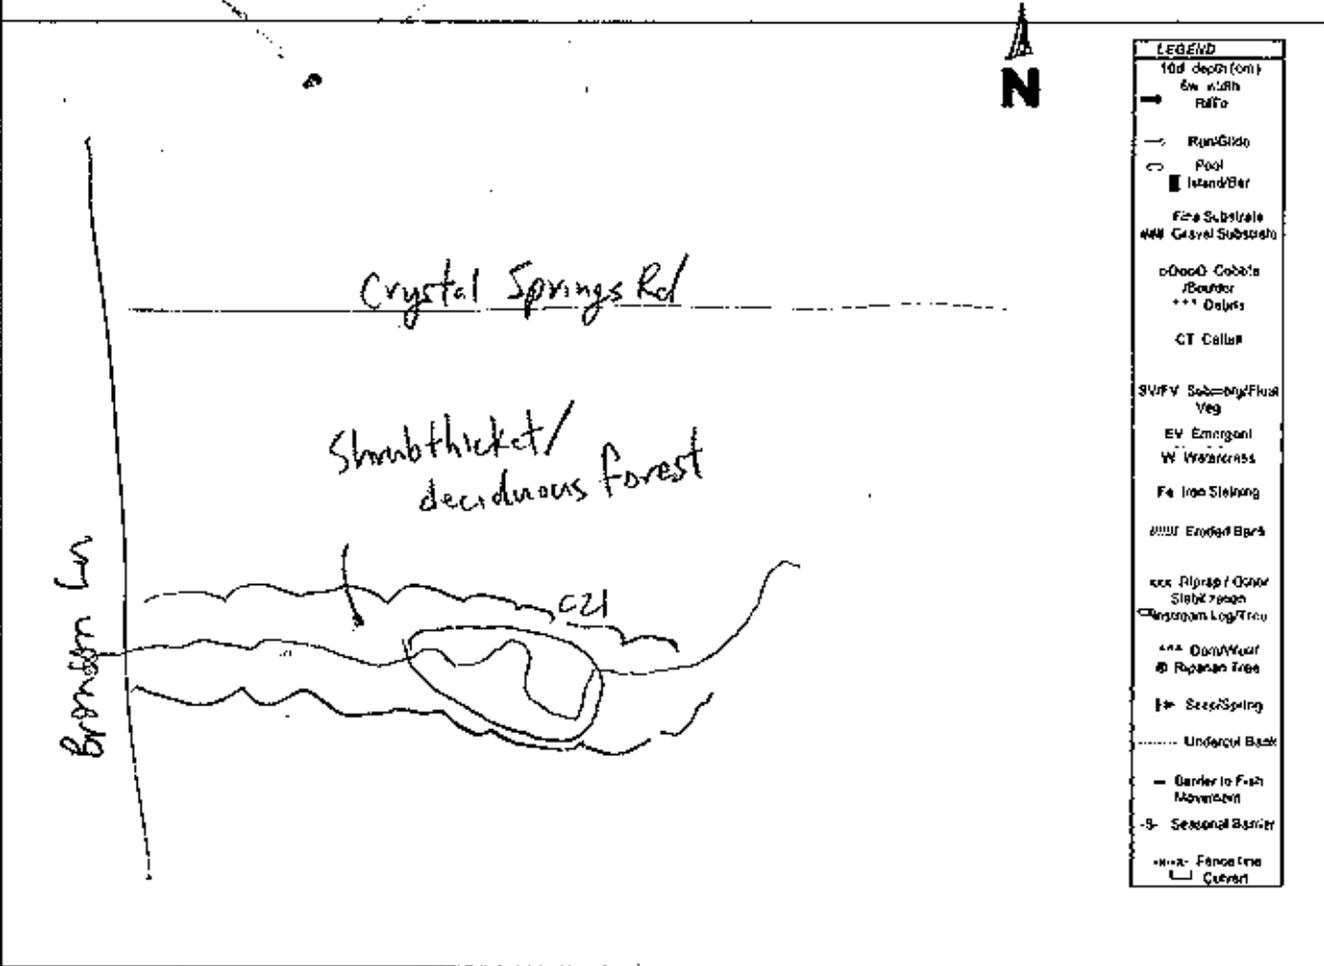
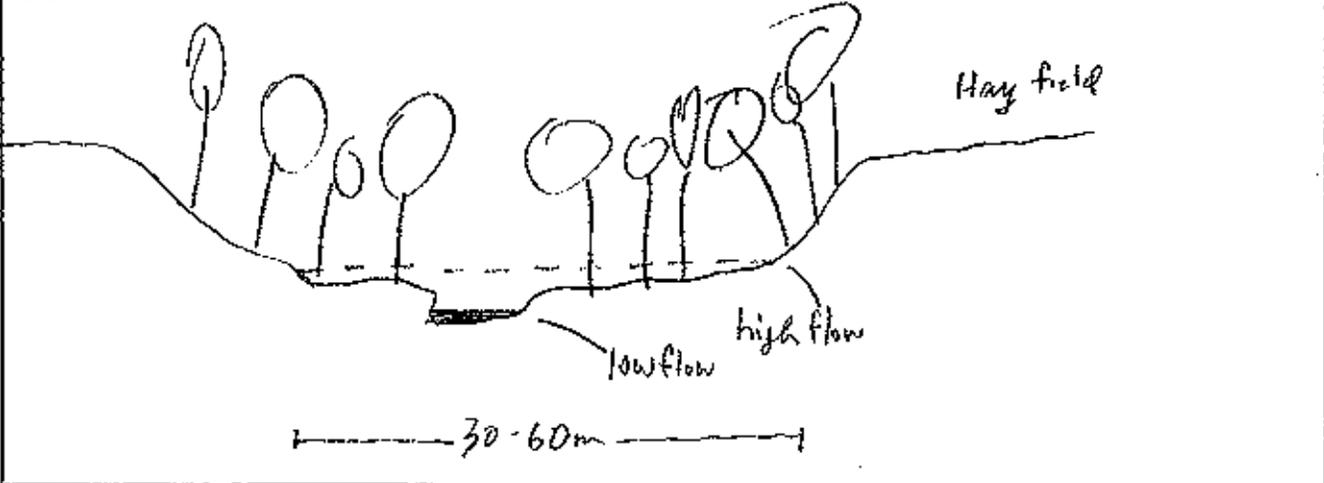
Study Area: Jericho Goshen Bluewater Land Parcel# BLW 1065 Turbine # C21

Watercourse Sketch

Horizontal View of Channel

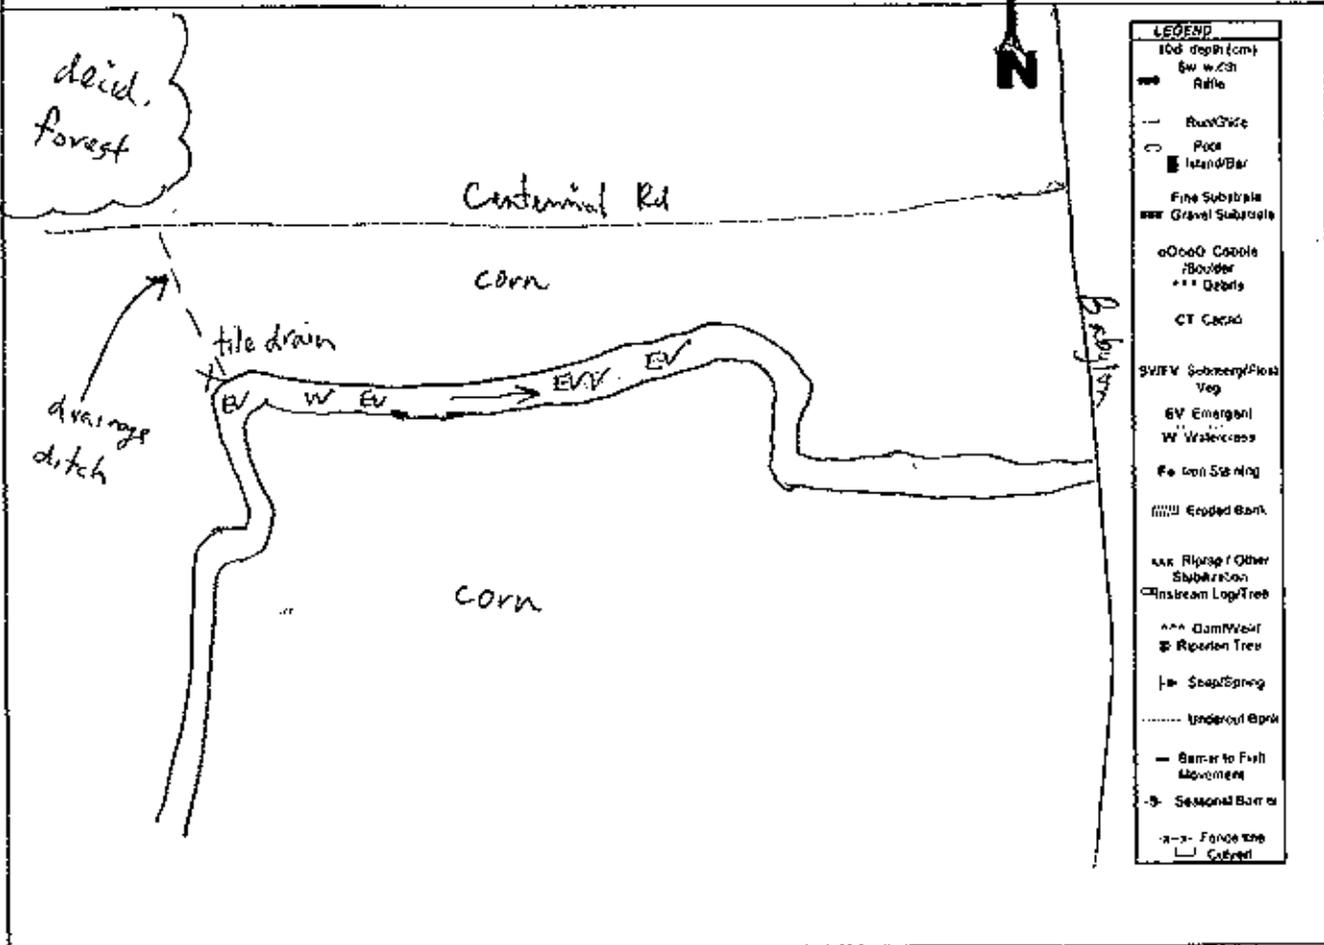
Study Area: Jencho Goshan Bluewater Land Parcel# 1042 Turbine# Site C25

Watercourse Sketch

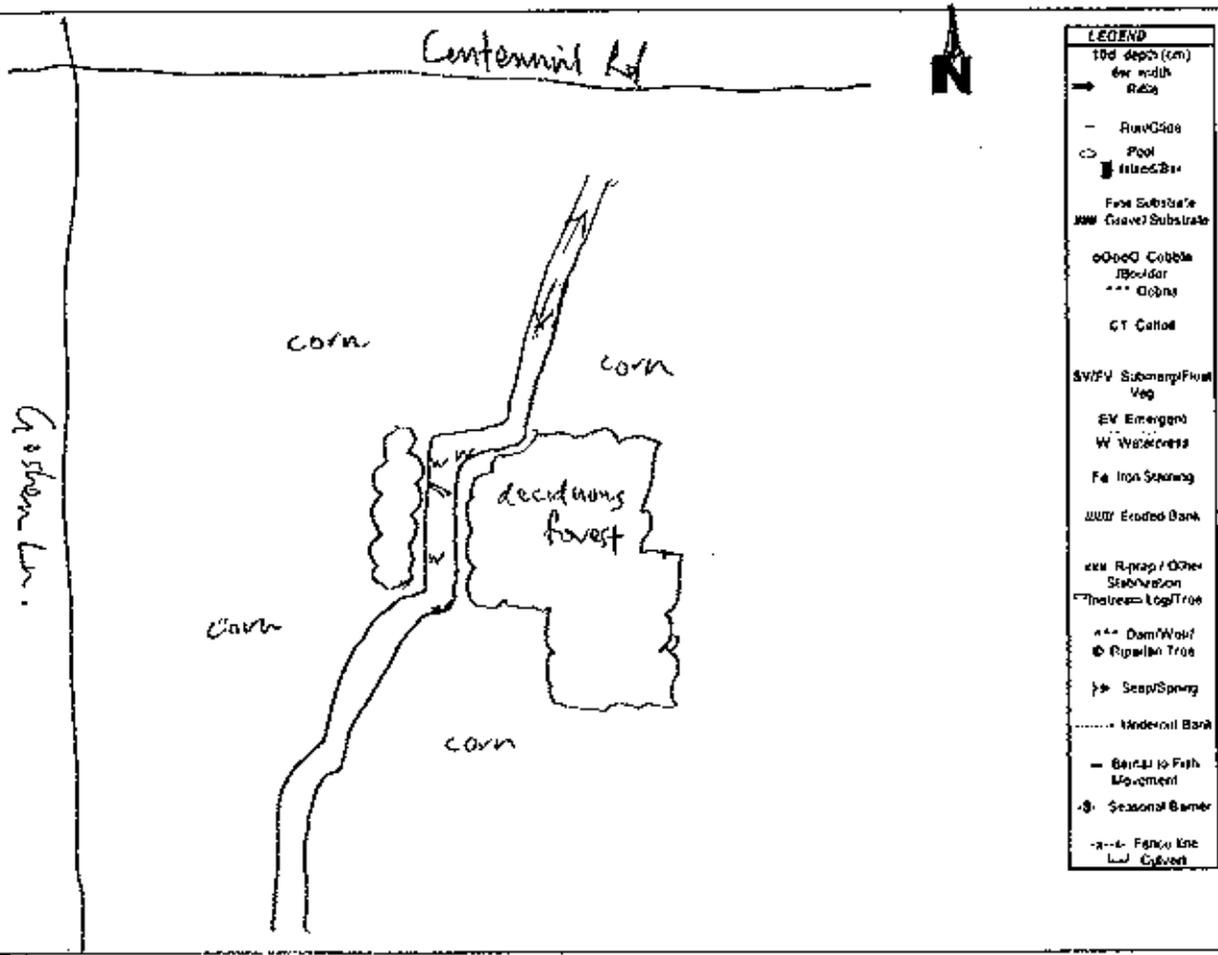
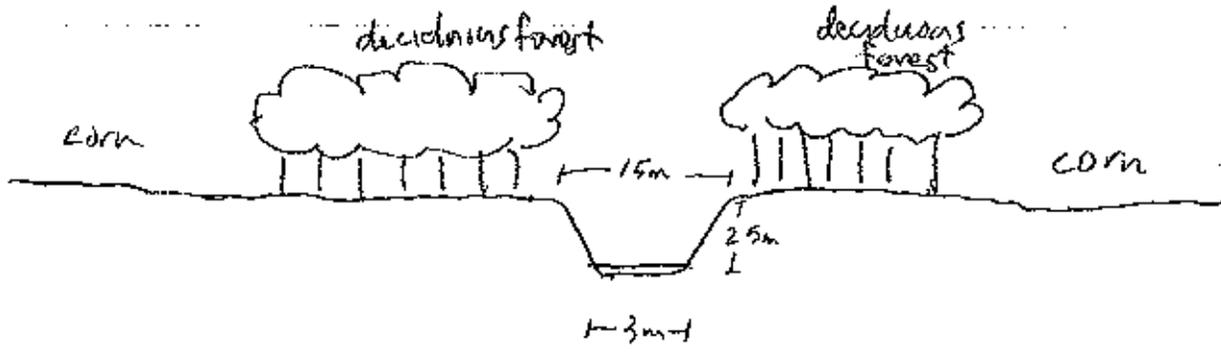
Study Area: Jencho Goshen Bluewater Land Parcel# BUN1450/51 Turbine# 27 / Site C28

Watercourse Sketch

Horizontal View of Channel

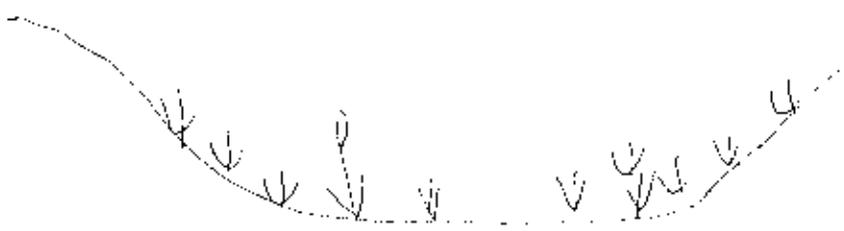
0455115, C42  
Turbine

Horizontal View of Channel

**Notes:** (include any inputs into the system i.e. tile drainage, seepages, overland flow)  
 no tile drains observed, gully or rill features flowing into valley area. - WC is located in valley area adjacent fields corn. tile drain @ C42.3 - water flowing from 2.5 ft

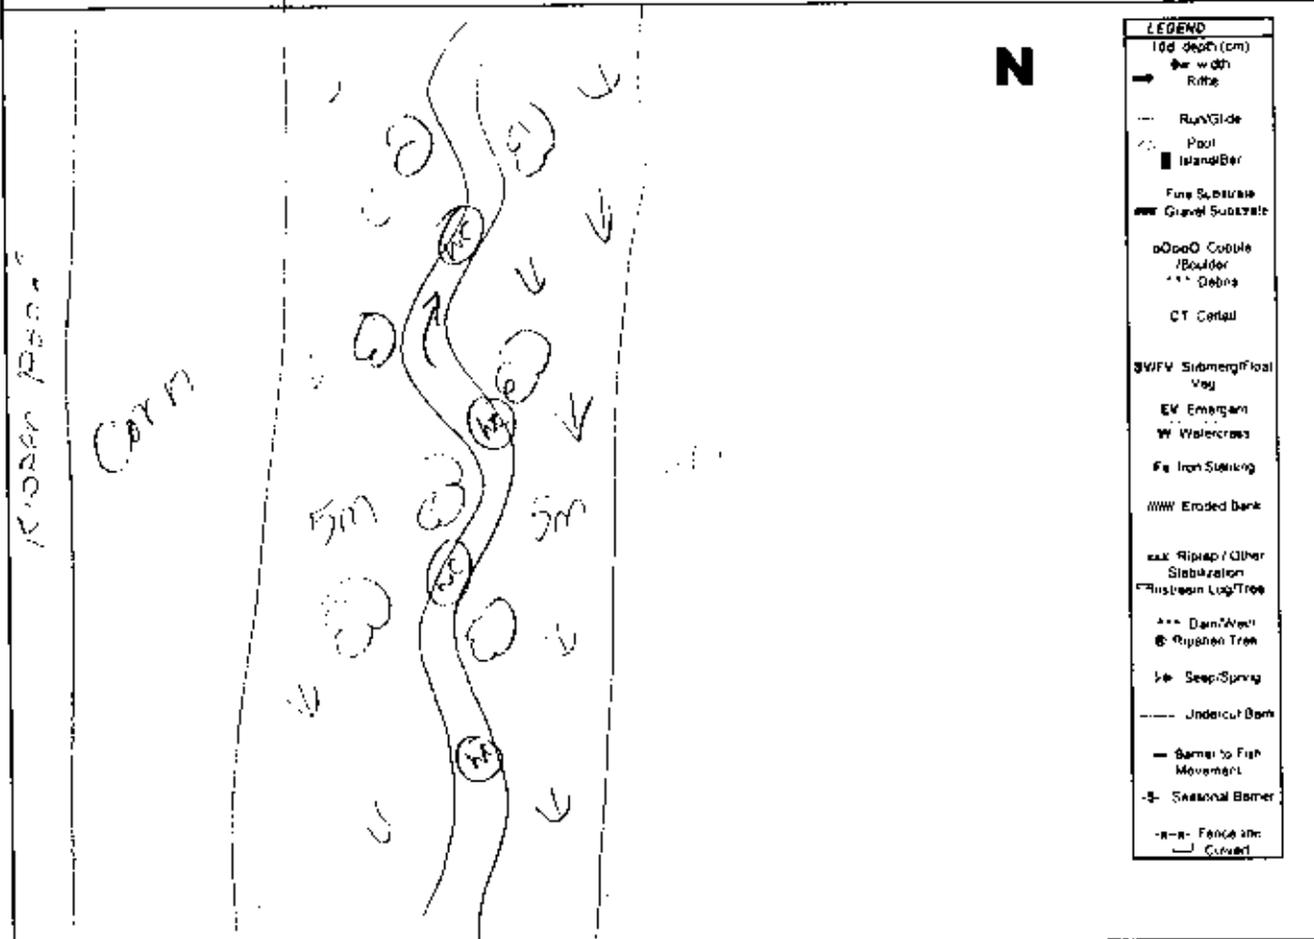
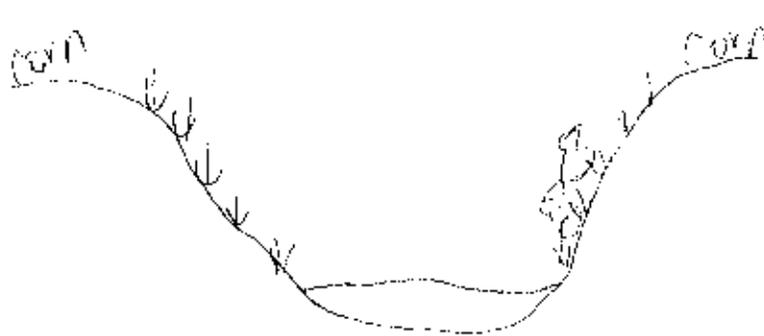
Study Area: Jericho Goshen Bluewater Land Parcel# 1066 Turbine # CH6

Watercourse Sketch

Horizontal View of Channel

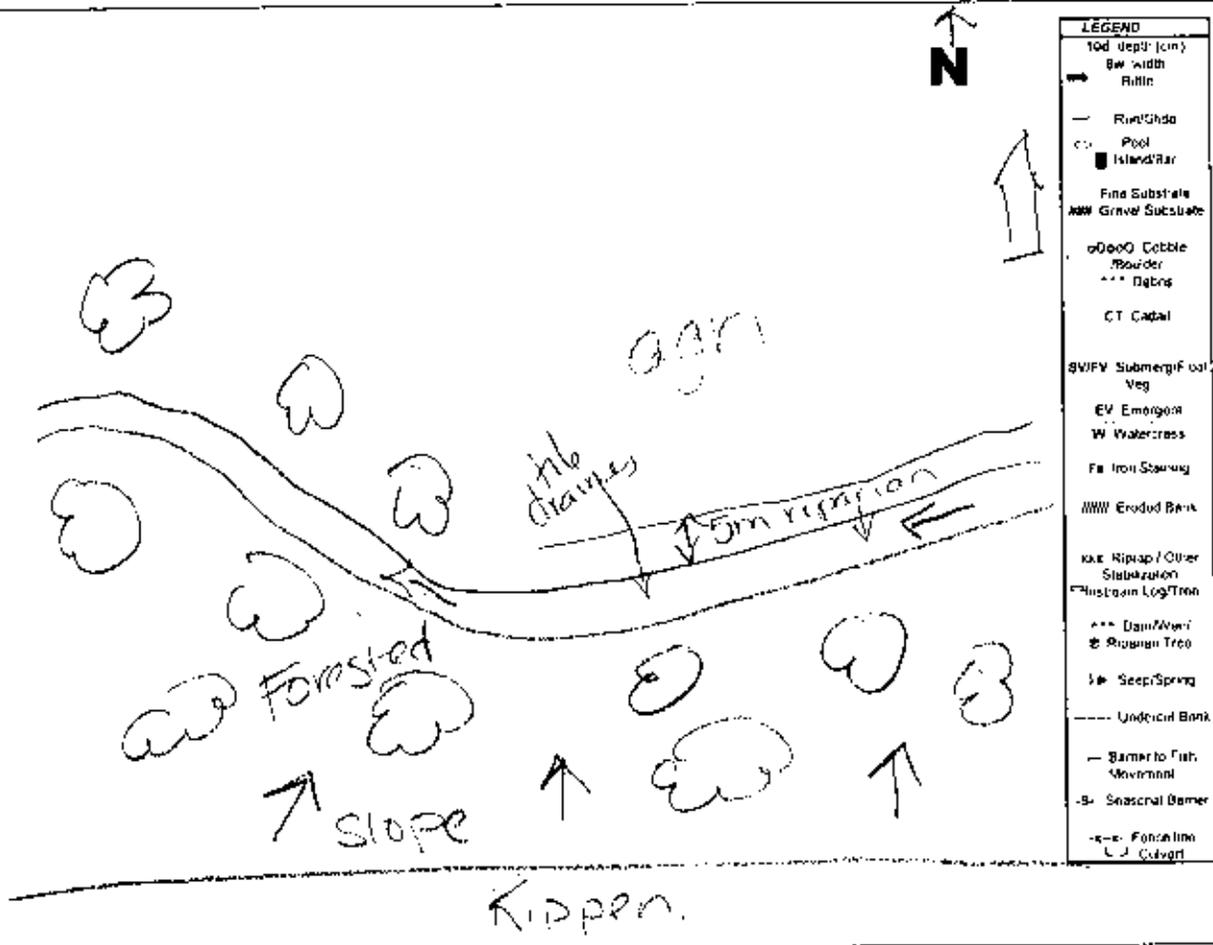
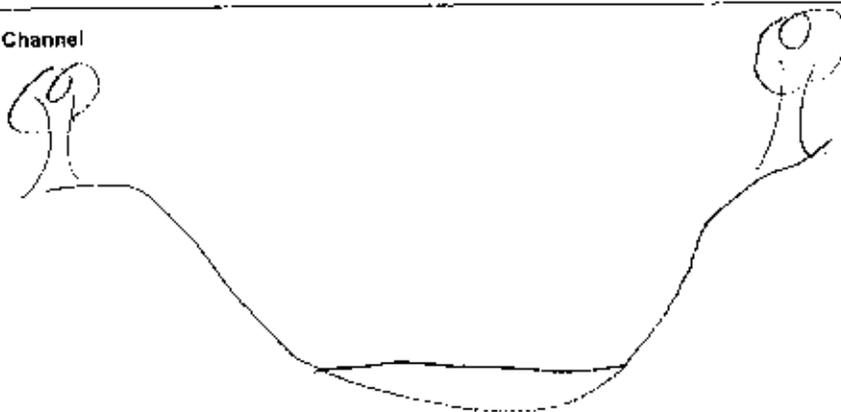
Study Area: Jericho Goshen Bluewater Land Parcel# 10663 Turbine # C410

Watercourse Sketch

Horizontal View of Channel

Notes: Bank scouring observed  
erosion occurring around area where channel narrows

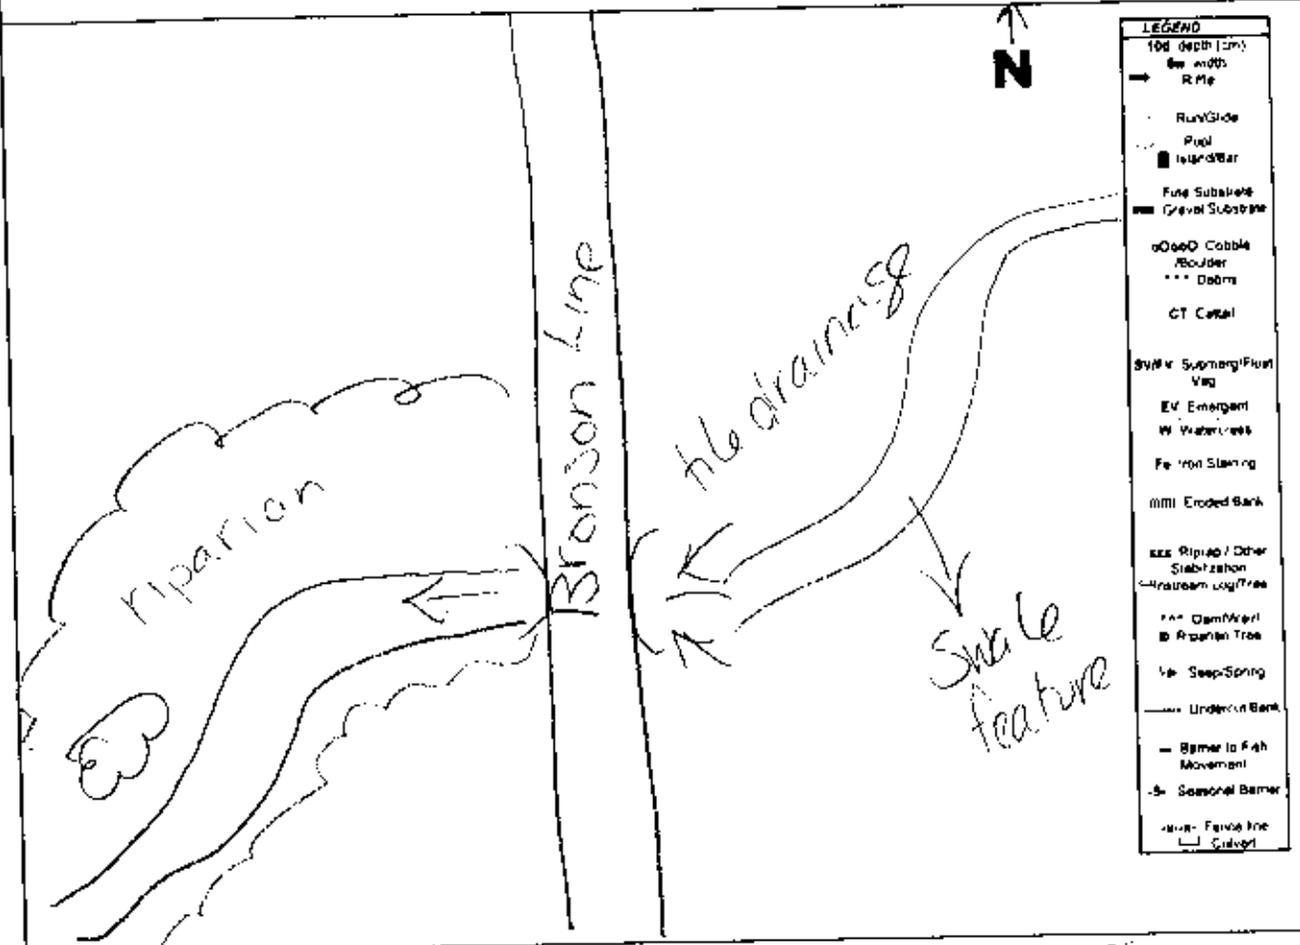
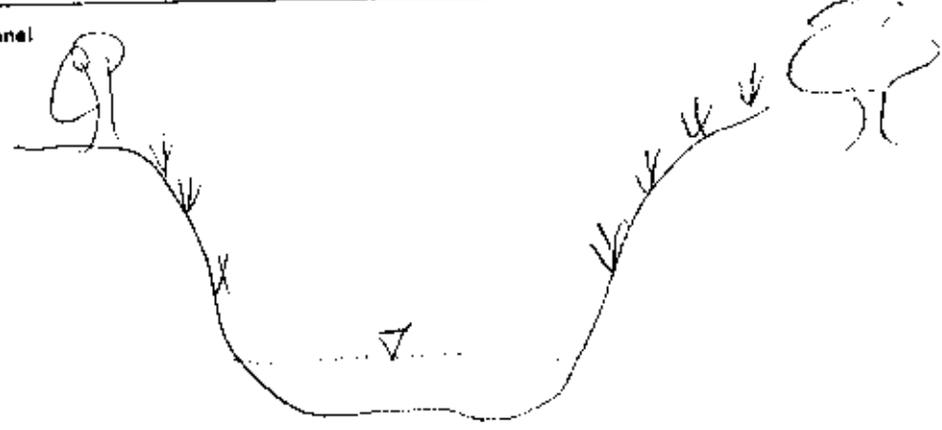
C83

Horizontal View of Channel

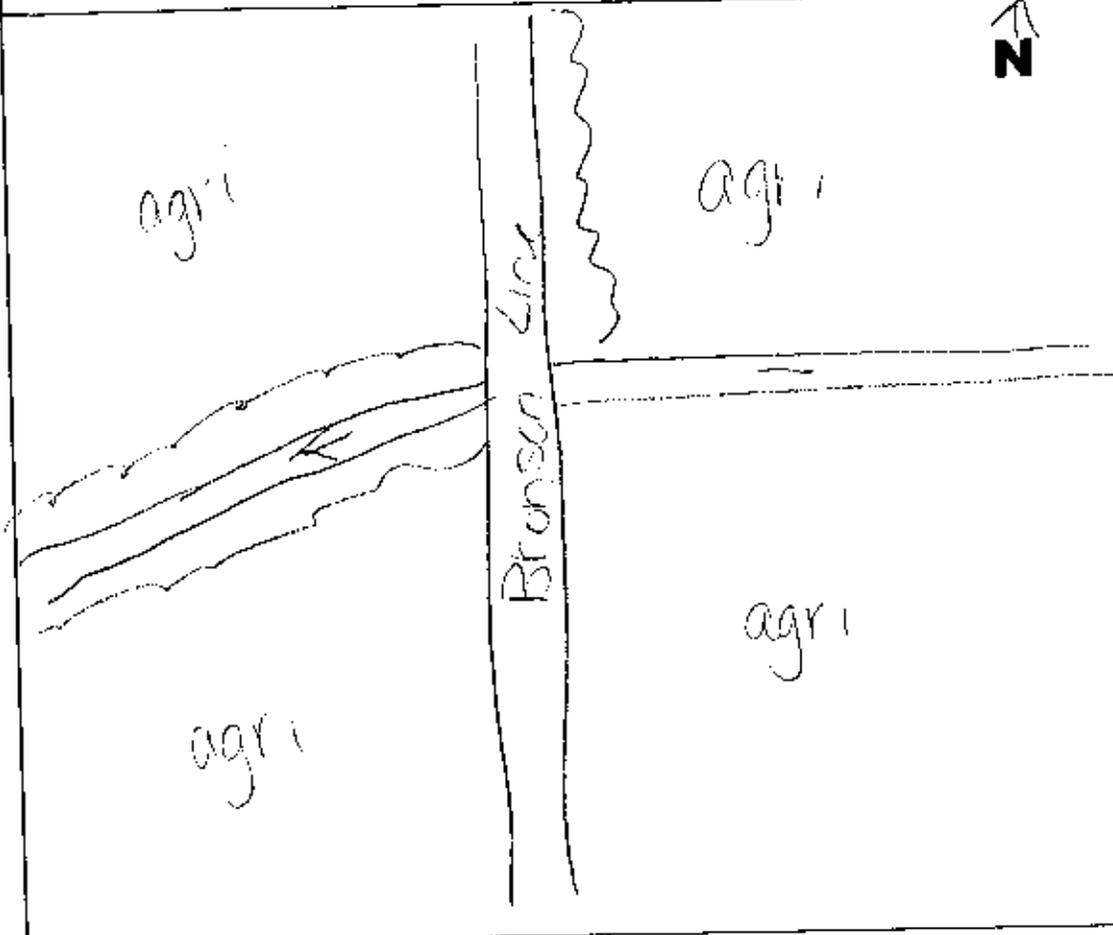
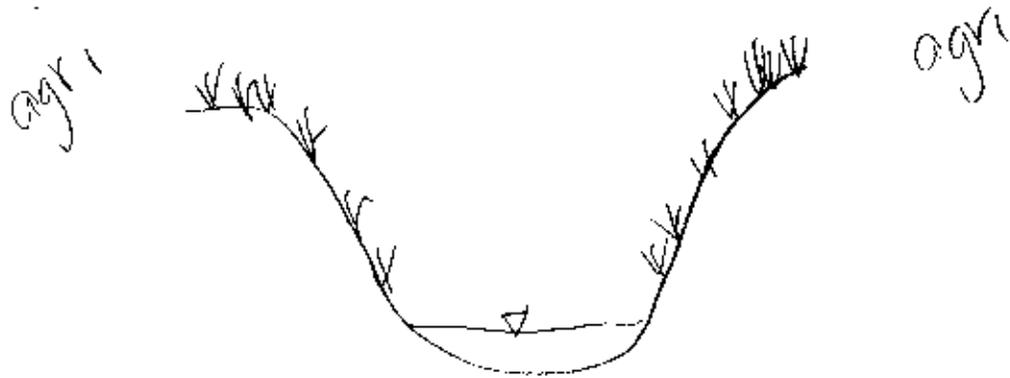
C54

Horizontal View of Channel

In-Situ Water Quality		Ground Water Indicators	
WT (°C):	AT (°C):	Watercress <input checked="" type="checkbox"/>	Bank Seepage <input type="checkbox"/>
pH:	Cond (µs/cm):	Iron Staining <input type="checkbox"/>	None <input type="checkbox"/>
Water Clarity: Clear <input checked="" type="checkbox"/>	Turbid <input type="checkbox"/>	Bubbling <input type="checkbox"/>	Other <input type="checkbox"/>
Notes:			
Stream Morphology			
Site Length (m):		Bank Stability:	
Channel Dimensions		Stable	Slightly unstable
Mean Wetted Width (m): 2.5	Mean Bankfull Width (m): 0.905	Moderately unstable	Unstable
Mean Wetted Depth (m): 0.20	Mean Bankfull Depth (m): 3.7	Left Bank	Right Bank
		<input type="checkbox"/>	<input checked="" type="checkbox"/>
		<input type="checkbox"/>	<input checked="" type="checkbox"/>
Flow Description:			
Notes: bank seepage on west side Top = 1.10 m 2.30 w

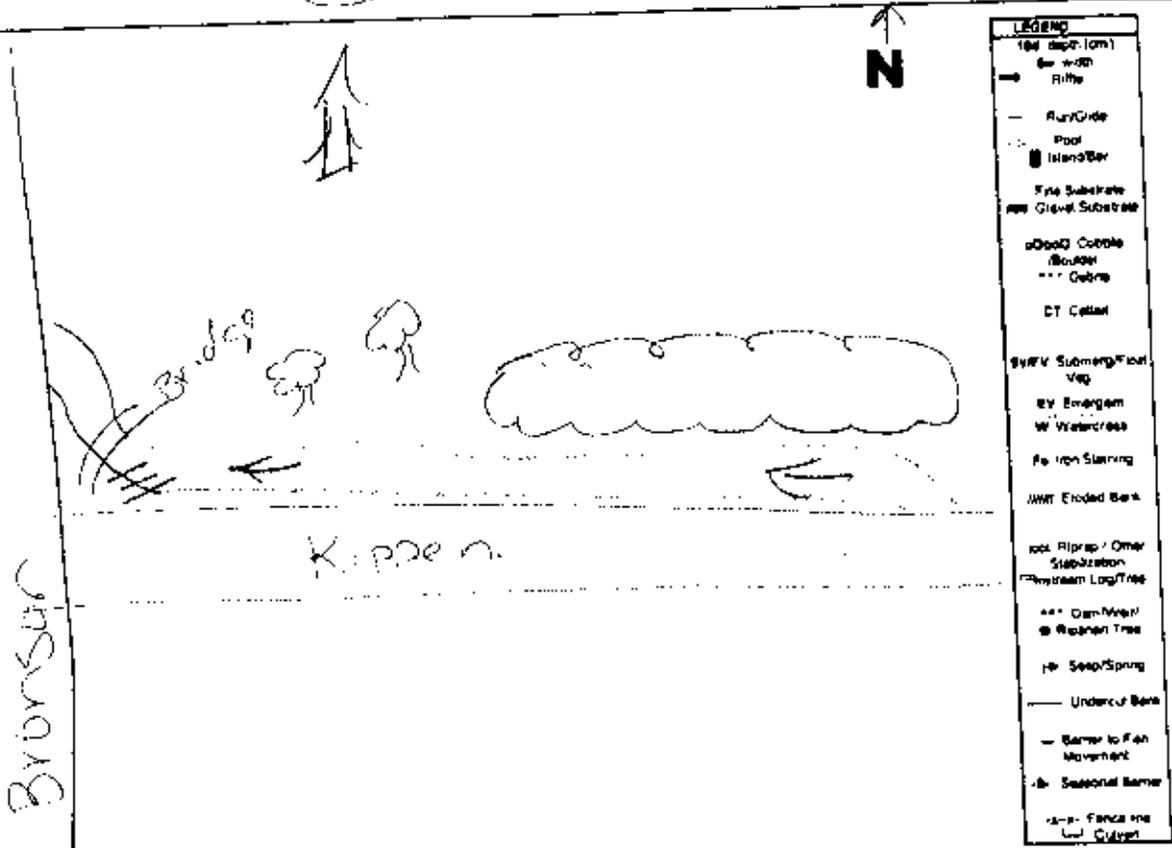
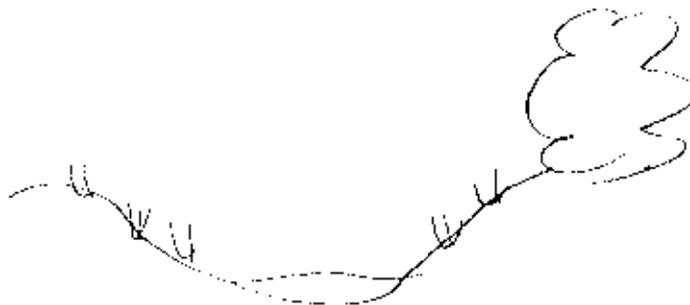
Study Area: Jencho Goshen Bluewater Land Parcel# 1069 + 1568 Turbine # C32

**Watercourse Sketch**

**Horizontal View of Channel**

Other:					
Notes: (include any inputs into the system i.e. tile drainage, seepages, overland flow) tile drains entering watercourse					
In-Situ Water Quality - none.		Ground Water Indicators			
WT (°C):	AT (°C):	Watercress <input checked="" type="checkbox"/>	Bank Seepage <input type="checkbox"/>		
pH:	Cond (µm):	Iron Staining <input type="checkbox"/>	None <input type="checkbox"/>		
Water Clarity: Clear <input checked="" type="checkbox"/>	Turbid <input type="checkbox"/>	Bubbling <input type="checkbox"/>	Other <input type="checkbox"/>		
Notes: tile drains flowing					
Stream Morphology					
Site Length (m):	Bank Stability:				
Channel Dimensions		Stable	Slightly unstable	Moderately unstable	Unstable
Mean Wetted Width (m): 1.3	Mean Bankfull Width (m): 4.5	Left Bank <input type="checkbox"/>	<input checked="" type="checkbox"/>	<input type="checkbox"/>	<input type="checkbox"/>
Mean Wetted Depth (m): 0.25	Mean Bankfull Depth (m): 1.8	Right Bank <input type="checkbox"/>	<input checked="" type="checkbox"/>	<input type="checkbox"/>	<input type="checkbox"/>

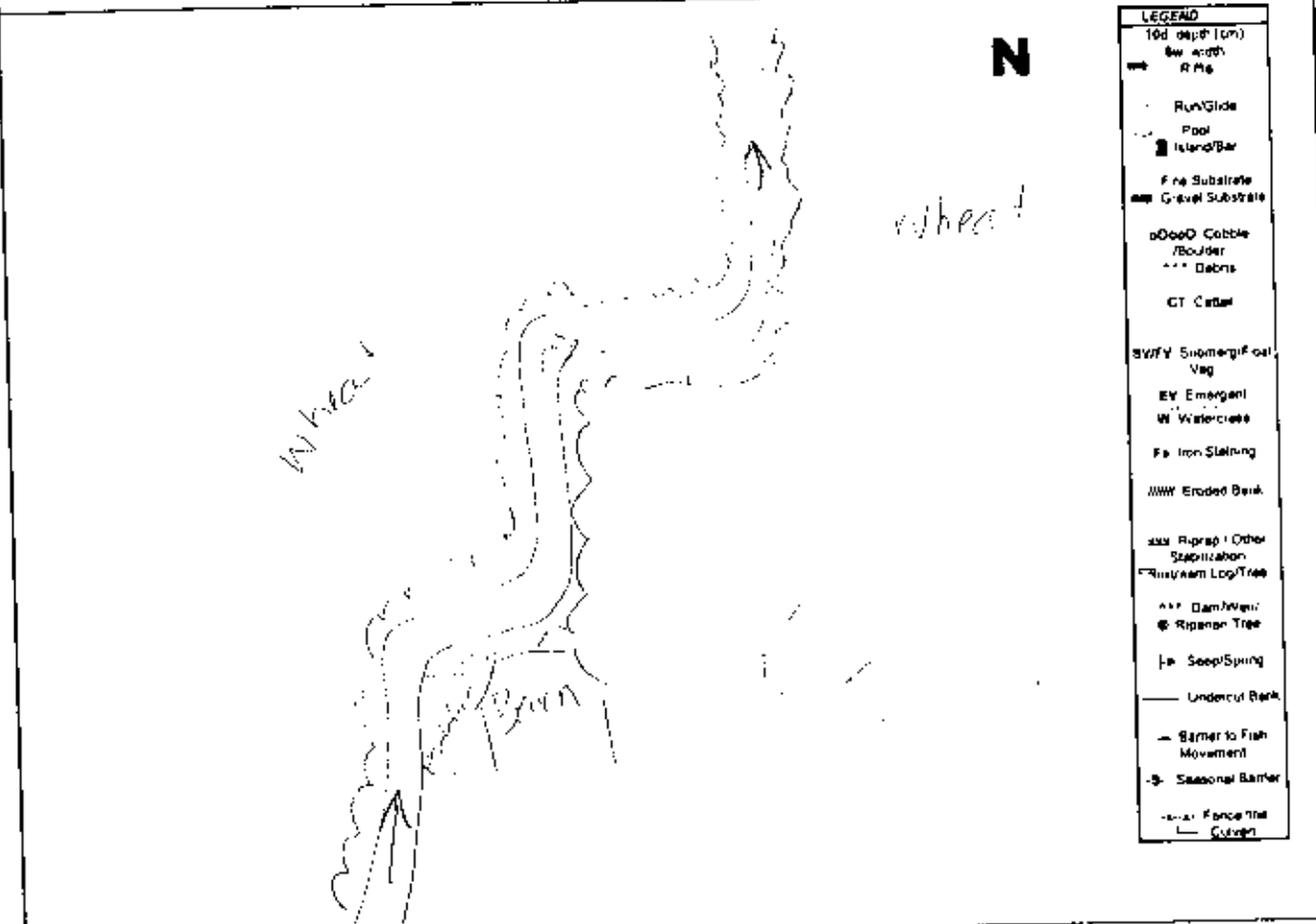
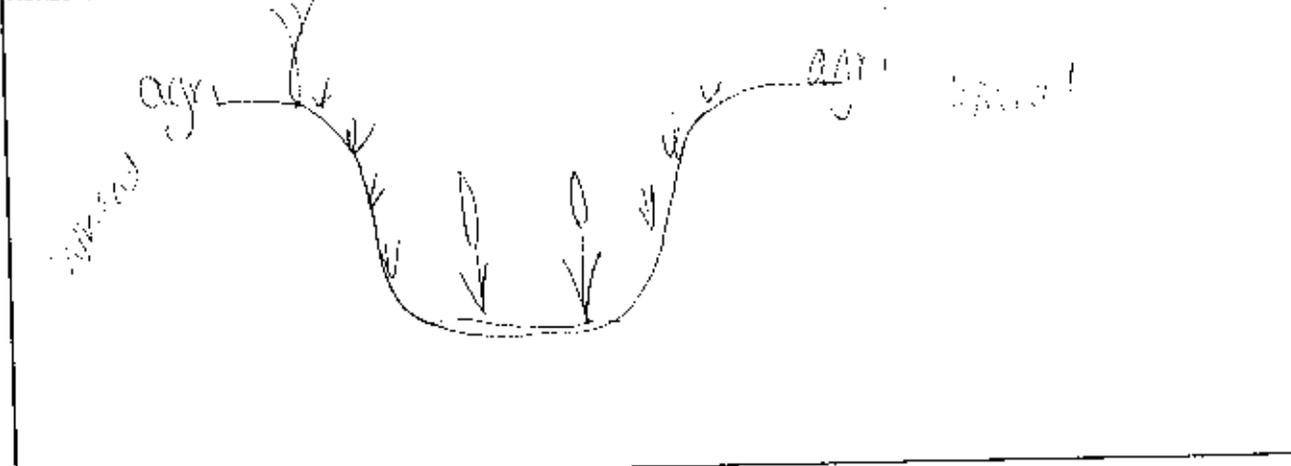
C87

Horizontal View of Channel

Other:			
Notes: (include any inputs into the system i.e. tile drainage, seepages, overland flow)			
tile drain inputs → several			
In-Situ Water Quality		Ground Water Indicators	
WT (°C): 10°C	AT (°C): 8°C	Watercress <input checked="" type="checkbox"/>	Bank Seepage <input type="checkbox"/>
pH: /	Cond (µ/cm): /	Iron Staining <input type="checkbox"/>	None <input type="checkbox"/>
Water Clarity: Clear <input checked="" type="checkbox"/>	Turbid <input type="checkbox"/>	Bubbling <input type="checkbox"/>	Other <input type="checkbox"/>
Notes: some we			
Stream Morphology			
Site Length (m):		Bank Stability:	
Channel Dimensions		Stable      Slightly unstable      Moderately unstable      Unstable	
Mean Wetted Width (m): 3.00	Mean Bankfull Width (m): 4.00	Left Bank	<input type="checkbox"/> <input checked="" type="checkbox"/> ↔ <input checked="" type="checkbox"/> <input type="checkbox"/>
Mean Wetted Depth (m): 0.12	Mean Bankfull Depth (m): 1.0	Right Bank	<input type="checkbox"/> <input checked="" type="checkbox"/> ← → <input checked="" type="checkbox"/> <input type="checkbox"/>

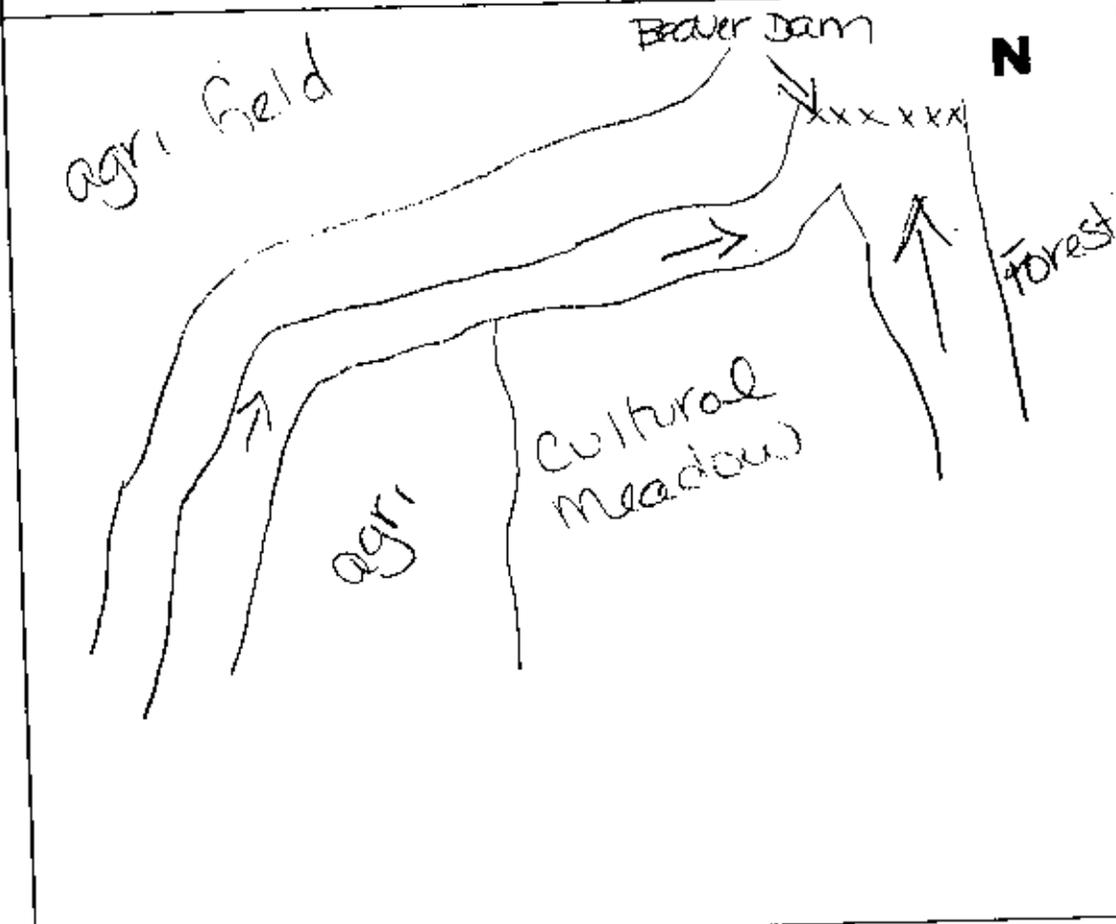
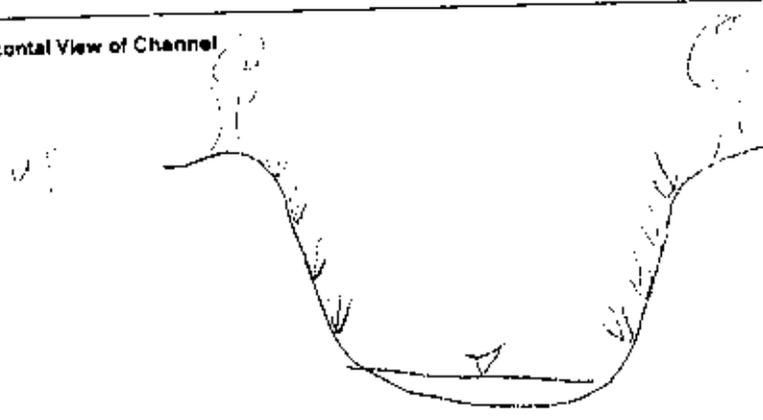
099

Horizontal View of Channel

<input type="checkbox"/>	<input type="checkbox"/>
Flow Description: no flow - bank up from Beaver dam			
Notes: bank scouring observed To B - 3.5 To B W - 7.8 m

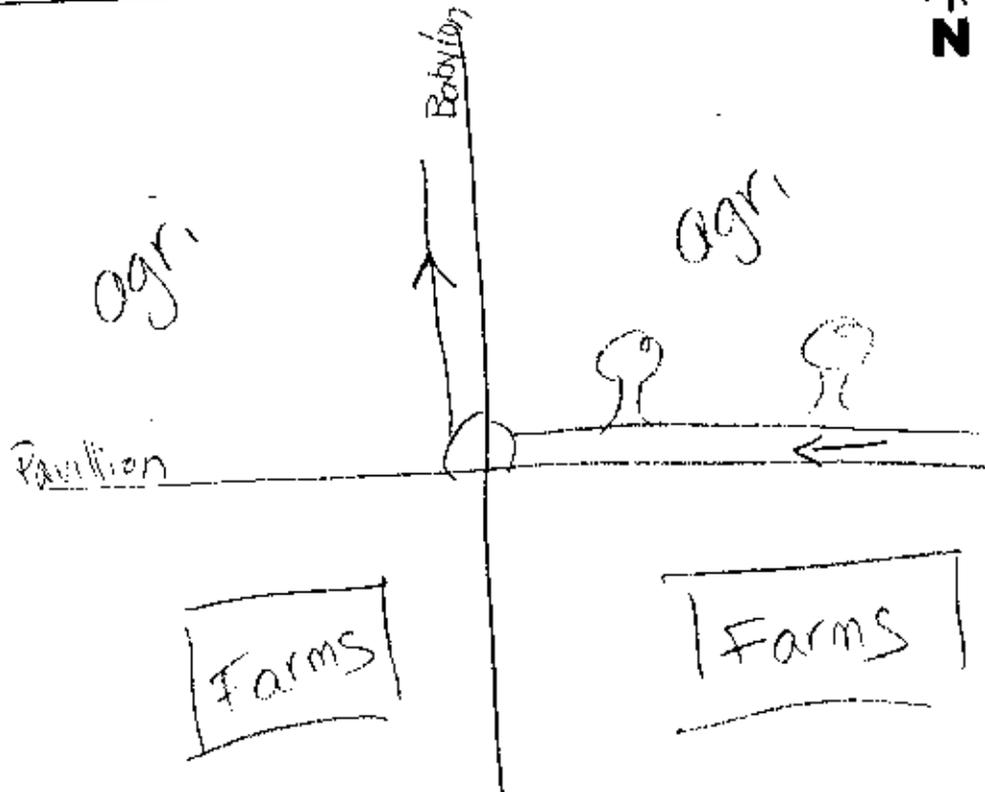
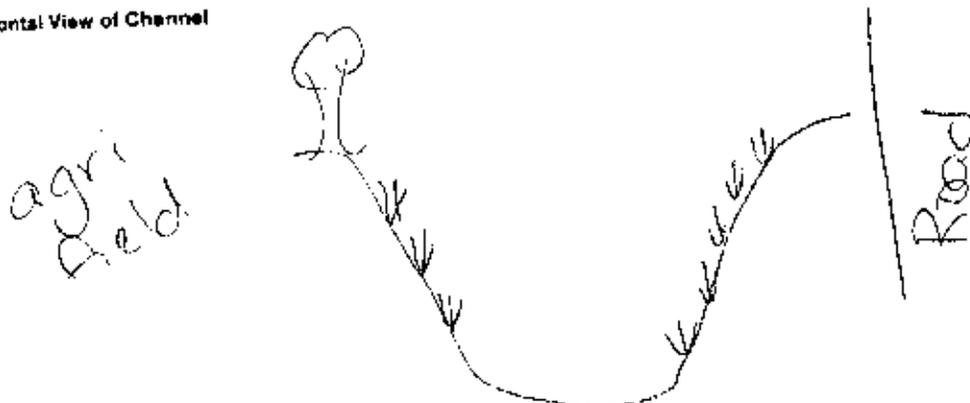
- agri drain along road - channeling of flows through broken cement culvert
- cultural meadow area
- grass lined channel
- some flow
- u/s - flows through pipe culvert - grass lined
- by main channel

Horizontal View of Channel

Notes: (include any inputs into the system i.e. tile drainage, seepages, overland flow)			
<u>tile drainage on both sides of road</u>			
<b>In-Situ Water Quality</b>		<b>Ground Water Indicators</b>	
WT (°C):	AT (°C):	Watercross <input checked="" type="checkbox"/>	Bank Seepage <input type="checkbox"/>
pH:	Cond (µm):	Iron Staining <input type="checkbox"/>	None <input type="checkbox"/>
Water Clarity: Clear <input checked="" type="checkbox"/>	Turbid <input type="checkbox"/>	Bubbling <input type="checkbox"/>	Other <input type="checkbox"/>
Notes:			
<b>Stream Morphology</b>			
Site Length (m):		Bank Stability:	
Channel Dimensions		Stable	Slightly unstable
Mean Wetted Width (m):	1.0	Mean Bankfull Width (m):	2.0
Mean Wetted Depth (m):	0.20	Mean Bankfull Depth (m):	1.0
		Left Bank	<input type="checkbox"/> Stable <input checked="" type="checkbox"/> Slightly unstable <input type="checkbox"/> Moderately unstable <input type="checkbox"/> Unstable

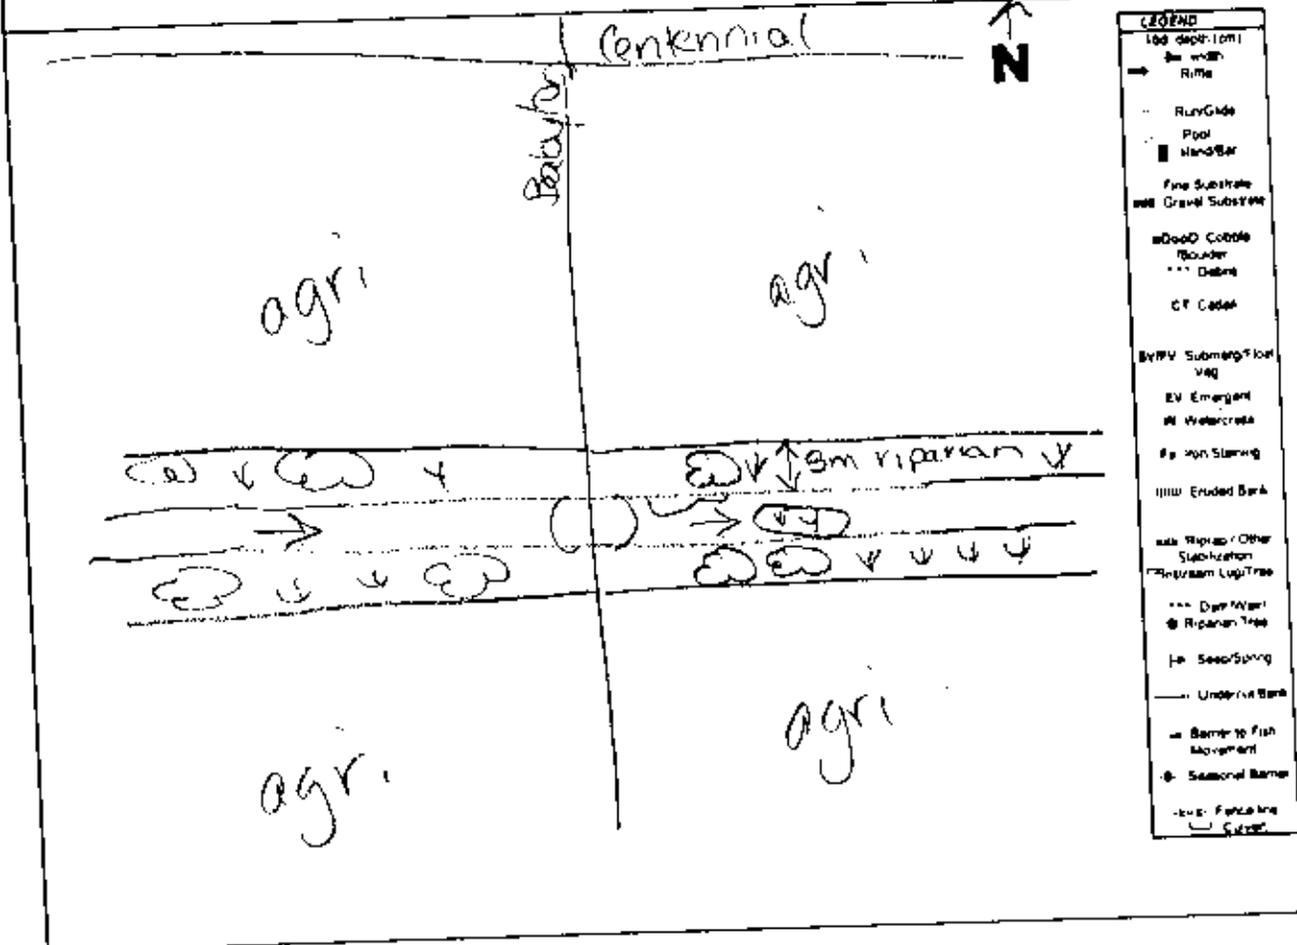
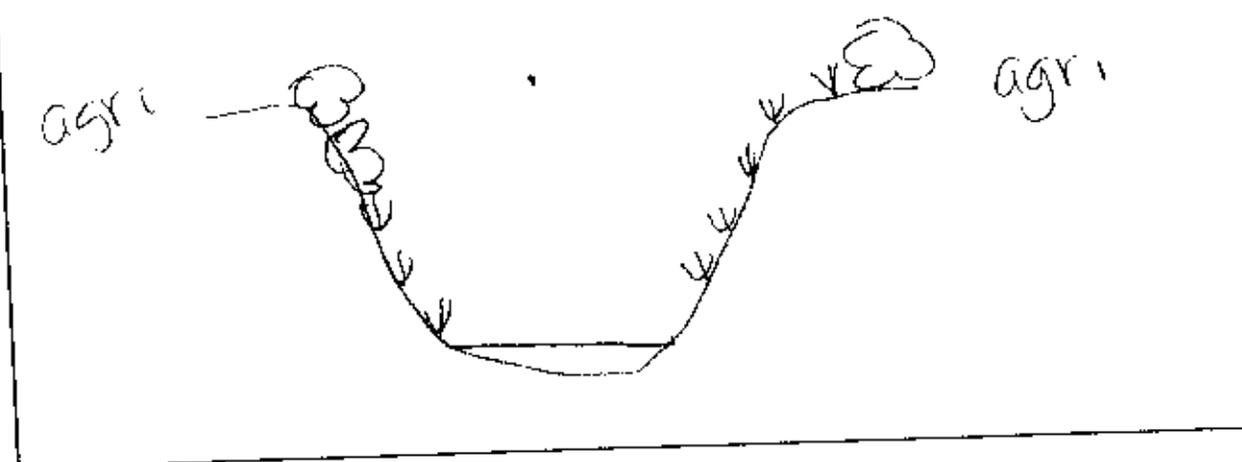
C52

Horizontal View of Channel

Other:			
Notes: (Include any inputs into the system i.e. tile drainage, seepages, overland flow)			
<u>agricultural channelized drainage</u>			
<u>tile drain on ULS LB side &amp; RB</u>			
In-Situ Water Quality		Ground Water Indicators	
WT (°C): <u>10.1°C</u>	AT (°C):	Watercress <input checked="" type="checkbox"/>	Bank Seepage <input type="checkbox"/>
pH: <u>8.18</u>	Cond (µm): <u>69</u>	Iron Staining <input type="checkbox"/>	None <input type="checkbox"/>
Water Clarity: Clear <input checked="" type="checkbox"/>	Turbid <input type="checkbox"/>	Bubbling <input type="checkbox"/>	Other <input type="checkbox"/>
Notes:			
Stream Morphology			
Site Length (m):		Bank Stability:	
Channel Dimensions		Stable	Slightly unstable
Mean Wetted Width (m): <u>2.00</u>	Mean Bankfull Width (m): <u>5.0</u>	Moderately unstable	Unstable
Mean Wetted Depth (m): <u>0.20</u>	Mean Bankfull Depth (m): <u>1.2</u>	Left Bank <input type="checkbox"/>	<input checked="" type="checkbox"/>

Right Bank <input type="checkbox"/>	<input checked="" type="checkbox"/>
Flow Description:			
Notes: <u>bank scouring observed</u>			
<u>TOB H - 2.5</u>			
<u>TOB W - 10m</u>

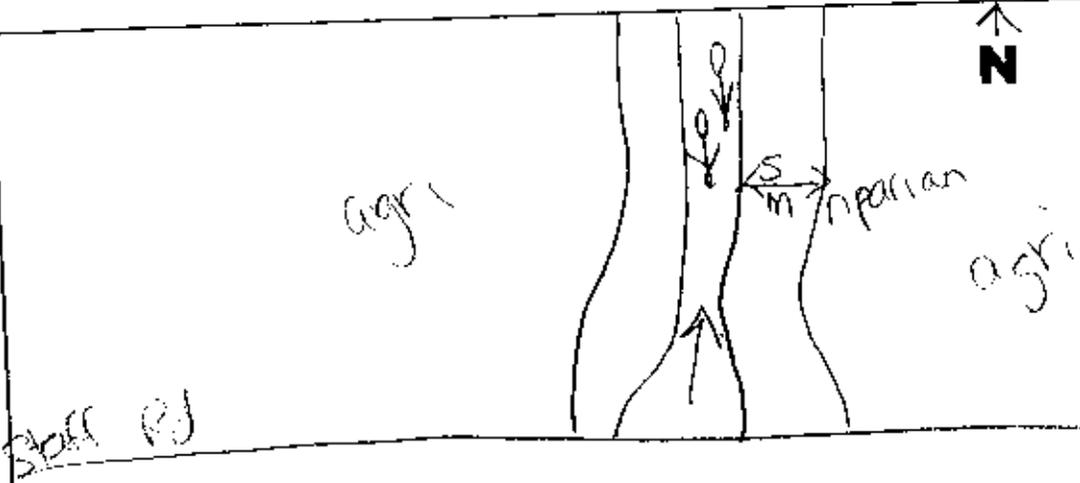
Study Area: Jericho Goshen Bluewater Land Parcel # 1452, 1453 Turbine # C Lolo

Watercourse Sketch

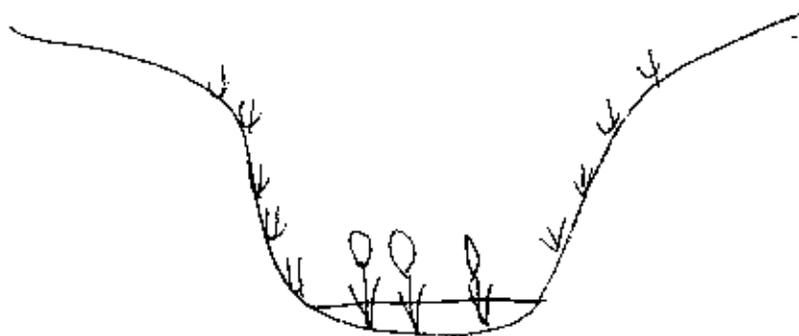
Wetland Site  
C104

Horizontal View of Channel

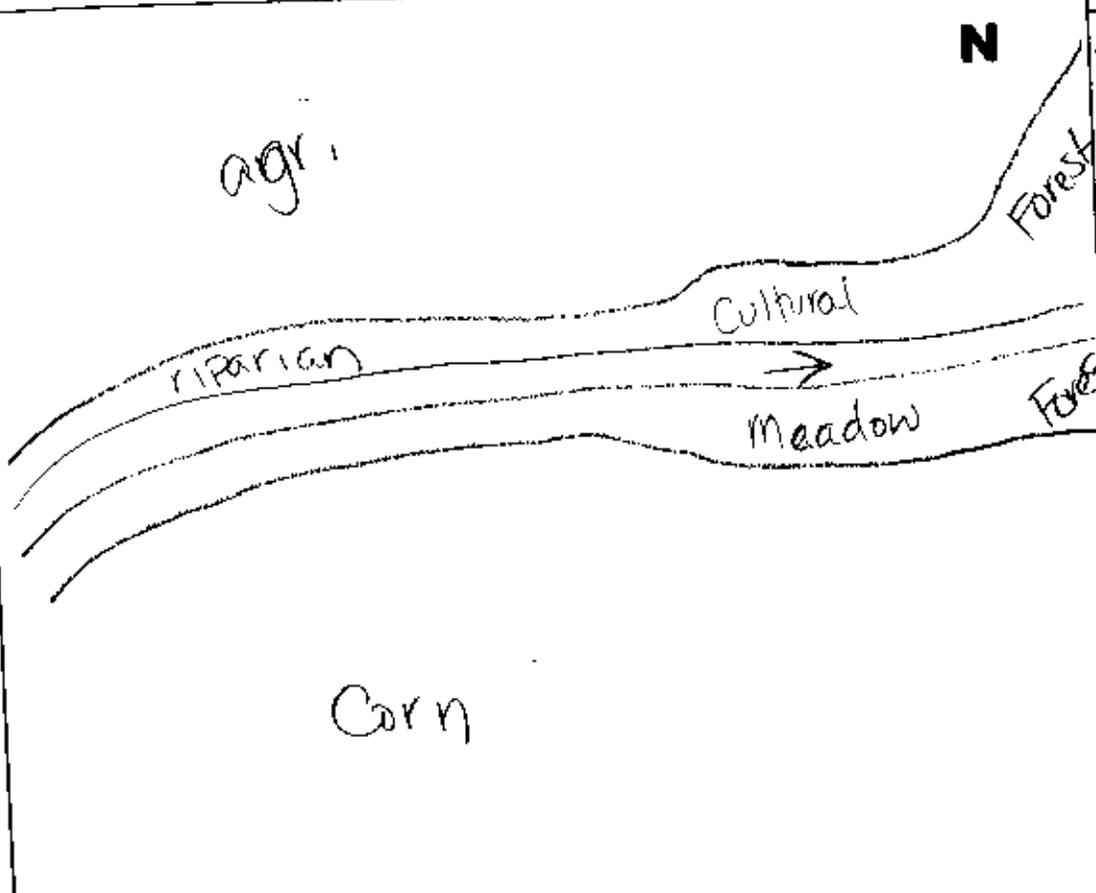
C 30

- 10d depth (cm)
- 6w width
- R/M
- Run/Side
- Pool
- Island/Bar
- Fine Substrate
- Gravel Substrate
- Wood Cobble Boulder
- \*\*\* Debris
- Capital
- SWW Submerged Veg
- EV Emergent Watercress
- Fe Iron Staining
- WHI Eroded Bank
- CCA Riprap / Other Stabilization
- Tree/Log/Tree
- \*\*\* Dam/Veget
- ⊙ Riparian Tree
- ⊙ Seep/Spring
- Underl Bank
- Barrier to Fish Movement
- ⊖ Seasonal Barrier
- Force the Current

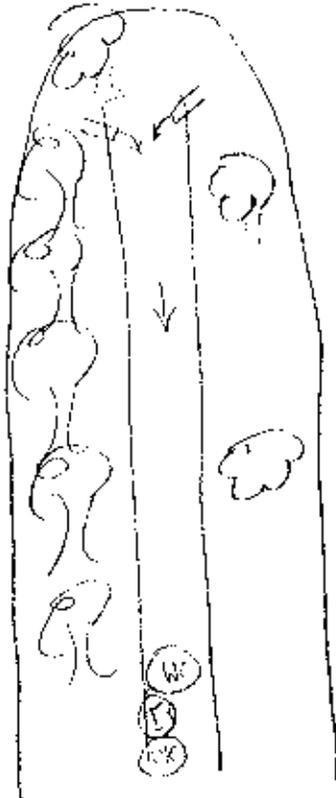
LEGEND	
10d	Depth (cm)
sw	width
cm	cm
---	Run/Glide
o	Pool
■	Island/Bar
---	Fine Substrate
---	Gravel Substrate
o	Dead Cobble
o	Boulder
---	Debris
CT	Cutbank
g	Submerged
g	Emergent Veg
g	Emergent
W	Watercress
F	Iron Staining
MM	Erosion Bank
---	Repair - Other
---	Stabilization
---	Structure Log/Tree
---	Dam/Weir
o	Repair Tree
o	Seep/Spring
---	Undercut Bank
---	Barrier to Fish Movement
---	Seasonal Barrier
---	Fence line
---	Gully

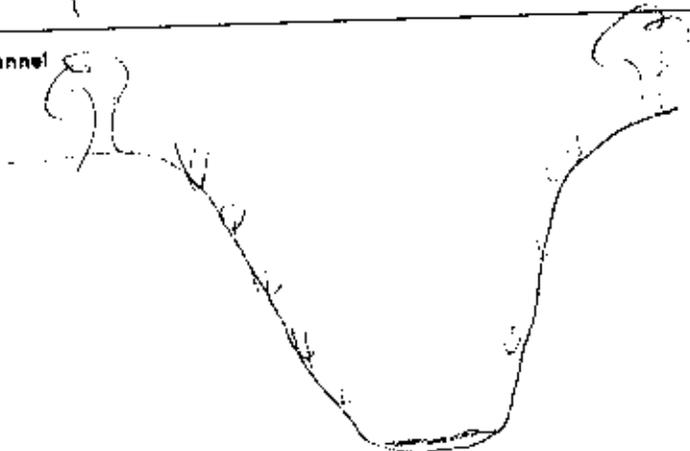
C112

Horizontal View of Channel
