# Appendix A

Estimated Zones of Potential  
Recharge and Discharge Areas

### Six Conservation Authorities Geological and Hydrogeological Model Project

## Assessment of Water Bodies and Distance to Project Components

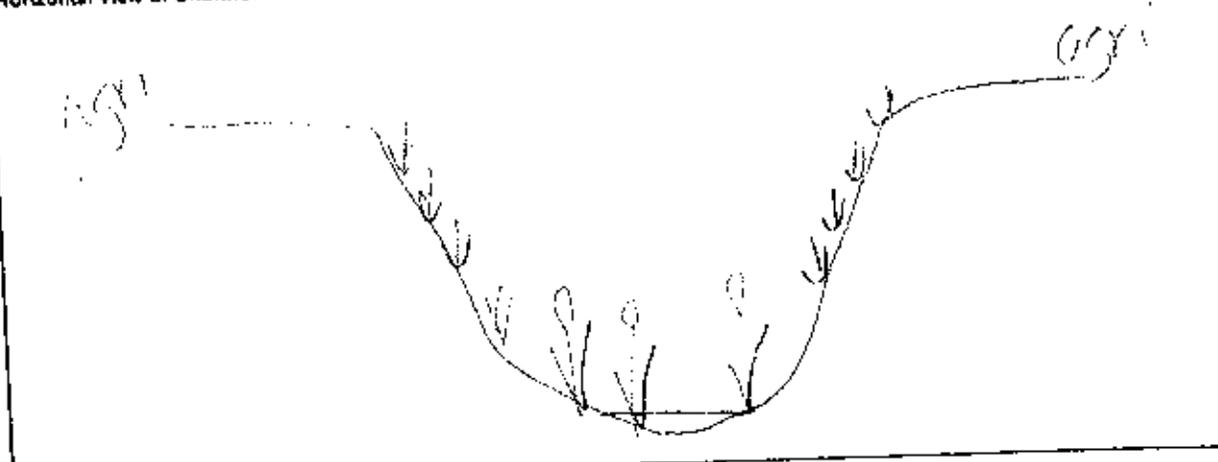
Horizontal View of Channel

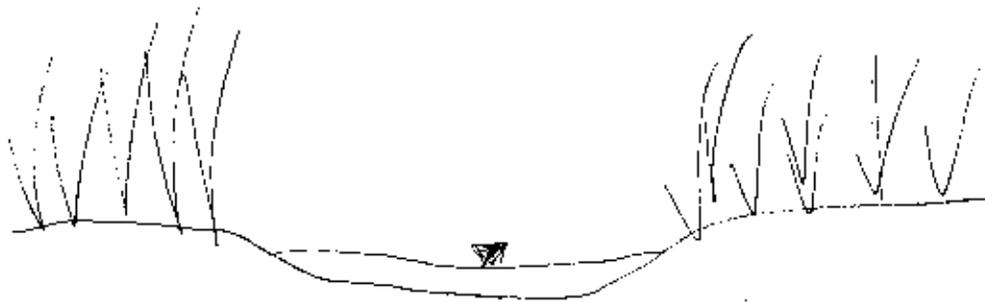
Horizontal View of Channel

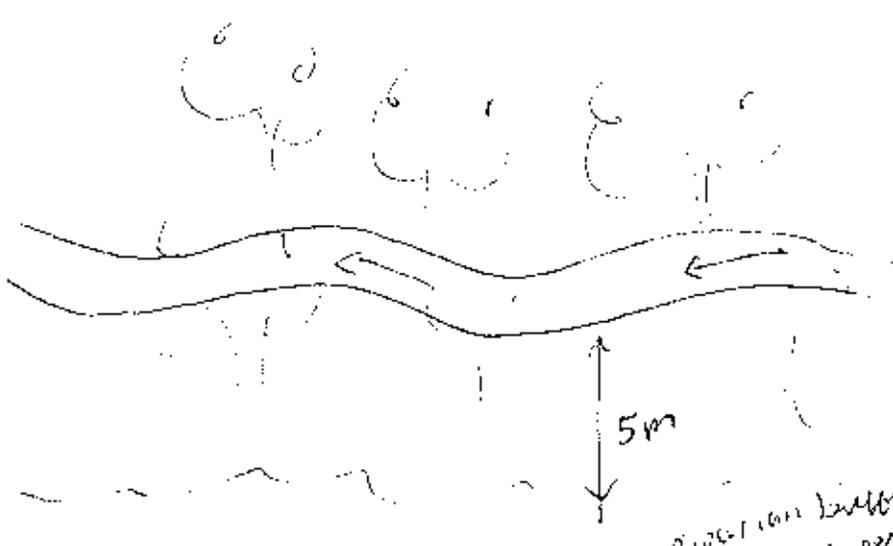
LEGEND	
100	Depth (cm)
80	Bank width
0.1m	Flow
-	Run/Gide
□	Pool
■	Island/Bar
-	Fine Substrate
	Gravel Substrate
o	Small Cobble
o	Large Boulder
---	Open
CT	Catch
	Supraglacial
	Veg
	Emergent
W	Watercress
	Iron Slating
	Eroded Bank
	Riprap / Other Stabilization
	Recessed Log/Tree
---	Dam/Weir
o	Riparian Tree
	Scrap/Song
---	Undercut Bank
---	Barrier to Fish Movement
---	Seasonal Barrier
---	Fence Line
---	Subnet

*Banker riparian habitat  
to deciduous trees  
by top of bank*

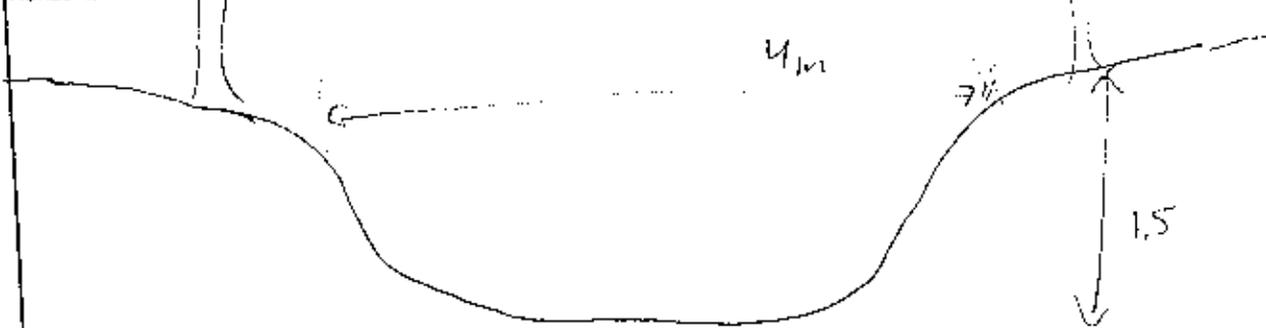
Horizontal View of Channel

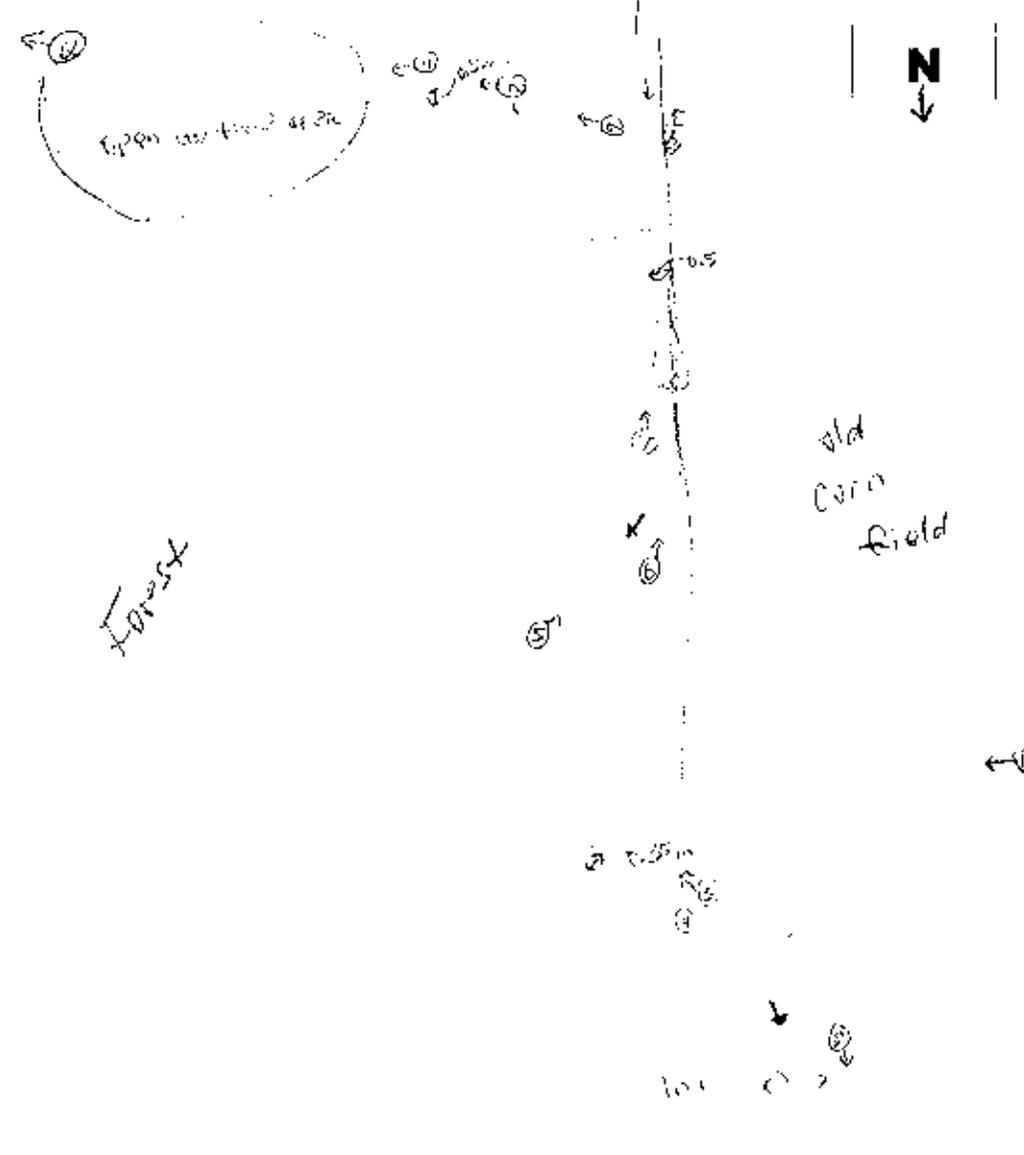
Study Area: Jericho Goshen Bluewater Land Parcel# BLV 1029 Site ID Turbine 19

B-93  
going into forest area

- 10g depth (cm)
- 6w width
- Rufa
- Rufa/Glide
- Pool
- Hard Bar
- Fine Substrate
- Gravel Substrate
- Cobble/ Boulder
- Debris
- OT Canal
- SWFV Submerged/Veg
- EV Emergent Vegetation
- W Watercress
- Fa Iron Staining
- AWH Eroded Bank
- R/Rap/Other Stabilization
- Instream Log/Tree
- Dam/Weir/Obstruction
- Riparian Tree
- Seep/Spring
- Undercut Bank
- Bank to Fish Movement
- Seasonal Barrier
- Fence line
- Subway
